Date: 7/19/2013 No. N-2036

Product Family: Pro-Turn 200 & 400 Series Mowers

Subject: ZT-5400 Transaxle

SUBJECT: Improperly Assembled ZT-5400 Bypass

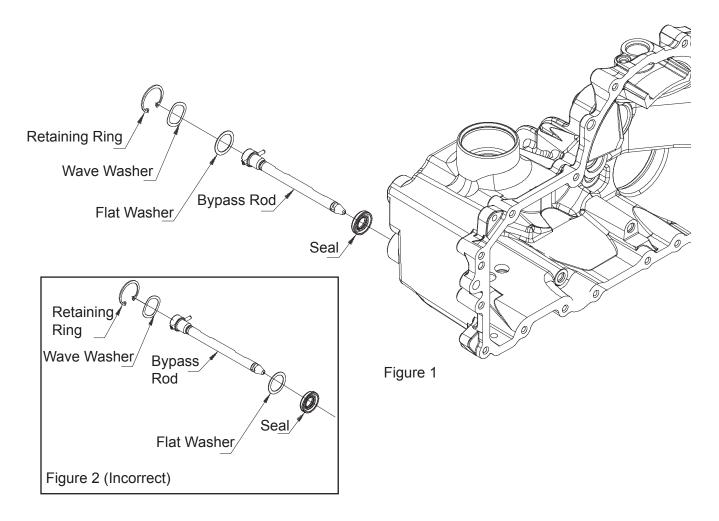
It has come to Hydro-Gear's attention that the bypass on some ZT-5400s may be assembled incorrectly. This can cause the transaxle to malfunction. Inspect the order of the transaxles bypass components. A correctly assembled bypass will have the seal, bypass rod, flat washer, wave washer and retaining ring installed in that order (see Figure 1). For example there have been reports of the bypass assembled incorrectly with the flat washer between the seal and the bypass rod (see Figure 2).

To correct this the retaining ring and wave washer will need to be removed and set aside. In order to keep oil loss to a minimum the bypass rod only needs to be partially removed. This will allow the technician to work the flat washer off the bypass rod. Once the flat washer was been removed the bypass rod can then be installed back into the transaxle. The flat washer, wave washer and retaining ring can then be installed (see Figure 1). Only a small amount of oil should be lost during this procedure. If needed, top off the reservoir.
