# Service Bulletin

**Product Family: Pro-Turn Mowers**

**Subject: Improper Clamping of Engine Pulley and Spacer**

## Kit Number: 59102100

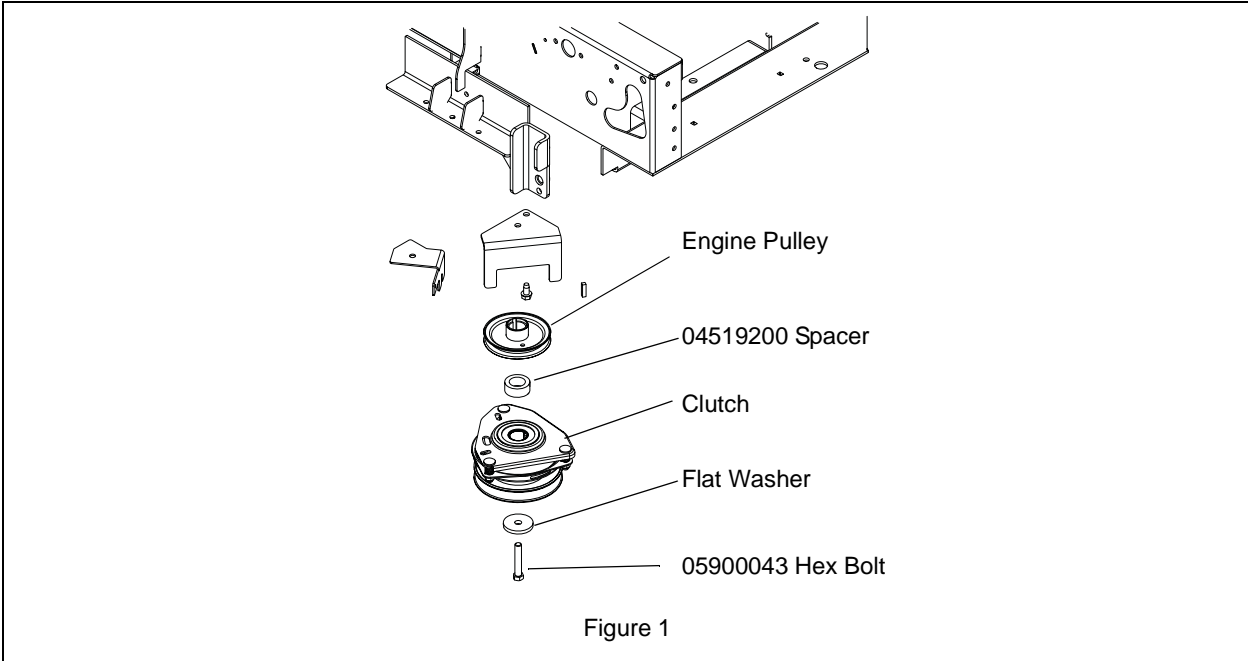
Figure 1

Ariens Company has learned that the engine pulley (p/n 07331600) and crankshaft spacer (p/n 04519200) used on the Pro-Turn models in the serial number ranges listed above may not be clamped tightly when the clutch is mounted. This possible condition is due to variances in the length of the engine crankshaft and the components mounted on the crankshaft.

The new spacer is slightly longer than the original to ensure that the clutch, spacer, and engine pulley are clamped tightly when properly mounted on the crankshaft. **The new spacer is gold in color so it can be easily distinguished from the original spacer which is black.**

The new clutch-mounting hex bolt is ¼" longer than the original to ensure adequate thread engagement.

To eliminate this condition, Ariens has created a clutch spacer kit p/n 59102100. This kit contains a new crankshaft spacer (p/n 04519200) and a new clutch mounting bolt (p/n 05900043). See Figure 1.

Dealers are to immediately inspect Pro-Turn mowers in their inventory with a serial number 21999 or below. If the spacer above the clutch is gold in color, no further action is necessary. If the spacer is black, then kit 59102100 must be installed prior to retail sale.
