GRAVELY Service Bulletin

Product Family: Pro-Turn 400 Series Mowers

Subject: Air Ride Seat 04383700

Dealer Action: Inspect and Correct as Necessary

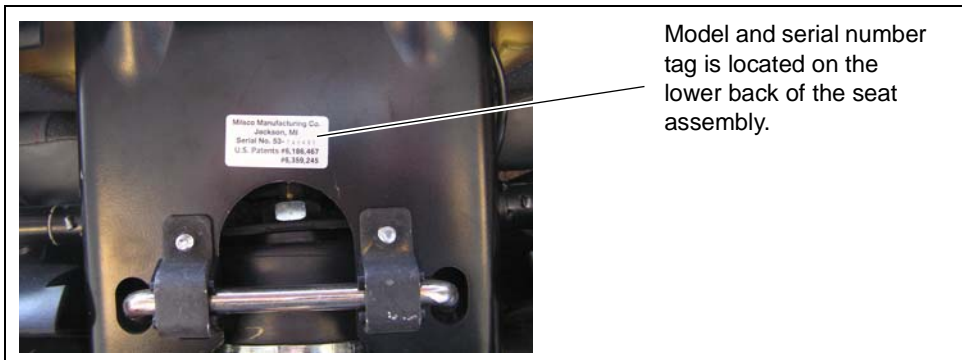
1. Check the Milsko serial number of the seat on an affected unit. If the serial number of the seat is above 53-798950 then it is not necessary to do any further inspection.

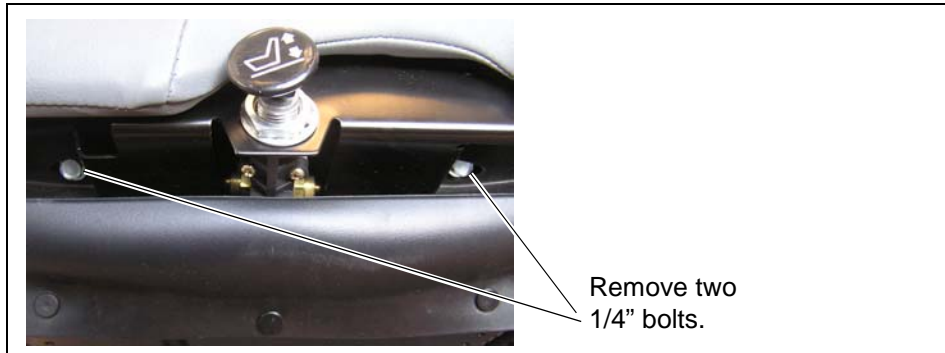
2. If the Milsco serial number is 53-798950 or below, remove the lower seat cushion. Remove two 1/4-20 bolts under the front of the cushion. Pull cushion up and forward to remove.

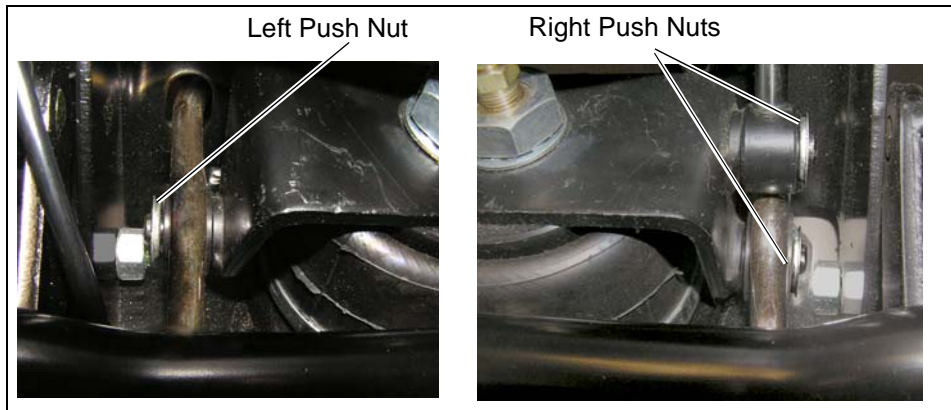
Ariens Company has discovered that push nuts used in the manufacture of air ride seats p/n 04383700 may not have been properly seated. In some cases, improperly seated push nuts have come off, allowing control arms attached to the air-spring saddle to come loose leading to the saddle bending and damaging the air-spring bellows.

3. Inspect the three push nuts holding the arms to the air-spring saddle. One is found on the left side and two are on the right side.

4. If the push nuts are not seated properly, use a forked pry bar or screw driver to push the nut into the correct position.
5. Properly seated, the push nut will be pressed against the lip on the shaft. The following photograph shows the lip with the push nut removed.
