# Errata Sheet

10 July 2000 / Release 1.5

<b>Device:</b>	<b>C505A-4RM, C505CA-4RM</b>
<b>Stepping Code / Marking:</b>	<b>ES-BA, BA</b>
<b>Package:</b>	<b>P-MQFP-44</b>

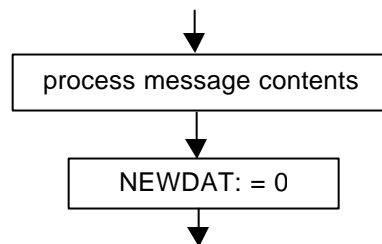
**CAN.4: Flowchart sequence in figure in User's Manual regarding Micro-controller handling of the Last Message Object is partly incorrect (C505CA only)**

For the software flowchart figure 6-37 in User's Manual 08.97, the correct would be to first 'process message contents' and then to 'clear bit NEWDAT'.
