MCF5280 Device Errata

By: Microcontroller Division

MCF5280DE
Rev. 2.0
01/2006

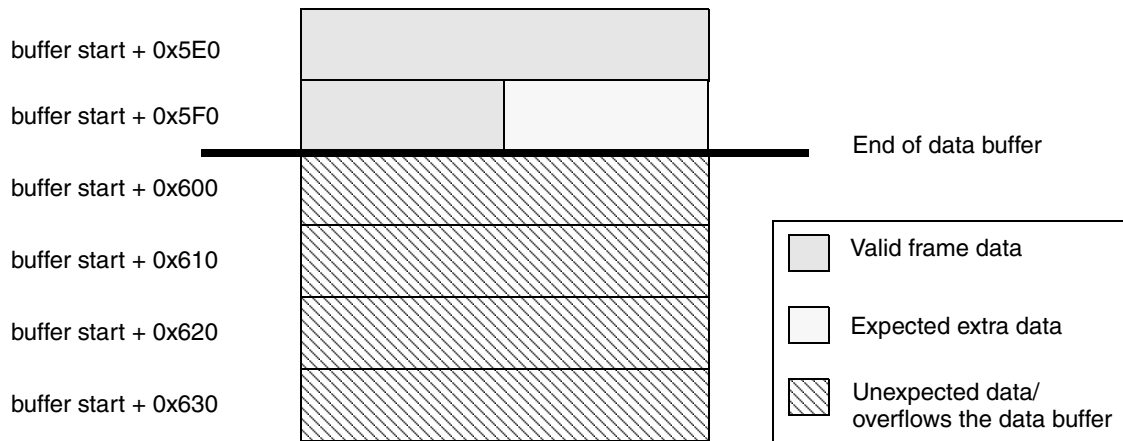
Figure 1. Buffer Overrun Example

When the FEC is connected to a 10BaseT network, if length of the data stored in a descriptor is not evenly divisible by 16 (not line-aligned), then the FEC will write extra lines at the end of the buffer—the entire line that contains the last valid data is written and at least one extra line, but up to four lines after the end of the valid data can also be written. In most cases this is not a problem, since the extra lines of data still fall within the limits of the buffer. However, if the valid data ends near the end of the buffer, then the extra lines written by the FEC might be outside of the data buffer. This leads to corruption of the next buffer, descriptor, data, or code stored in the adjacent memory.

For example, as shown in [Figure 1](#), if the max buffer size is programmed to 0x600 and a frame that is 0x5F8 bytes long is received, then a line is written starting at buffer start + 0x5F0. The first half of the line at buffer start + 0x5F0 is valid frame data that should be processed by the FEC driver; the second half of the line is additional data that is written because the FEC will only write complete lines. This data should be ignored by the FEC driver. So far, this is correct FEC behavior as originally specified. However, the FEC will repeat the last line of valid data a number of times. The line at buffer start + 0x600 will be written, and as many as three additional lines beyond the end of the data buffer could be written.

1. Only use 100BaseT.

2. Allocate extra lines for the receive data buffers. The actual allocated memory for each buffer should be equal to the receive buffer size programmed in the FEC's EMRBR register plus four lines (16 byte-sized lines).
3. Program the data buffer size one line larger than the max packet size (data buffer size = EMRBR + 0x40).
