Maintenance Experience

Data Products Issue 4, 2009

- One Special Document
- Ten Maintenance Cases of ZTE's Data Products

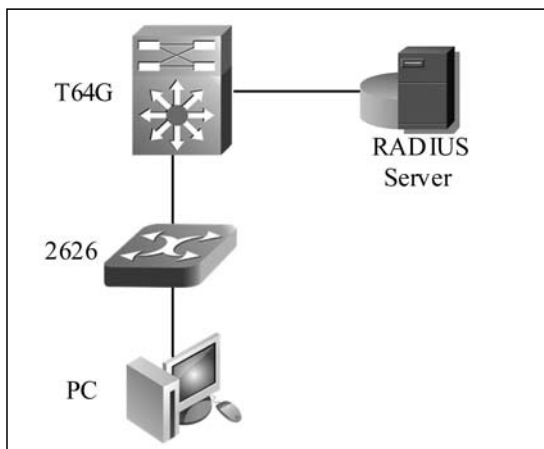
Figure 1. 802.1x Authentication Disconnection Malfunction

User PC passed the authentication by ZXISAM and was connected to the Internet properly. However, ZXIASM authentication frequently failed after user restarted the PC.

if they pinged the gateway of 2626 by 2626 when the authentication was failed. Engineers used command **show arp** in T64G to view ARP entry. The result showed that ARP information of 2626 always could not be learnt.

The malfunction reason was clear now. The disconnection between authenticator system and authentication system caused the failure of the user authentication.

Engineers used the command `arp add <A.B.C.D> <xx.xx.xx.xx.xx>` in T64G to statically bind ARP entry of 2626. Here, <A.B.C.D> is the IP address, and <XX.XX.XX.XX.XX> is the MAC address. After that, engineers pinged the gateway of 2626 in 2626 again, and they found the connection was recovered and no packet was lost. Engineers pinged Radius server and still no packets were lost. In this time, user could pass the authentication and accessed to the Internet. ■

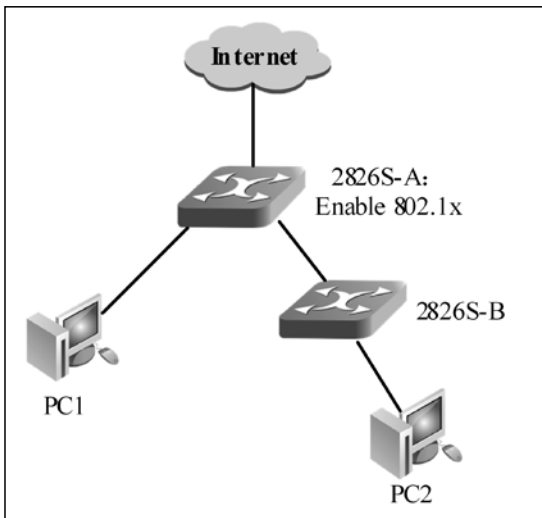
Figure 1. Network Structure

As shown in Figure 1, ZXR10 2826S switches A and B composed the network. 802.1X was enabled in 2826S-A. 2826-B acted as HUB for accessing without any configuration. The users connected to 2826-B could not pass Radius authentication.

Engineers planned to connect a HUB to 2826S-A for user accessing. However, engineers found that 2826S-B could not act as HUB without any configuration and PC2 could not pass the authentication.

Thus it could be seen that ZXR10 2826S could not process 802.1x packet like a HUB if without any configuration. By default, 802.1x transparent transmission function is disabled in ZXR10 2826S. That is to say, 802.1x protocol packets could not be transparently transmitted by 2826S. Therefore, the connected user failed to pass authentication.

The following command is used to enable 802.1x transparent transmission function.

```
zte(cfg)# set dot1x-relay enable
```

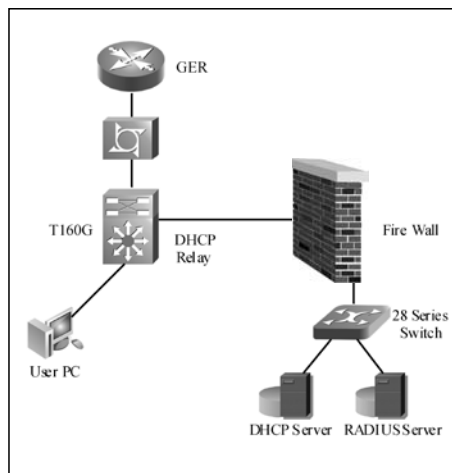
Figure 1. DHCP Relay

As shown in Figure 1, DHCP server function was configured in Radius server, DHCP Relay was configured in T160G. However, user PC failed to automatically obtain IP address in T160G.

5. Engineers inspected relay information of DHCP Server. They found the fault reason that DHCP relay address was the interconnection address between T160G and firewall. The correct relay address shall be gateway address of users.

Engineers modified DHCP relay address and tested again. PC could obtain IP address and connected to the Internet. The malfunction was recovered. ■

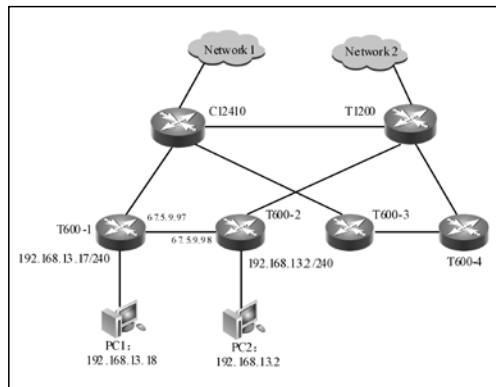
Figure 1. DCN Network Topology

- PC1 and PC2 could not ping each other successfully.
- T600-2 could not ping PC1, but T600-1 could ping PC2.

5. Engineers found that PC 2 gateway and mask configuration were correct, but the malfunction occurred due to PC1 gateway, mask configuration or other factors.

The mask configuration of PC1 was incorrect so that PC1 recognized that it and PC2 belonged to the same network segment. Therefore, after PC1 received packets from PC2, it would send ARP request to ask PC2 MAC address but not send ping respond packet to T600-1. Additionally, engineer could not ping PC1 in T600-2 because the ping packet sent by T600-2's MAC source address was 192.168.13.1. ■

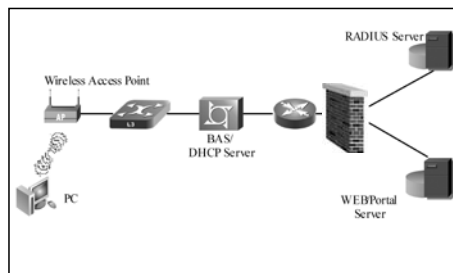
Figure 1. WLAN+DHCP+WEB Authentication Topology

When user entered any website in IE browser, such as www.zte.com.cn, an authentication interface appeared. However, when user entered user name and password for web authentication, a prompt of “authentication failure, for some reasons, code 13000001, information: server is busy, please try it later” or “error information: 11001000, SDX error” appeared.

7. Engineers contacted the staff from Portal manufactory again. The staff found that challenge packets had been sent to BRAS by Portal server, but there were no BRAS reply packets. BRAS nas-ip-address and user IP addresses had been added into Portal server. At this time, engineers could not find any user information or Challenge packets even if they captured packets or used **debug radius user** command in BRAS.

8. Engineers contacted the staff from operator to check the policy information performed by firewall for Portal server. Finally, operator staff found that he configured an incorrect Portal server address.

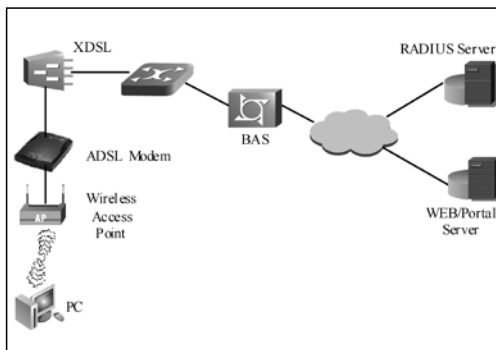
Figure 1. Network Topology

Malfunction phenomenon 2: When users entered their user name and password in authentication webpage, No.15 alarm "communication with Portal Server is failed" appeared.

Malfunction 1 is usually caused by incorrect configuration of special acl. However, engineers found that special acl was configured correctly already. Here, the IP addresses of Portal server and DNS were permitted, and engineers could ping the IP addresses of Portal server and DNS server in PC.

If a website is based on HTTPS, it can not be accessed by entering "http://x.x.x.x". The differences between HTTP and HTTPS caused malfunction 1.

Engineers searched Radius attribute table, and they found the attribute of NAS-PORT-TYPE was 16 if the access mode was XDSL. However, when access mode was WIRELESS_IEEE802_11, the attribute was 19. The configuration of access type in BRAS sub-interface influenced this attribute. In malfunction 2, PC was connected to switch without AP, therefore, the access type of BRAS sub-interface should be Ethernet.

1. The force-web can not appear for WLAN users because of the incorrect special acl configuration. However, the malfunction 2 was caused by HTTPS. Therefore, engineers need to communicate with Portal server staff in detail when configuring parameters, including IP address and port of Portal server, monitoring port and so on. Engineers need to check which kind of protocols is used for authentication webpage, HTTPS or HTTP.

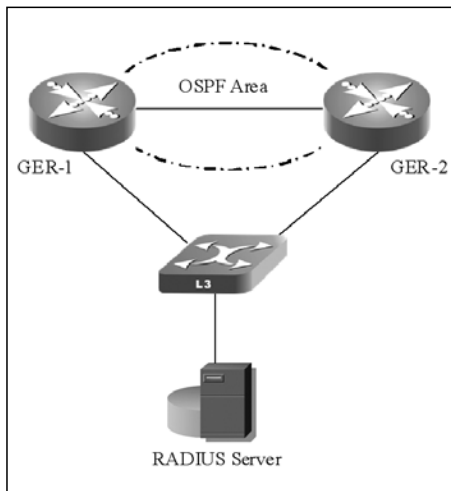
Figure 1. VRRP Packet Loss

After GER-1 restarted, the packets sent from Radius server to the devices in other network segments would be lost in a short time.

From the above information, engineers found that system adopted VRRP preempt by default even if VRRP preempt was not configured in the interface.

Engineers suspected that the master gateway of GER-1 had switched to GER-1 already after GER-1 restarted, but the convergence of OSPF route has not been finished yet in GER-1. That caused the packet loss.

Another solution is to cancel VRRP preempt. After GER-1 restarted, the master gateway switched to GER-2. If GER-2 is failed, the master gateway will be switched back to GER-1. Engineers did not know the original network design idea, so they respected and followed the original design to make GER-1 as master gateway.
