Device **XC878CLM Series**
Marking/Step **AC**
Package **PG-LQFP-64**

This Errata Sheet describes the deviations from the current user documentation. The module oriented classification and numbering system uses an ascending sequence over several derivatives, including already solved deviations. So gaps inside this enumeration can occur.

- XC878CM-13/16FF
- XC878CLM-13/16FF

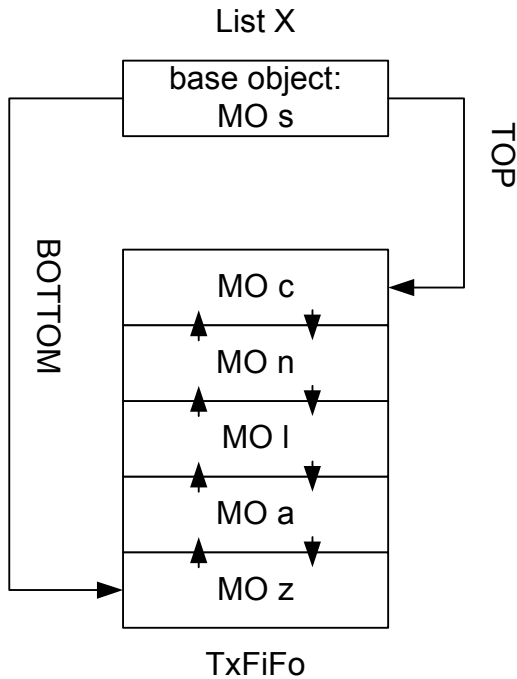
Figure 1 FIFO structure

A Tx FIFO overflow interrupt will not be generated after the transmission of the Tx FIFO base object.

If Tx FIFO overflow interrupt needed, take the FIFO base object out of the circular list of the Tx message objects. That is to say, just use the FIFO base object for FIFO control, but not to store a Tx message.

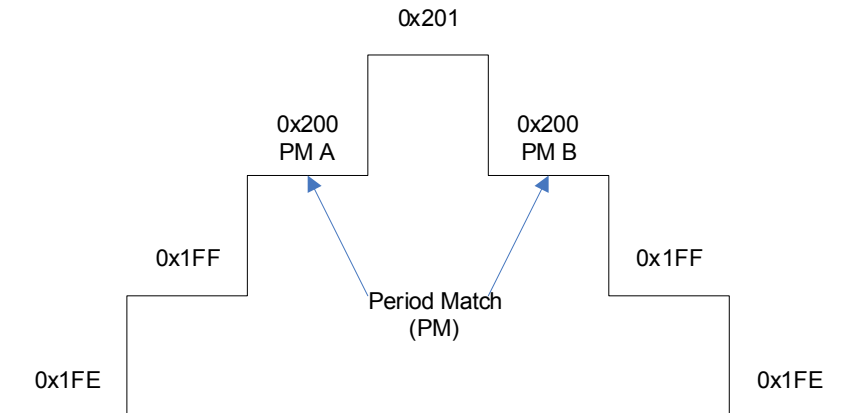
Figure 3 Counting sequence of T12 in center-aligned mode

After detecting a period match (PM A) in centre-aligned mode, T12 counts down from PM + 1 as shown below:

This means a second PM event (PM B) will occur during the counting down. If ADC is triggered externally via ETRx2 (T12PM), it will be triggered twice in succession. Depending on how real-time the application code is running as well

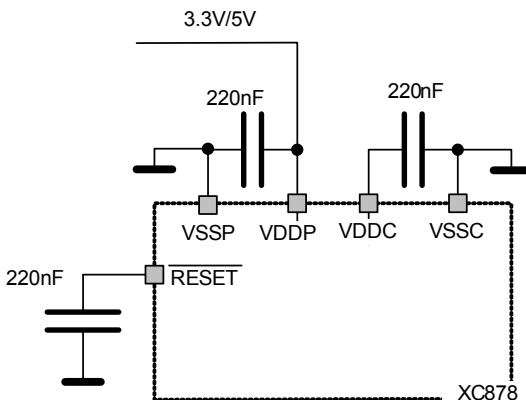
Figure 4 Noise Immunity Enhancement Circuitry

During power up, the EVR functionality may be affected due to injected noise from any functional pin. In order to enhance the noise immunity, the external reset pin RESET must be asserted until VDDC reaches $0.9 * VDDC$. The delay of external reset can be realized by an external capacitor at RESET pin. This capacitor value must be selected so that VRESET reaches 0.4 V, but not before VDDC reaches $0.9 * VDDC$.

A typical application example is shown in **Figure 4**. A 220 nF capacitor is connected to VDDP pin, VDDC pin and RESET pin. In addition, it is also essential to put it as close as possible to the chip.

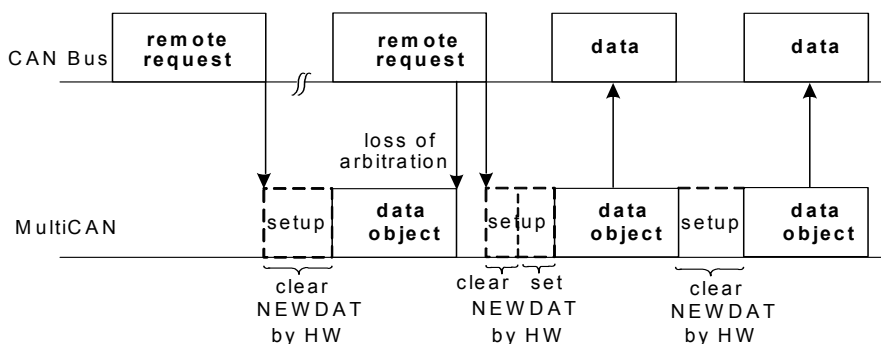
Figure 6 Loss of Arbitration
PIN_XC8.H001 Current over GPIO pin must not source V_{DDP} higher than 0.3V

When the appropriate message object (data frame) triggered by the first remote frame wins the arbitration, it will be sent out and NEWDAT is not reset. This leads to an additional data frame, that will be sent by this message object (clearing NEWDAT).

There will, however, not be more data frames than there are corresponding remote requests.
