# HP LaserJet Product UPDATE Newsletter.

# HP Monochrome LaserJet printer updates

## HP LaserJet P2015 Series Printer: Abnormal LED pattern

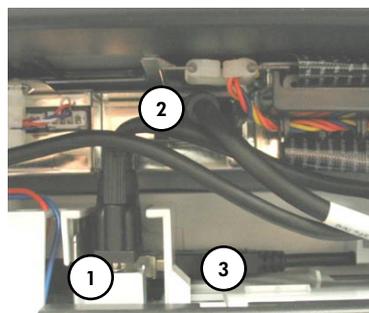
**Figure 3.** Cables at rear of scanner (rear cover removed)

5/6C – Check scanner cabling: if a boot-up hang occurs at this phase, power down the MFP and remove the rear cover of the scanner. Reseat the cable connections as indicated below:

1. Reseat PCI-e cable at top of ICB
2. Reseat PCI-e cable at SCB pca
3. Reseat Control Panel USB cable at side of ICB

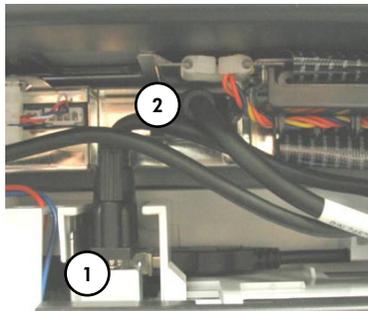
**Figure 3.** Cables at rear of scanner (rear cover removed)

The 30.01.41 scanner error is the result of lost communication between the formatter and the scanner control board (SCB). The message can also be displayed as “Scanner error, Scanner power, Cable, and CPB” (the copy process board [CPB] on this product is combined with the SCB).

1. Upgrade the firmware (RFU) to 53.011.2. (This revision contains a fix which resolves a potential timing conflict at boot-up).
2. If the 30.01.41 continues and is intermittent, it is likely related to a seating issue with one of the cables in the communication path. Perform the following steps:
  - Reseat the formatter
  - Reseat the PCI-e cable at the top of the ICB (#1 below)
  - Reseat the PCI-e cable at the SCB (#2 below)

If the 30.01.41 is a hard failure, try reseating the cables as indicated above. Carefully inspect the standoffs into which the cable attaches on the SCB. Verify the standoffs are securely fastened to the SCB. If the failure persists, replace the SCB (CC454-60003).

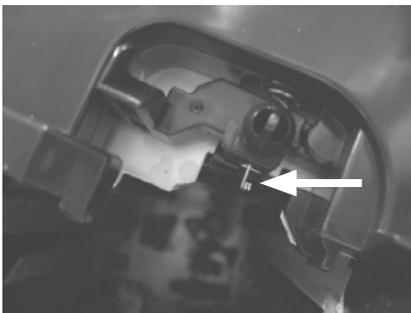
Figure 1a. Good lock lever

If a color is missing when the device is first powered on, remove the print cartridge and check the front of the cartridge slot at the top. If the pressure lever on the slot is broken, the ground spring will be pulled up and away from the cartridge and the color will not print (see Figures 1a and 1b).

Replace the pressure lever (RC2-3983-000CN). The instructions for replacement can be found in document cxxxxxxx.

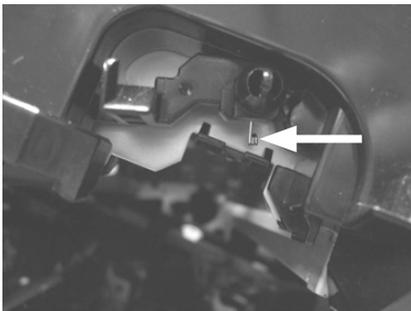
Figure 1b. Broken lock lever

Rough handling during shipment causes the pressure lever to fail. The lever provides the ground path for the drum current during image formation. If there is no ground, there is no image. A newly designed pressure lever will soon be implemented to provide greater immunity to rough handling during shipping.

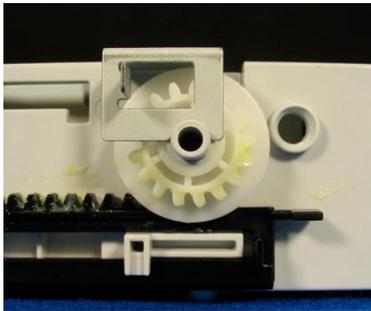
**Figure 4a.** Tray 2 present flag in correct position on gear shaft.

Check the Tray 2 present flag on the back of the tray. The flag can be knocked out of position when reinstalling the tray if the tray is not correctly positioned on the rails. Reposition the flag to fix the problem.

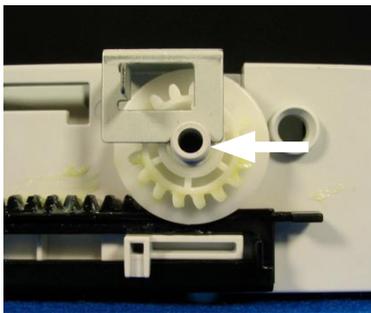
**Figure 4b.** Tray 2 present flag incorrectly positioned on flange of shaft – needs to be moved down to ride on the shaft.

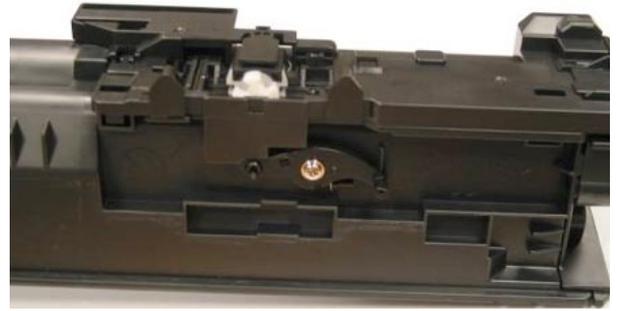
After printing as few as 800 pages from a new print cartridge, the Replace <Color> Cartridge message appears on the control panel (due to the nature of the issue, toner may have spilled inside the printer as well). This typically occurs because the toner gates of the print cartridge and the image drum are out of sync during installation, thereby preventing toner from moving from the print cartridge into the image drum. When the image drum requests toner from the print cartridge and the level does not change in the image drum, the cartridge is assumed by the system to be empty and a Replace <Color> Cartridge message appears on the control panel.

is closed. Open the shutter to see the gate. The image on the left shows the gate open. The gate is closed in the image on the right – this is the proper position when the cartridge is outside the printer.

1. Remove the individual color print cartridge indicated in the control panel error message.
2. Turn the cartridge upside down, as shown in the image below.
3. Check to make sure the toner gate on the cartridge

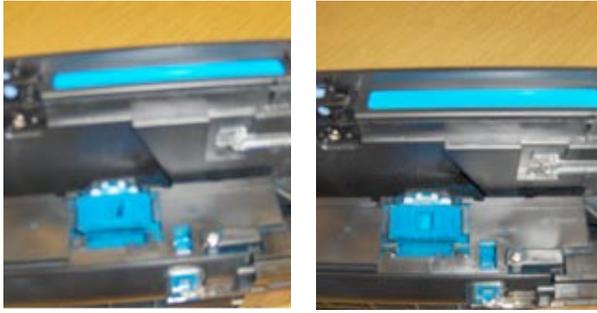
7. Locate the toner gate on the top rear of the image drum. The image on the left shows the gate open and the image on the right shows the gate closed. Closed is the proper position when the image drum is outside the printer.

8. If the gate is open, press the black lever release down, then turn the white gear until the gate closes completely (see image below).

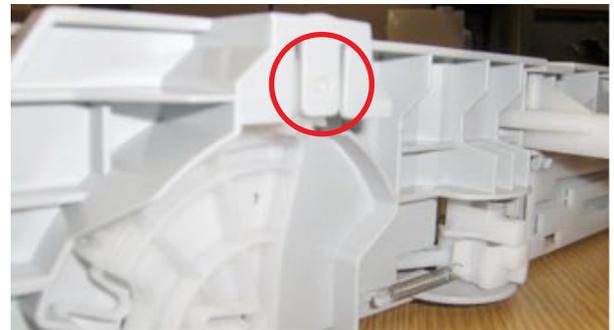
Tab in the correct position.

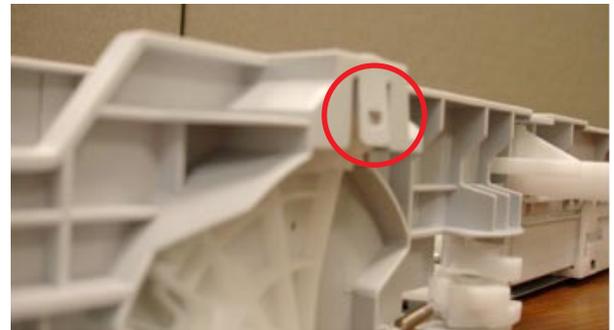
Tab pulled out of position.

2. If the tab is pulled out of position, the gear will not mesh with the gear on the lift assembly, causing a grinding noise as the lift assembly attempts to lift the tray.
3. Replace the paper tray. The tab is being reinforced to keep this from occurring in the future.
