**Device**            **C164CM-4EF**  
**Marking/Step**   **Step (E)ES-AB, AB**  
**Package**           **P-TQFP-64**

This Errata Sheet describes the deviations from the current user documentation.

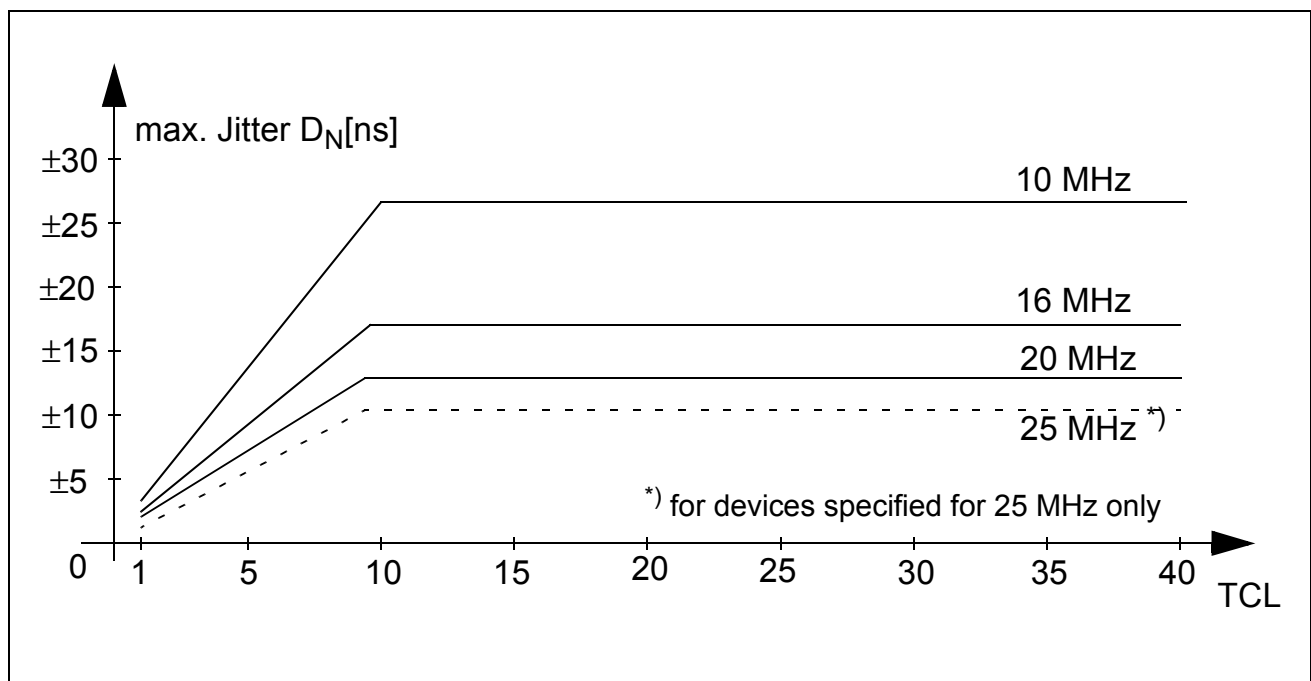
Figure 1 Additional Jitter

The value of the additional jitter is not a fixed one but it depends on the kind of activity on the external bus or output pins. The additional jitter increases with the number of output/bus pins which are switched at the same time to a new voltage level because the problem is caused by noise on the on-chip power supply.

The accumulated jitter is in the specified range for accumulated periodes longer than N = 40 TCL.

In the case that the additional jitter causes problems in the system which cannot be relaxed with software adapted timing parameters the following workarounds are possible:

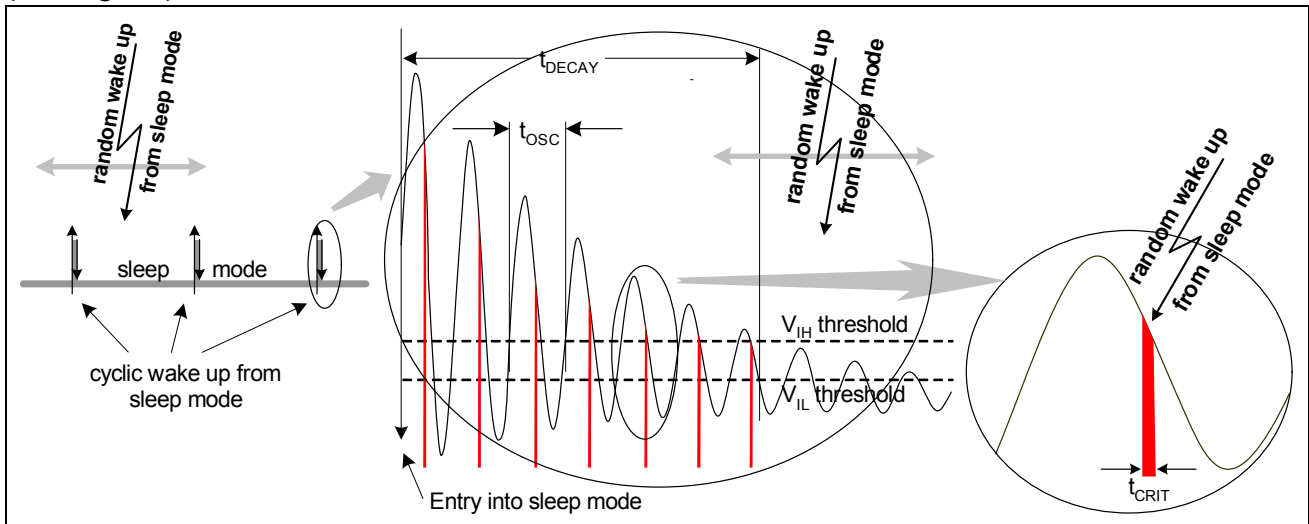
**Figure 2 Critical Event**

Due to a synchronization problem, the device may not correctly wake up from sleep mode if an asynchronous external wake up trigger occurs already in the oscillator decay time, i.e. in a particular time window before the device has actually entered sleep mode (see figure)

3. the external wake up trigger signal (fast external interrupt or signal on pin  $\overline{\text{NMI}}$ ) coincides with the critical time window ( $t_{\text{CRIT}}$ ) of each oscillator cycle during the decay time of the clock signal at pin XTAL1 (critical times shown in red in figure)

The problem occurs only in the decay time of the main oscillator and in a very small window around the clock edge at XTAL1 ( $t_{\text{CRIT}}$  is about 5 ps wide).

- Select RTC on in sleep mode (SYSCON1.SLEEPCON = 01<sub>B</sub>).  
For devices with auxiliary oscillator (e.g. C161CS), select main oscillator as clock source (SYSCON2.RCS = 0).
- Avoid a wake up during the main oscillator decay time

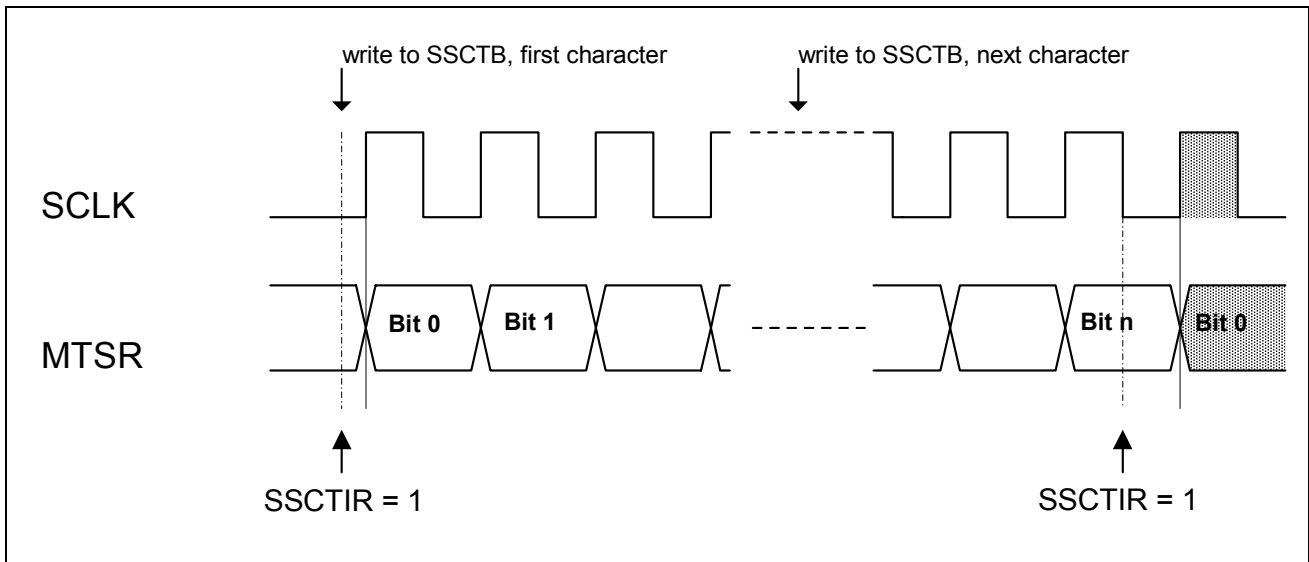
**Figure 3 SSCTB Timing**

When SSCTB has been written while the transmit shift register was empty (and the SSC is enabled), flag SSCTIR is set to '1' directly after completion of the write operation, independent of the selected baud rate. When the transmit shift register is not empty when SSCTB was written, SSCTIR is set to '1' after the last latching edge of SCLK (= 1/2 bit time before the first shifting edge of the next character). See also e.g. C167CR User's Manual V3.1, p. 12-5.

Typically, in interrupt driven systems, no problems are expected from the modified timing of flag SSCTIR. However, when flag SSCTIR is polled by software in combination with other flags which are set/cleared at the end or at the beginning of a transfer (e.g. SSCBSY), the modified timing may have an effect.
