August 2013

Lesson Learned

- Vetting Issues
- Safety issues: Use of portable gas detection instruments
- Collision Analysys
- The Academic Lesson: excursus on B/L

Information Sharing Bulletin
is published by:
Premuda SpA - SQE Dept.
Email: sqe@premuda.net

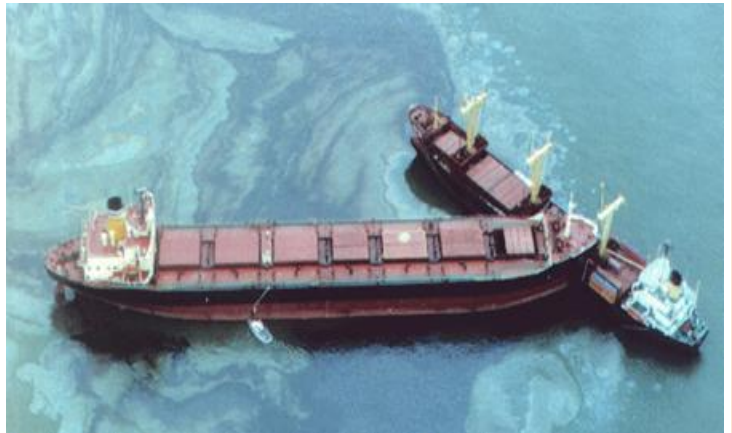
Collision between vessel at pilot station

A tanker collided with a dry cargo vessel at a river entrance. The tanker was outbound and approaching the pilot station to disembark the pilot, while the dry cargo ship had just picked up a pilot a few minutes before the collision. It was daylight but dense fog reduced the visibility to about 120 meters. Both vessels were preoccupied with pilot embarkation/disembarkation preparations. There were only the pilot and the master on the bridge of the tanker. The master was distracted with manual steering and the pilot was occupied with disembarkation arrangements. Due to circumstances of traffic and tidal current, the dry cargo ship was about 0.4 miles in the way of the outgoing channel. The vessels were aware of each other's presence 6-7 minutes prior to the accident. The pilot of the tanker tried to contact the dry cargo ship for several minutes in vain. Later, the pilots had communicated their intentions and agreed that the tanker would head southerly and pass from the port side of the cargo ship. But the pilot of the tanker was again distracted with disembarkation arrangements and did not make the agreed manoeuvre. The last attempts of communication were unsuccessful due to radio interference. Shortly afterwards, both ships came in sight of each other and it was realized that a collision was imminent. The pilots advised to put the helm midship and to go full astern, however, the two vessels collided. There was a VTS in operation in the region but VTS operators were passive during the development of dangerous situations.

The tanker suffered damage to her bow. The dry cargo ship suffered damage on the port side under the forecastle area in way of the forepeak store, forepeak tank, anchor hawsepipe, and indentation under the water line in way of forepeak tank and bulbous bow. There were no injuries or pollution.

- The dry cargo ship drifted too much southward, well in way of the outbound traffic due to strong tidal current. Her speed was reduced considerably as she was getting ready to pick up the pilot, and this increased her drift and she landed in way of the outbound traffic lane. The bridge team of the dry cargo ship and the pilot were late to realize the developing danger caused by the ship's position.

- The bridge on the tanker was insufficiently manned in the circumstances and conditions. It did not comply with company requirements or port authority instructions to pilots, however, no additional resources were requested by the pilot.

- The navigator must have a good knowledge of the manoeuvring capabilities of the vessel.
- A detailed risk assessment should be carried out before entering areas of restricted sea room and plans for contingencies must be in place. Above is a clear example of the usefulness of Risk Assessment in evaluating all possible circumstances/hazards. Close monitoring of external factors such as currents, windage, shallow water effects on the vessel's manoeuvrability must be carried out. Human factors are to be considered too as clearly highlighted by the case study.
