## Editorial

With this in mind, this bulletin proposes three examples of excessive pitch attitude during critical flight phases: takeoff rotation and landing flare.

# Bounced landing followed by tailstrike - 1

## Bounced landing followed by tailstrike - 2

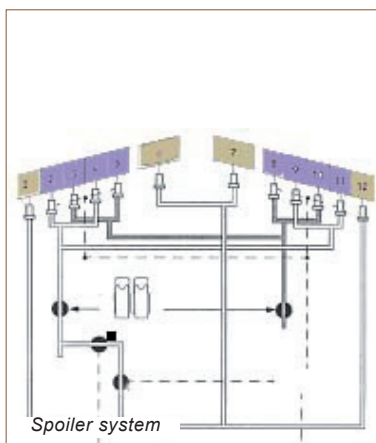
At the ramp, the Captain noticed that the tail skid and the lower left-hand part of the rear fuselage were scraped and dented.

Because the power levers were set to idle while the aircraft landing gear was still compressed, all the spoilers extended before the bounce. Given the system's operating logic, flight spoiler extension continued during the bounce, whereas the ground spoilers retracted. Low speed combined with the stalling moment caused when the spoilers extended led the aircraft to exceed its maximum landing attitude.
