Device Errata for the MPC850 Family

This document is a compilation of all MPC850 family device errata from silicon Revision 0.0 forward. Herein, the errata are classified and numbered, and each erratum is provided with a description and workarounds.

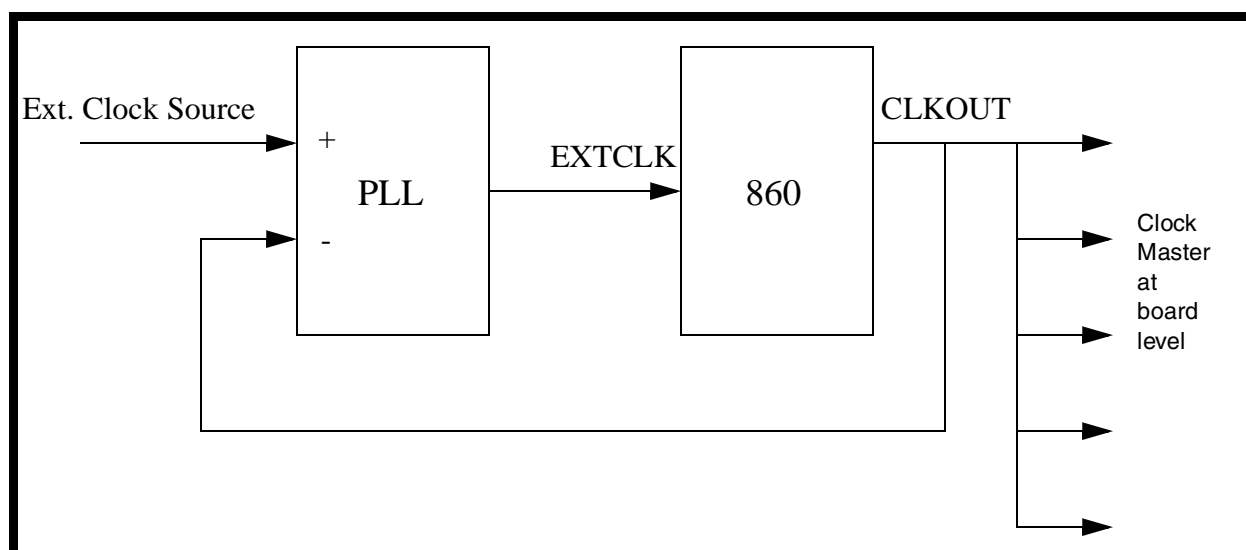
G4 Potential problems caused by skew between EXTCLK and CLKOUT

Important Note: The PLL has to be capable of operating with a permanent offset of -2nS, therefore the range of lock should extend to about -4nS.

A diagram of this concept is given below:

Corrected in Revision B.
