ES_LPC4370/50/30/20/10

Errata sheet LPC4370, LPC4350, LPC4330, LPC4320, LPC4310

Rev. 6.7 — 23 October 2015

Errata sheet

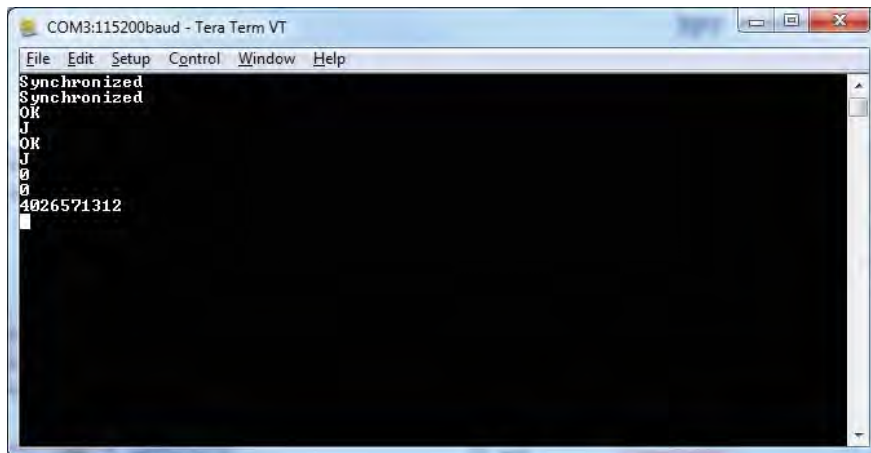
Incorrect example:

The 'J' command in ISP mode should return an error code, followed by an ASCII string representation of the part ID, followed by a 0. However what is actually returned is the error code, followed by a 0, followed by an ASCII string representation of the part ID. The problem is the last two items returned are swapped.

There is no work-around for this problem.

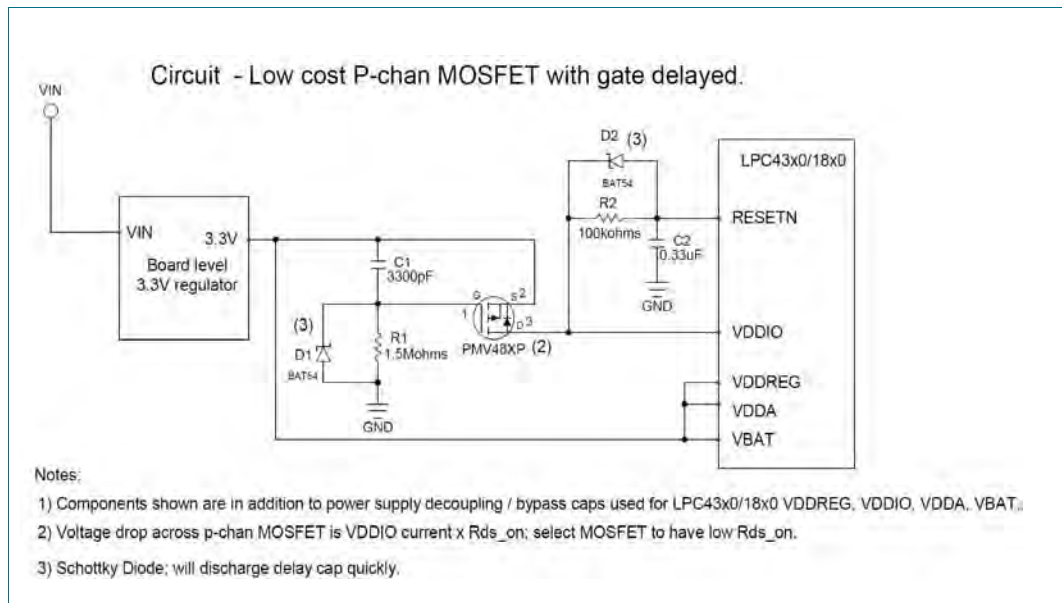
On all packages, repeated power cycling of the device may cause erroneous programming of the OTP banks. During ramp-up, the VDDREG supply voltage does not have enough time to settle and initialize the OTP controller before valid programming voltage is reached on the VPP pin. This may cause accidental programming of the OTP banks. Accidental programming of the OTP banks does not occur during Power-down of the supply voltage.

1. Ensure supply ramp-up time of 2 ms or greater:
 - a. For all packages, except BGA256, if the VDDREG, VDDIO, and VDDA pins are tied together, the supply voltage must have a linear ramp-up time of at least 2 ms. If the VDDREG, VDDA, and VDDIO pins are not tied together, follow the work-around in [List item 2 "Delay VDDIO and RESETN pin:"](#)
 - b. On the BGA256 package, if OTP programming is required, the voltage on the VPP pin should be delayed by 2 ms after the power supply on the VDDREG, VDDA, and VDDIO pins reaches the operating voltage level. If the VPP pin is tied to VDDREG, VDDA, and VDDIO pins, the supply voltage must have a linear ramp-up time of at least 2 ms. If OTP programming is not required on the BGA256 package, the VPP pin should be left as No-Connect (NC) because the VPP and VDDIO pins are separate.
2. Delay VDDIO and RESETN pin:

The power supplied to the VDDIO pin should be delayed by 2 ms after the power supply on the VDDREG and VDDA pins stabilizes at the operating voltage level. If booting from external sources (USARTx, SPIFI, EMC, USBx, SPI), the signal to the RESETN pin must also be delayed by 2 ms after the power supply on the VDDIO pin stabilizes at the operating voltage level. The following circuit diagram is an example that shows the P-channel MOSFET with the gate delayed and the R-C delay circuit connected to the RESETN pin.

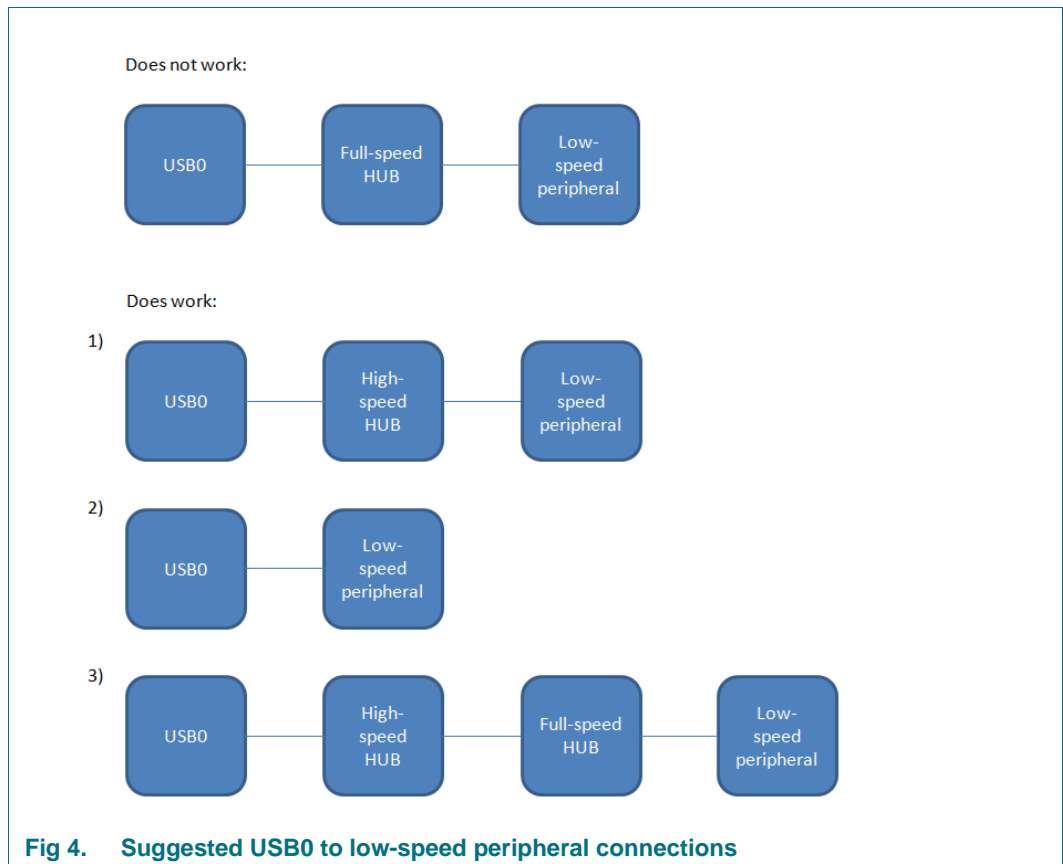
Fig 4. Suggested USB0 to low-speed peripheral connections

The USB controller called USB0 is unable to communicate with a low-speed USB peripheral in host mode when there is a full-speed hub directly connected to the USB0 port and a low-speed peripheral is connected in the tree somewhere below this full-speed hub. Only USB0 has this problem; the other USB controller, USB1 does not.

There is no work-around for this problem. It is suggested that the low-speed USB peripheral is either connected directly to USB0 or a high-speed hub is placed between that peripheral and USB0.

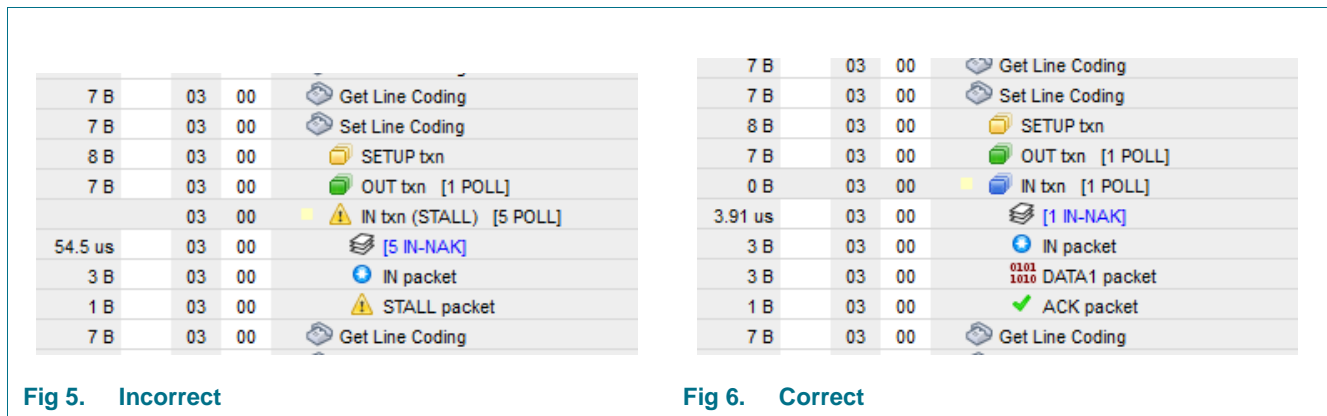
The CDC class USB ROM drivers return a STALL condition after the DATA stage of a Set Line Coding CONTROL transfer from the host. The correct behavior is to return an ACK.

The way to work around this bug is to override the default CDC class specific endpoint 0 handler and handle the processing of OUT packets in your application. Use the following source code in red to accomplish this.
