Device **TC1130**
Marking/Step **BB**
Package **PG-LBGA-208**

This Errata Sheet describes the deviations from the current user documentation.

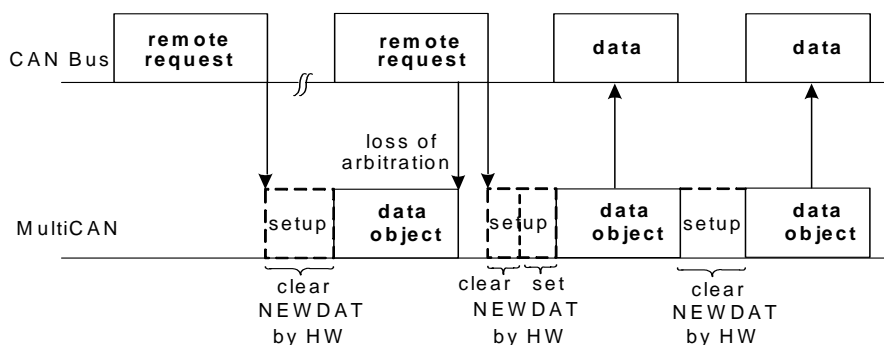
Figure 3 Loss of Arbitration

When the appropriate message object (data frame) triggered by the first remote frame wins the arbitration, it will be sent out and `NEWDAT` is not reset. This leads to an additional data frame, that will be sent by this message object (clearing `NEWDAT`).

There will, however, not be more data frames than there are corresponding remote requests.
