XC27x5X Derivatives

16/32-Bit Single-Chip Microcontroller
with 32-Bit Performance

Errata Sheet

V1.5 2013-02

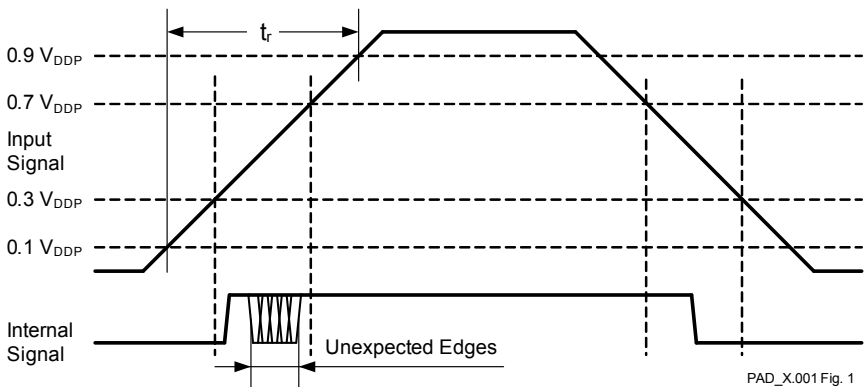
Figure 3 Example for a Slow Input Signal

The digital input- and I/O-pins are designed using Schmitt trigger input structures with hysteresis. Even with this structure, it is possible that very slow rising edges may generate spikes, resulting in unexpected additional edges at the input signal.

The next picture **Figure 3** is an example for a slow input signal, with spikes shown on the slow rising input signal.

The first rising edge in **Figure 3** of the internal signal is always valid. The edges which are marked with “Unexpected Edges” must be ignored.

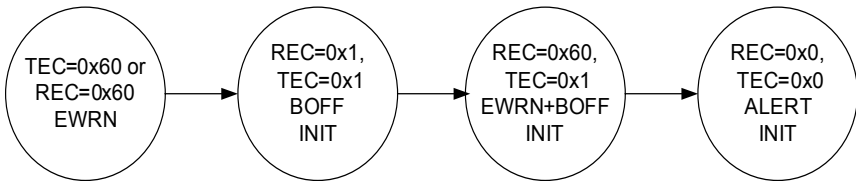
Figure 7 Alert Interrupt Behavior in case of Bus-Off

The MultiCAN module shows the following behavior in case of a bus-off status:

When the threshold for error warning (EWRN) is reached (default value of Error Warning Level EWRN = 0x60), then the EWRN interrupt is issued. The bus-off (BOFF) status is reached if $TEC > 255$ according to CAN specification, changing the MultiCAN module with REC and TEC to the same value 0x1, setting the INIT bit to 1_B, and issuing the BOFF interrupt. The bus-off recovery phase starts automatically. Every time an idle time is seen, REC is incremented. If REC = 0x60, a combined status EWRN+BOFF is reached. The corresponding interrupt can also be seen as a pre-warning interrupt, that the bus-off recovery phase will be finished soon. When the bus-off recovery phase has finished (128 times idle time have been seen on the bus), EWRN and BOFF are cleared, the ALERT interrupt bit is set and the INIT bit is still set.
