## URGENT FIELD SAFETY NOTICE

**Date:** 18 November 2014  
**Attention:** TomoTherapy® System Medical Physicist  
**Affected Product:** Software versions 2.0.1/2.0.2/2.0.3 (Hi-Art 5.0.1/5.0.2/5.0.3)

Accuray has become aware of a potential safety issue related to the TomoTherapy® Treatment System caused by a failure to monitor the jaw position after a jaw error occurs. This may result in an incorrect jaw position during treatment, without generating a system interruption.

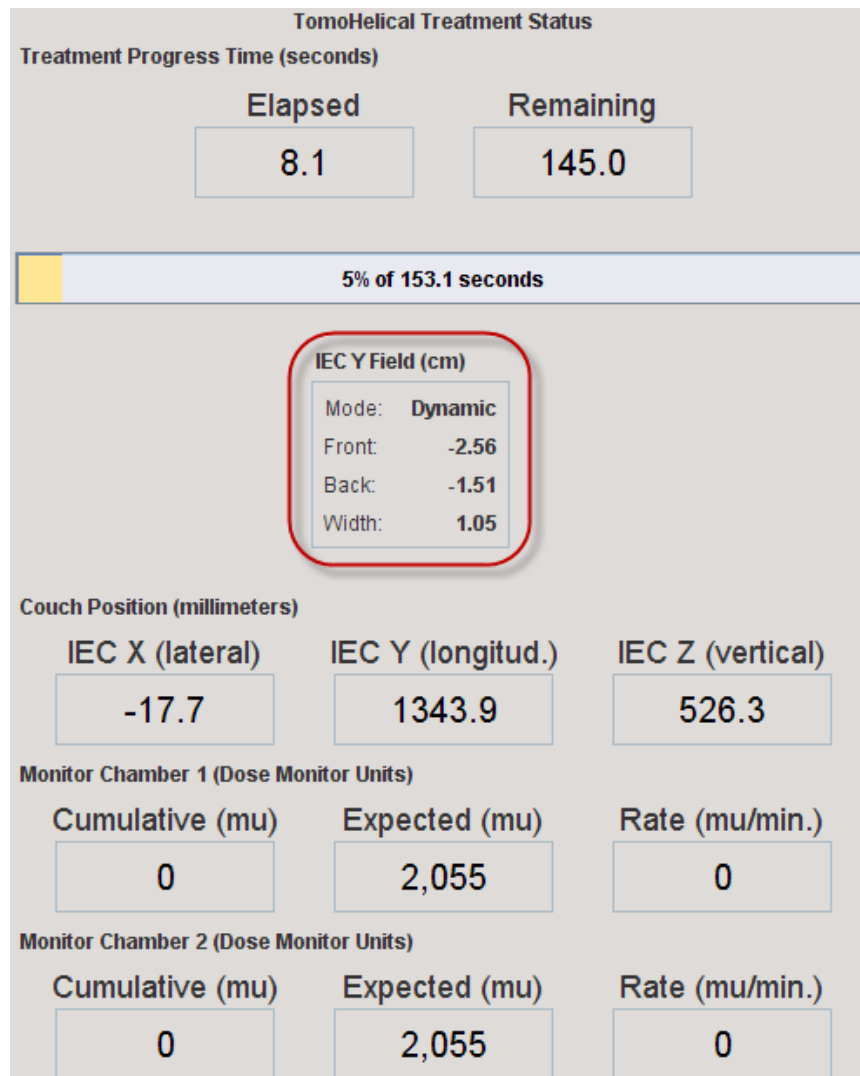
**Example:** For a dynamic jaw procedure, the field width will start at 1.05cm. In normal operation, this field width will increase until the maximum planned field width has been achieved. In the event that the issue above occurs, the field width will stay at 1.05cm for the remainder of the procedure, with the jaws in their maximally asymmetric position, as shown in the screenshot from the Operator Station in Figure 1, below.

**Figure 1.** Screenshot from the Operator Station, showing the asymmetric 1.05cm beam that would be expected at the superior edge of the target.

If the issue described in this notice occurs, this field will not change during treatment.

- Replan these procedures using the static jaw delivery mode, or
- At the Operator Station (see Figure 1), monitor the **Width** for the **IEC Y Field (cm)** at the beginning of these procedures to ensure that it increases over time. If it does not increase, stop treatment and contact Accuray Customer Support for assistance.
