**FINAL REPORT ON THE
ACCIDENT
TO ASSO AEREI CHAMPION V
UL260i REGISTERED OO-G08 AT
EBZH ON JULY 4, 2010.**

Ref. AAIU-2010-34
Issue date: 22 March 2011
Status: FINAL

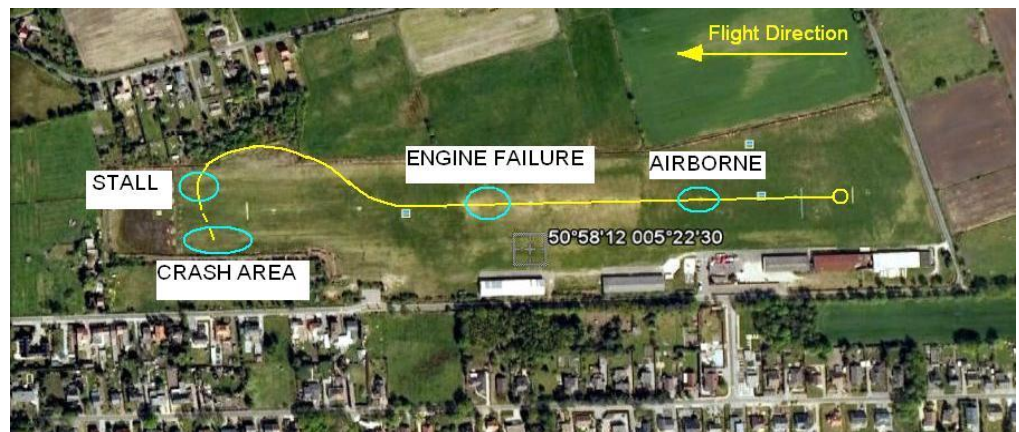
The airplane first hit the ground with the left hand wing tip and rebounded up to rest against the 2,0m high shoulder side of the airfield.

The first impact of the left hand wing tip was about 10m away from the final resting place. The second impact 5 m further was probably due to the nose landing gear.

The wreckage was found parallel to the runway in the opposite direction of the take off.

AAIU(be) recommends the airfield authority to consider the removal of the embankment bordering on the airfield (although its presence complies with ICAO requirements)

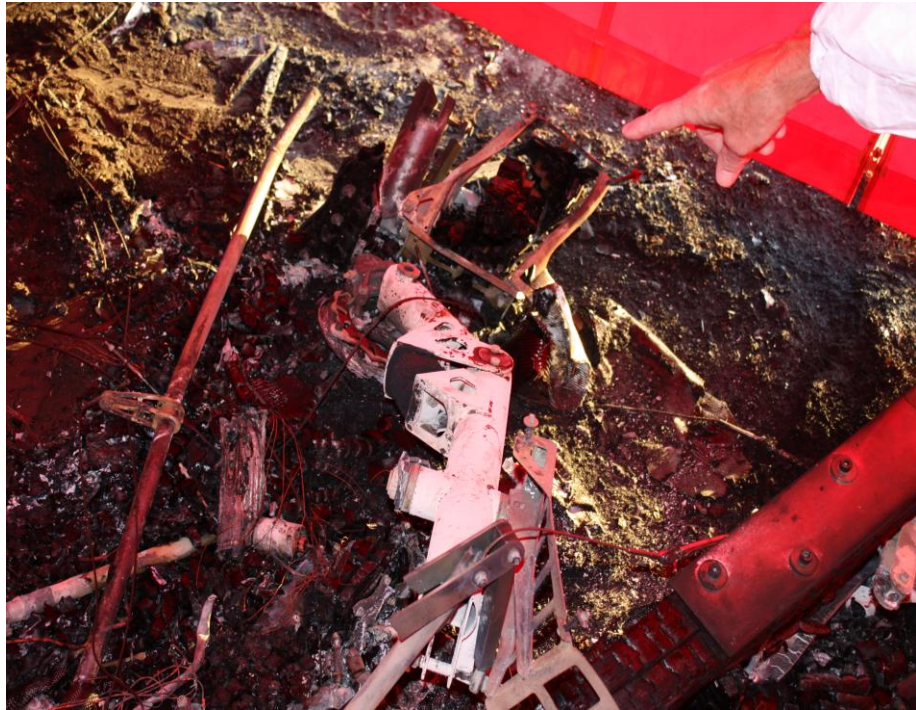
The airplane caught fire rapidly, and the wreckage was caught in a sea of fire, consuming the whole aircraft, with the exception of the heavy metallic parts.

Examples of some remaining metallic parts: One main landing gear and the central section of the wing spars.

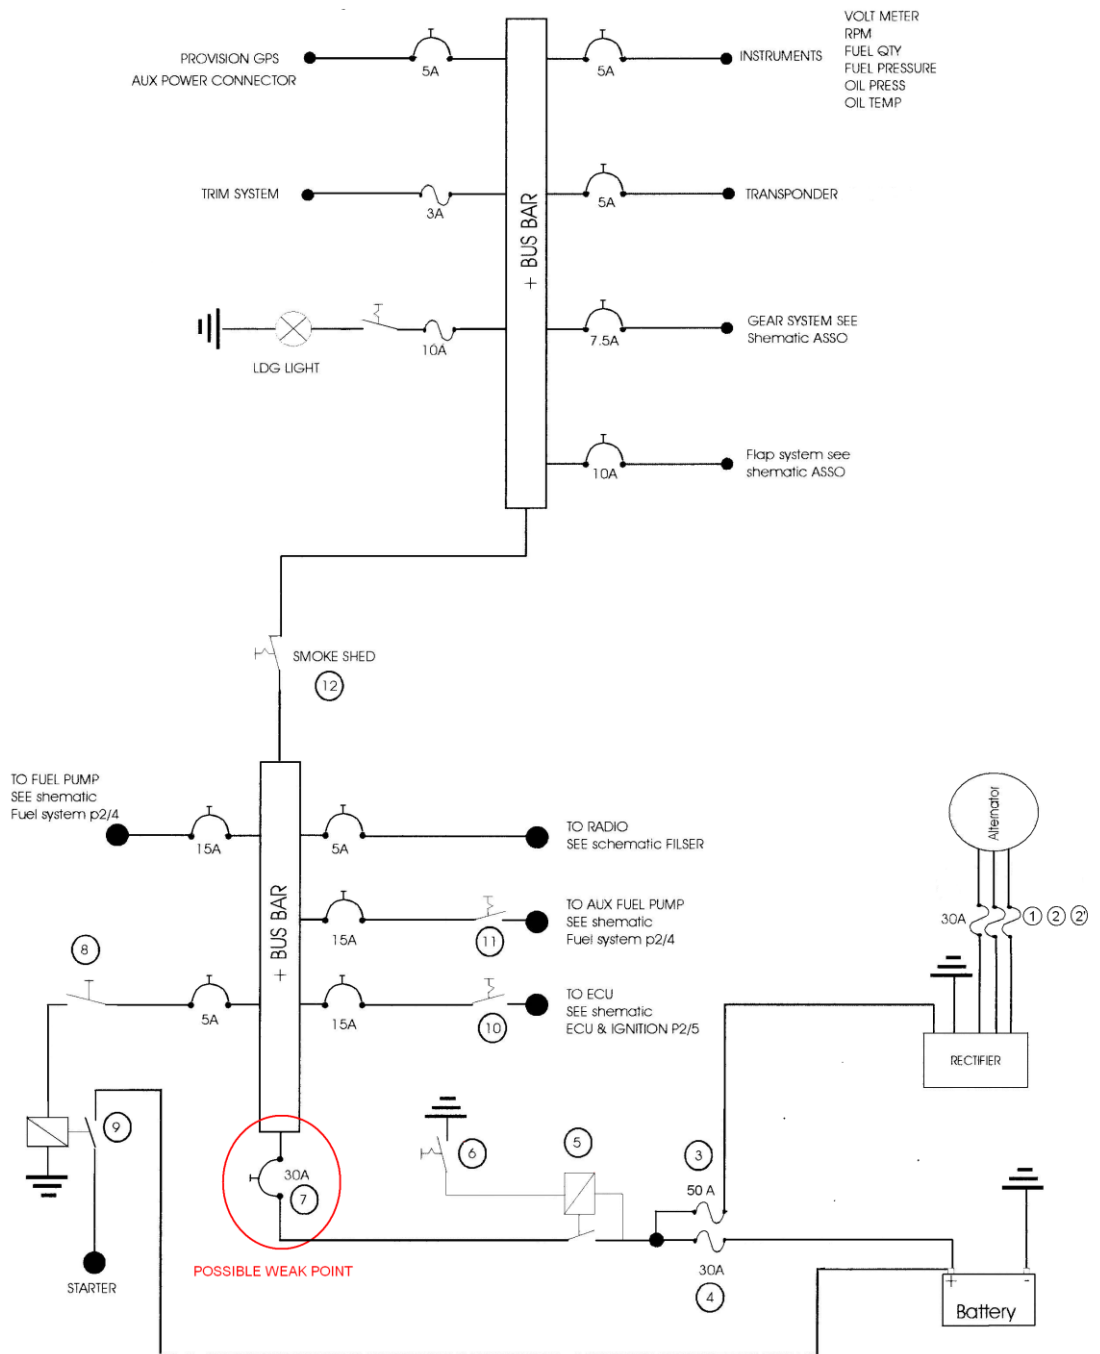
OO-G08 Electrical Schematic Diagram – Possible Weak Point

The overload could be caused either by one or by the combination of the following situations:

- A failure or a short circuit in any electrical component of the airplane.
- Abnormal mechanical friction in the operation of the landing gear, trim ...
- The peak starting current of the electrical motors.
- The use of the 6 Amp emergency fuel pump.

However no evidence was found to support this.

AAIU(be) recommends ULPOWER to draw the attention of the engine installers to the adequate design of the airframe electrical system.

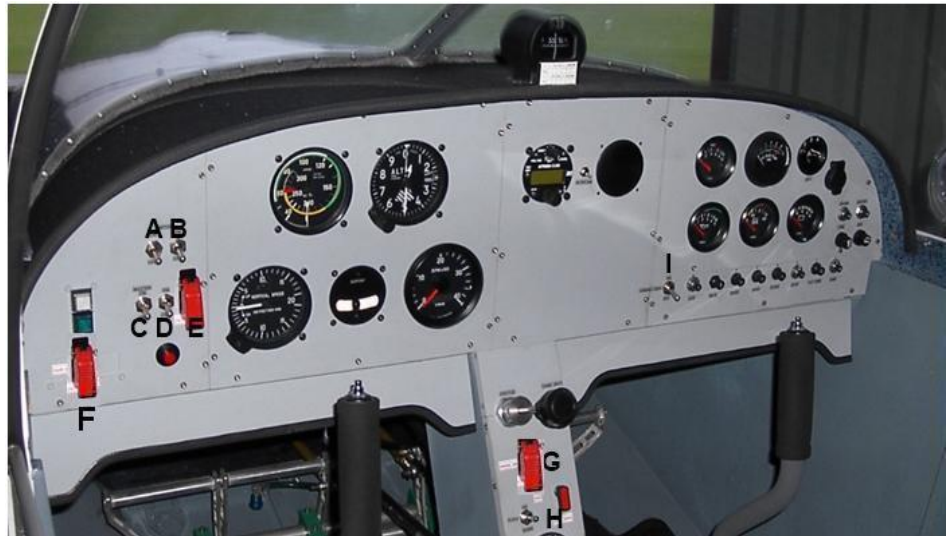
The above picture of OO-G08 shows the position and the design of the control switches installed on the instruments panel.

Airplane on the ground, all switches are normally selected DOWN.

In flight, the normal position of the switches is UP except for the smoke shed switch and the emergency fuel pump switch that normally remain down.

The engine failure occurred precisely at a stage of the flight when the pilot should retract the landing gear and the analysis of the instrument panel ergonomics shows that an inadvertent switching of the Master switch or the ECU switch is likely to occur when the pilot tries to reach the landing gear switch.

AAIU(be) recommends the Belgian ULM Federation to encourage Ultra Light Airplane manufacturers to use the CS 23 or the CS VLA specifications as a source of inspiration for, but not limited to, the design of instrument panels and electrical systems.

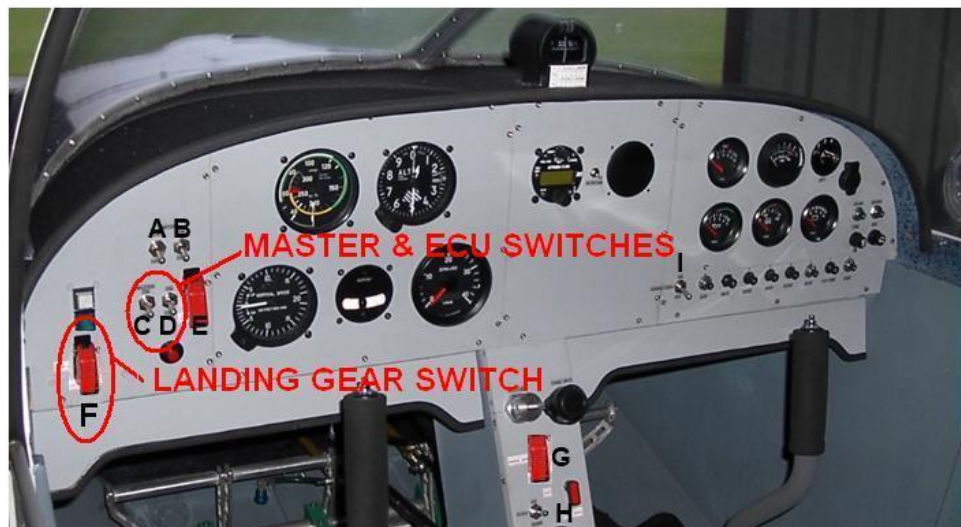
In this type of cockpit configuration, the pilot flies the airplane using his left hand to hold the stick and his right hand to hold the engine throttle.

To retract the Landing Gear the pilot needs to put UP the Landing Gear Switch identified "F". For this action he had two possibilities:
