# MPC5200 (L25R) Errata

by: Microcontroller Division

This document identifies implementation differences between the MPC5200, L25R (Rev. 1.2), and the processor's description contained in the *MPC5200 Microcontroller User's Manual* and the *MPC5200 Microcontroller Data Sheet*. Refer to <http://www.freescale.com> for the latest updates.

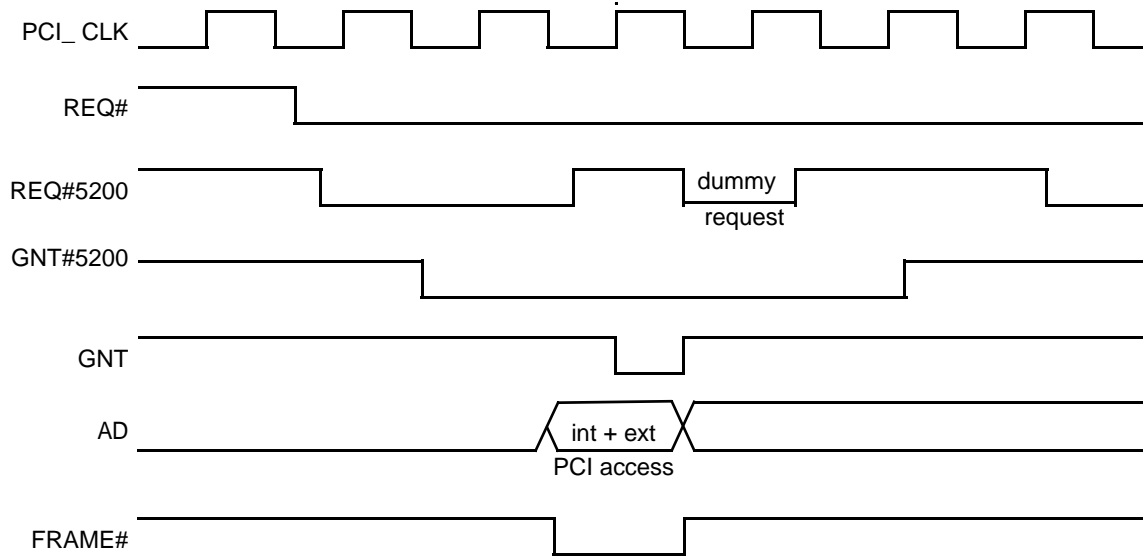
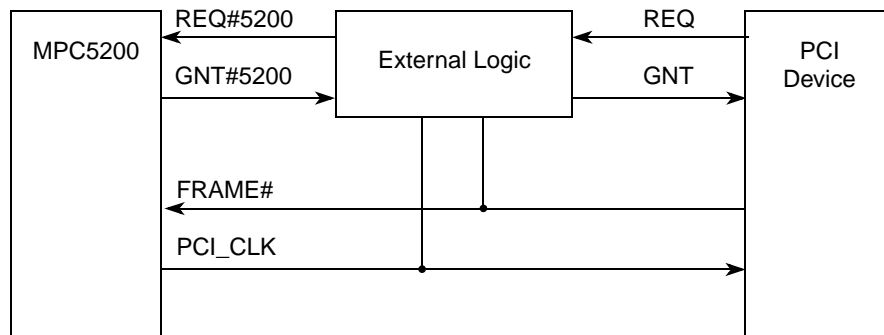
### 10.7.1 Description

The internal PCI arbiter should grant bus ownership only to one master at a time.

This rule of operation is violated under certain conditions. An external PCI Initiator requests (REQ#) and gets the bus (GNT#). If exactly at this time, in a window of one IP bus clock cycle, an internal PCI Initiator asserts a request for the bus too, the internal PCI arbiter grants the internal requestor, in addition to the external one. As a result of two granted initiators there is contention on the PCI bus.

### 10.7.2 Workaround

External logic is required to delay the GNT# by at least two PCI clock cycles and to deassert the REQ# when FRAME# becomes active and to reassert REQ# again.

The following diagrams illustrate the workaround:
