Device TC1782/84, TC1746
Marking/Step BA
Package see Data Sheet

02238AERRA

This Errata Sheet describes the deviations from the current user documentation.

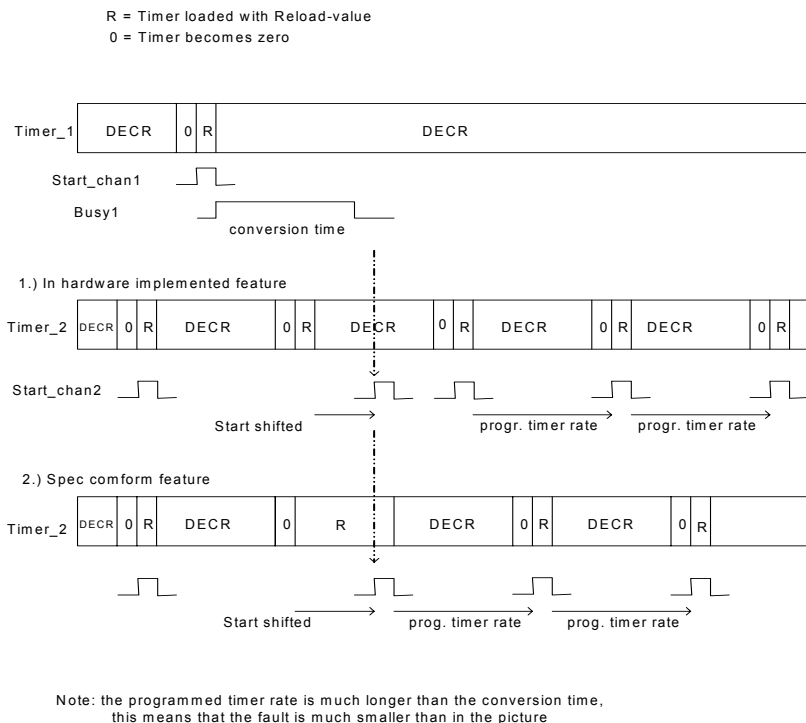
Figure 1 Timing concerning equidistant multiple timers

The correct behavior would be a reload when the requested conversion (of channel_2) is started.

Therefore the start of conversion for channel_2 is delayed by maximum one conversion-time. After this delay it will be continued with equidistant conversion-starts. Please refer to the following figure.

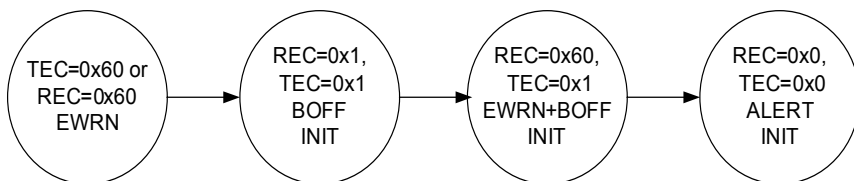
Figure 2 Alert Interrupt Behavior in case of Bus-Off

When the threshold for error warning (EWRN) is reached (default value of Error Warning Level EWRN = 0x60), then the EWRN interrupt is issued. The bus-off (BOFF) status is reached if $TEC > 255$ according to CAN specification, changing the MultiCAN module with REC and TEC to the same value 0x1, setting the INIT bit to 1_B, and issuing the BOFF interrupt. The bus-off recovery phase starts automatically. Every time an idle time is seen, REC is incremented. If REC = 0x60, a combined status EWRN+BOFF is reached. The corresponding interrupt can also be seen as a pre-warning interrupt, that the bus-off recovery phase will be finished soon. When the bus-off recovery phase has finished (128 times idle time have been seen on the bus), EWRN and BOFF are cleared, the ALERT interrupt bit is set and the INIT bit is still set.

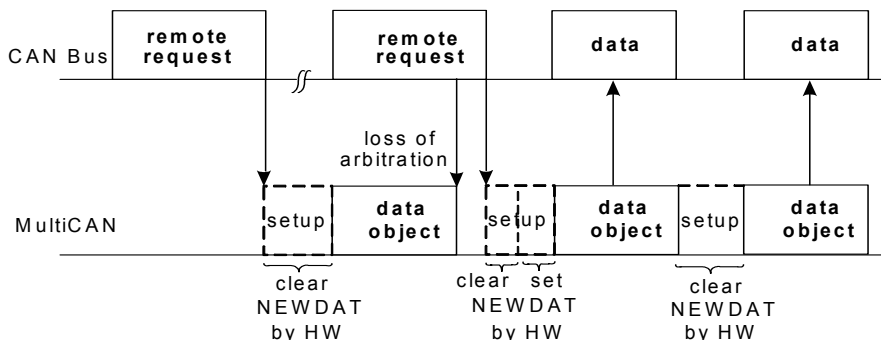
Figure 3 Loss of Arbitration

When the appropriate message object (data frame) triggered by the first remote frame wins the arbitration, it will be sent out and `NEWDAT` is not reset. This leads to an additional data frame, that will be sent by this message object (clearing `NEWDAT`).

There will, however, not be more data frames than there are corresponding remote requests.
