ECS Noise Detection Alarms due to Periodic 24-VDC Low Insulation

SL2012-561/KBH
April 2012

Ident No.: 3093078-1

Troubleshooting Electrical Noise

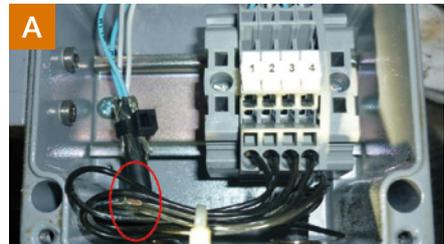
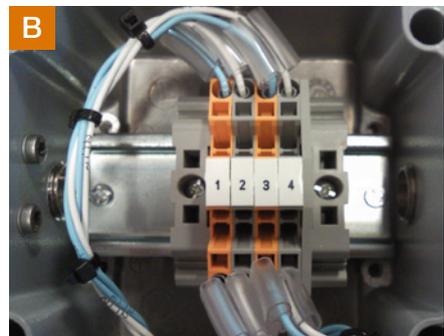
A: Chafed wires in MTBFP
B: Correctly installed wires in MTBEV

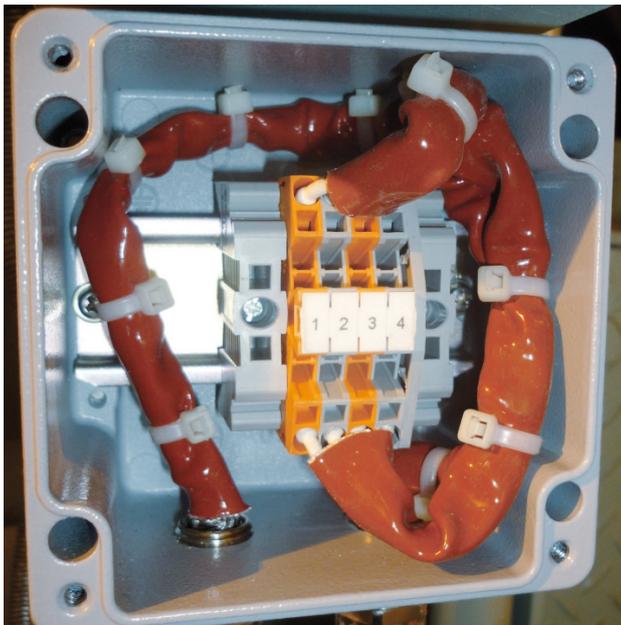
MTBEV installed with the "silicone kit"

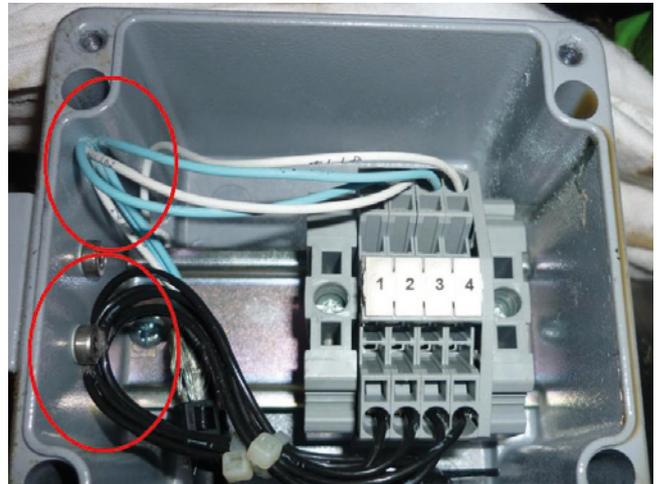
Chafed wiring inside an MTBFB

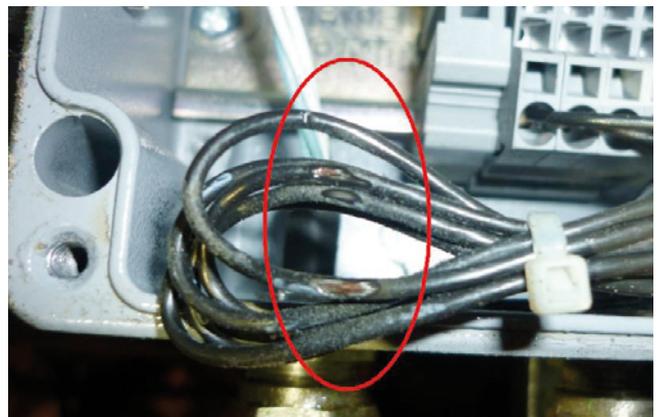
Chafed wiring inside an MTBFB

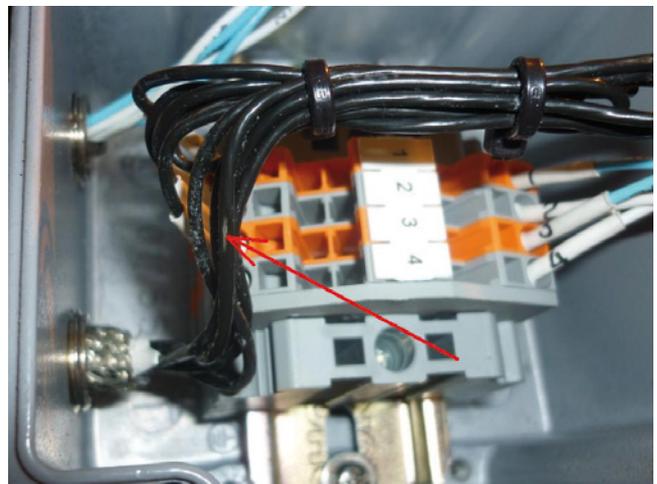
Chafed wiring inside an MTBEV

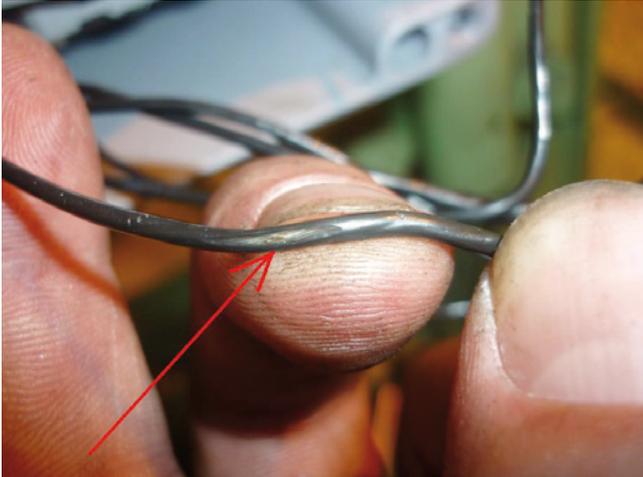
Chafed wiring inside an MTBEV

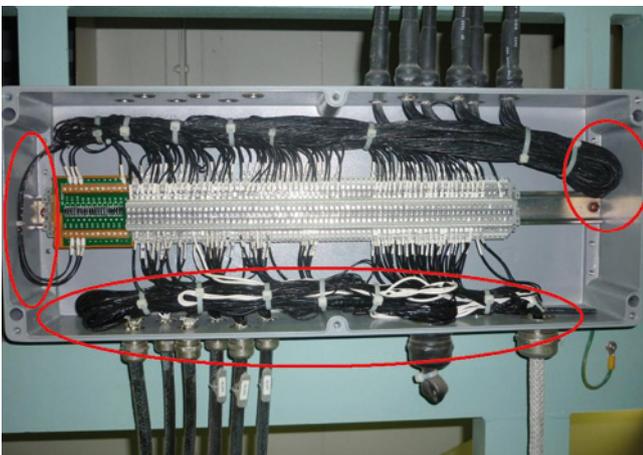
Wiring in contact with TB-LOP interior

It is also recommended to visually inspect and rectify the wiring inside these junction boxes, so as to ensure that no wires are in direct contact with the junction box interior or other ground-leading material.

Rectification can be done easily with wire straps only.

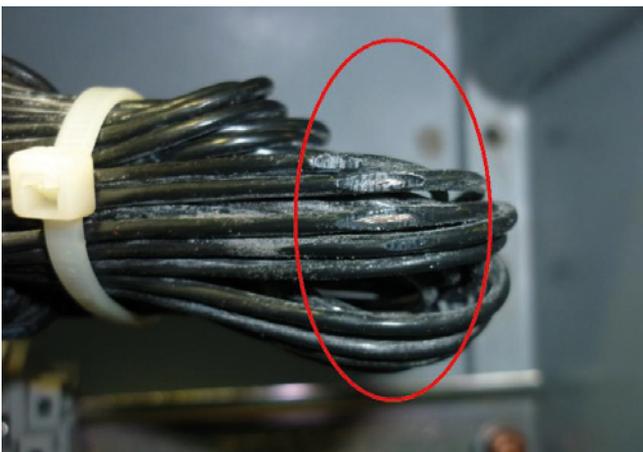
Chafed wiring inside a TB-LOP

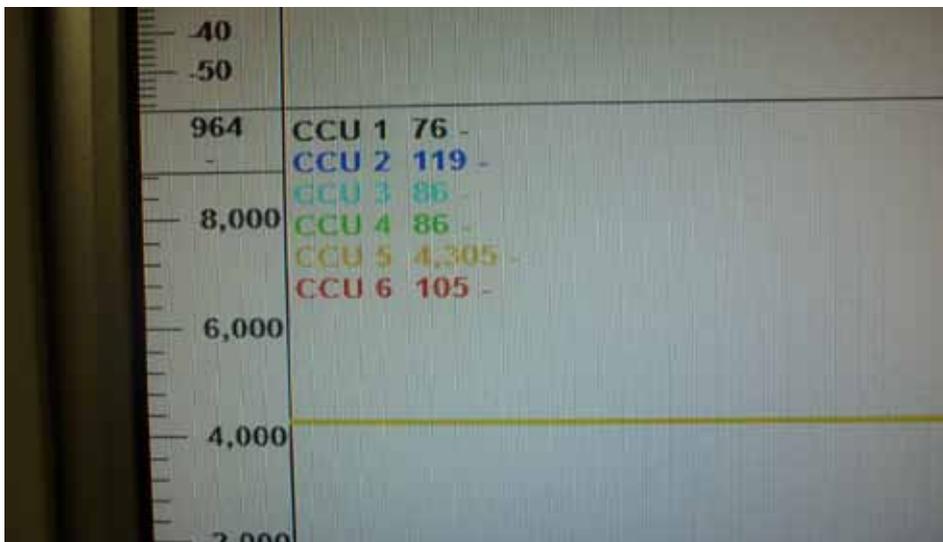
Figure 3: Example of very clear indication of an intermittent low insulation on CCU-5. This fault was located to be chamfered wires inside a MTBEV junction box.

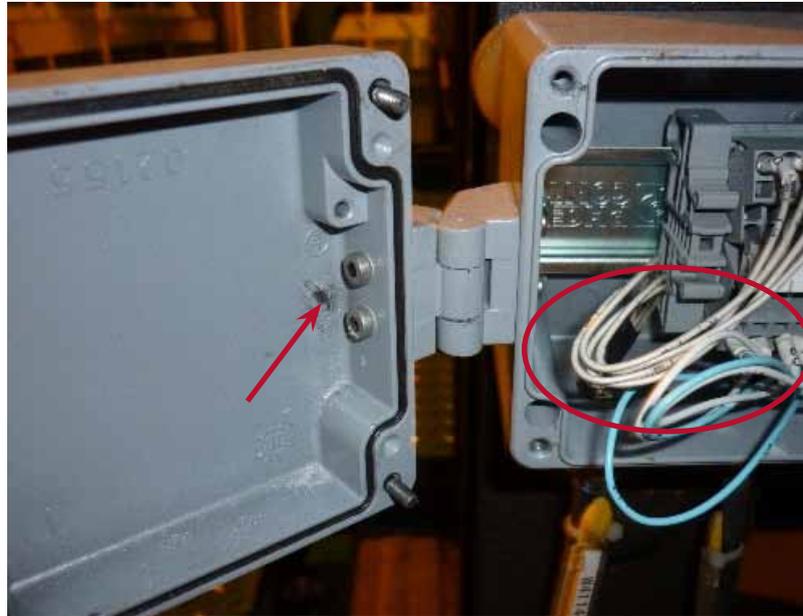
Figure 4: Upon opening the junction box it is apparent that the unsupported wires (red oval) have been chafing against the lid, causing a clear mark (read arrow).

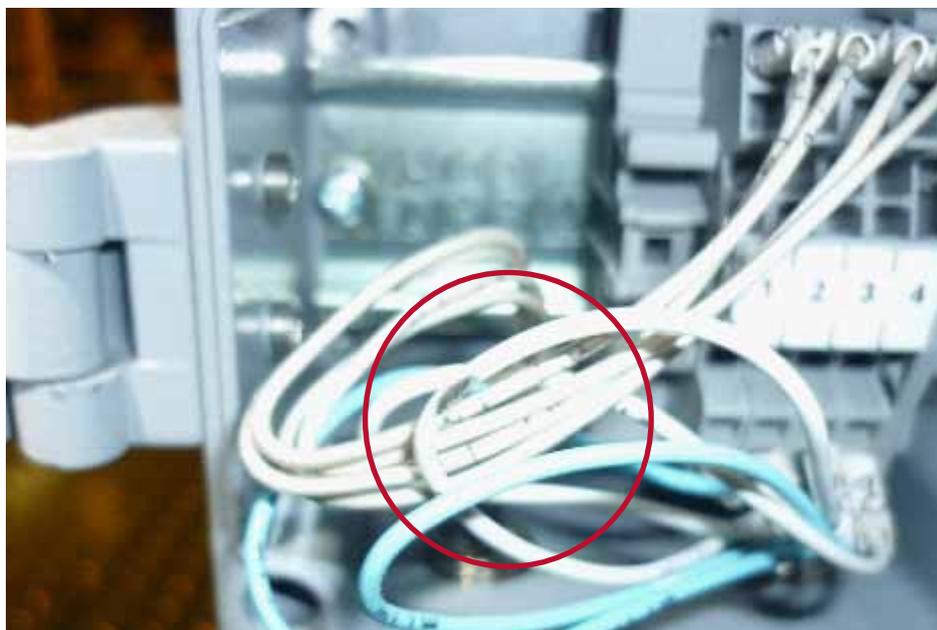
Figure 5: Examining the wires reveals that the insulation has been worn off (red circle); causing electrical noise whenever the uninsulated piece touched the side of the junction box.

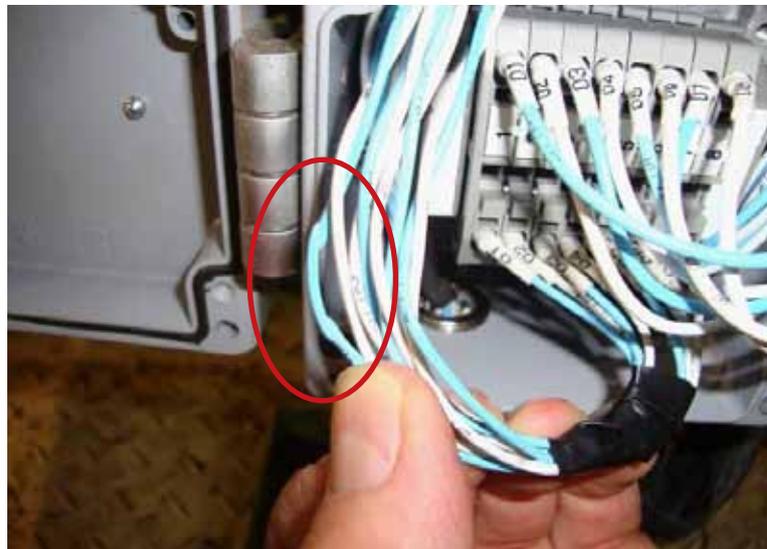
Figure 7: When opening the lid it can be seen that one of the wires had been pinched when the junction box was last closed (red circle); causing penetration of the insulation.

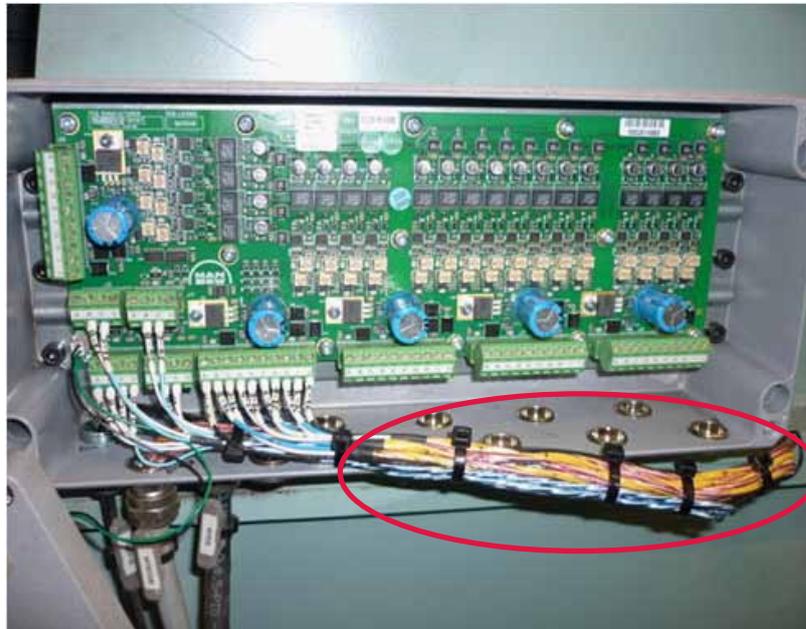
Figure 8: The open TSA box. Clearly showing the long, unsupported coil of wires (red oval).

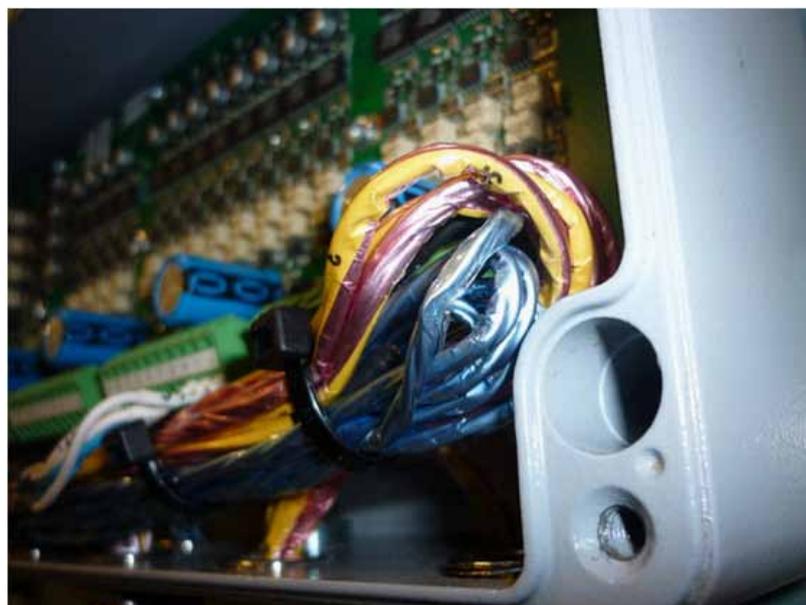
Figure 9: Close-up of the end of the wire bundle, indicating how it can chafe against the box.

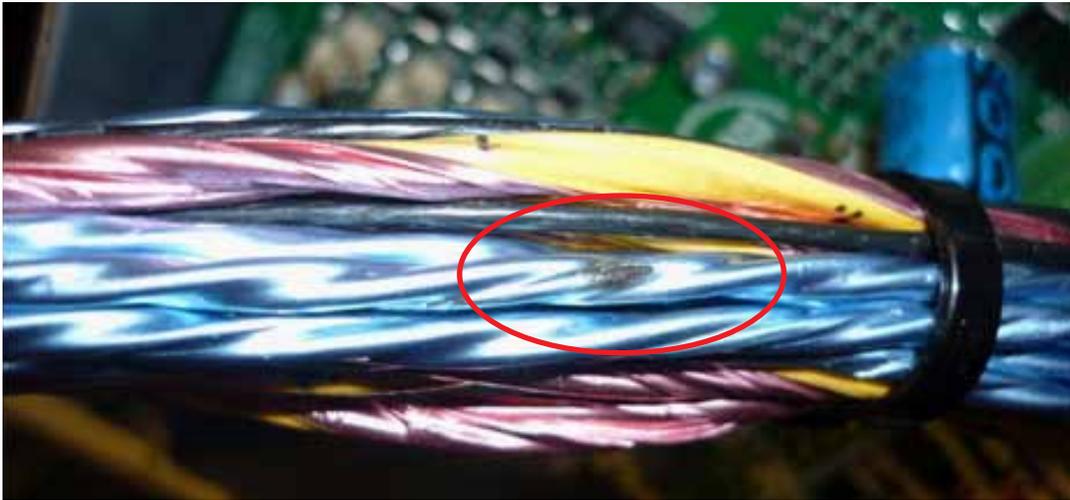
Figure 10: After the wire bundle has been opened up, the failure in the insulation can be seen (red circle).

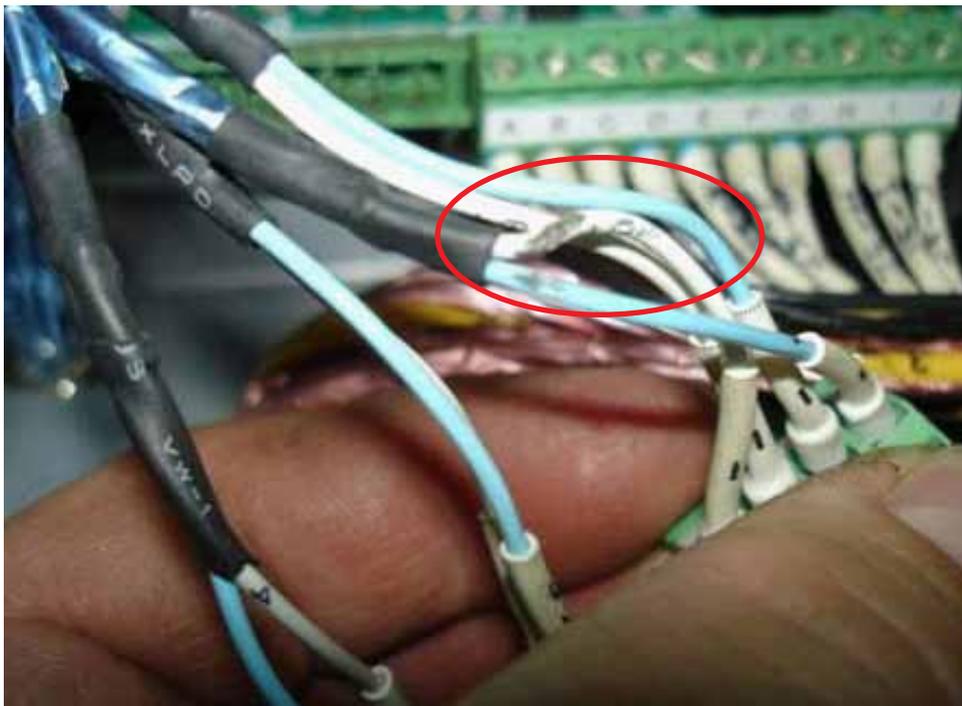
Figure 11: Additional chafing of the wires close to the plugs (red circle).

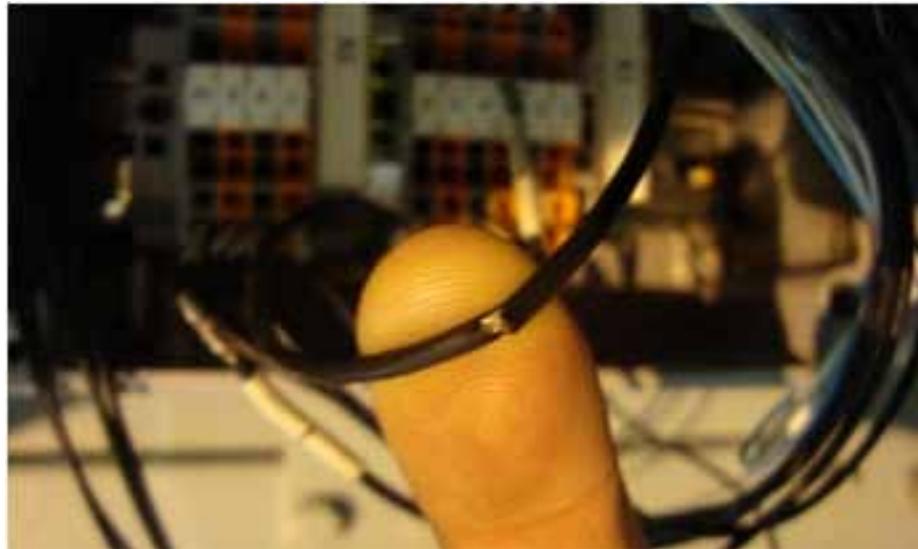
Figure 12: The wire with the insulation failure.

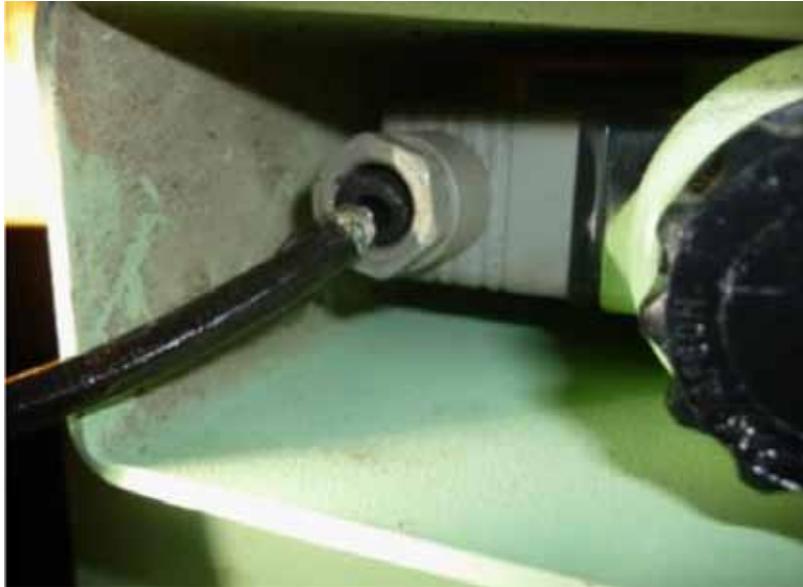
Figure 14: Cable damaged in connector to on/off valve for HPS pump.

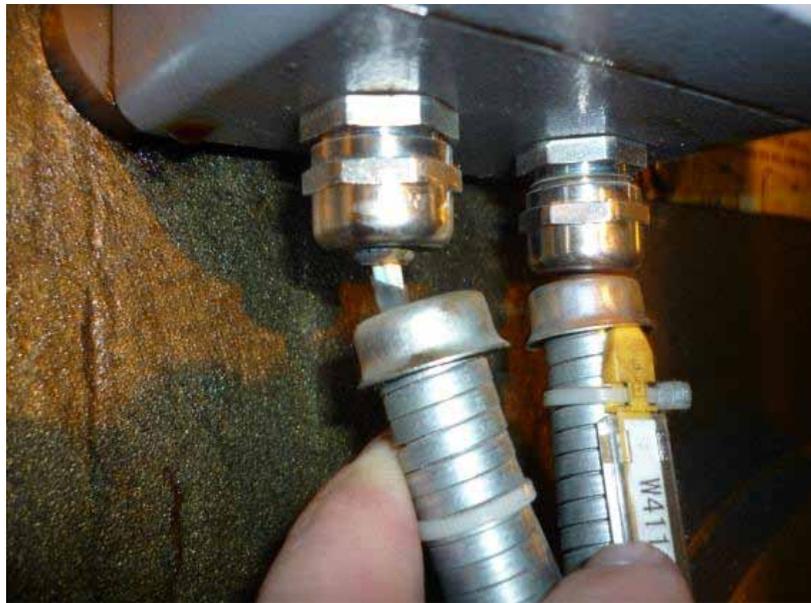
Figure 15: Cable damaged in gland to fuel plunger sensor tail junction box.

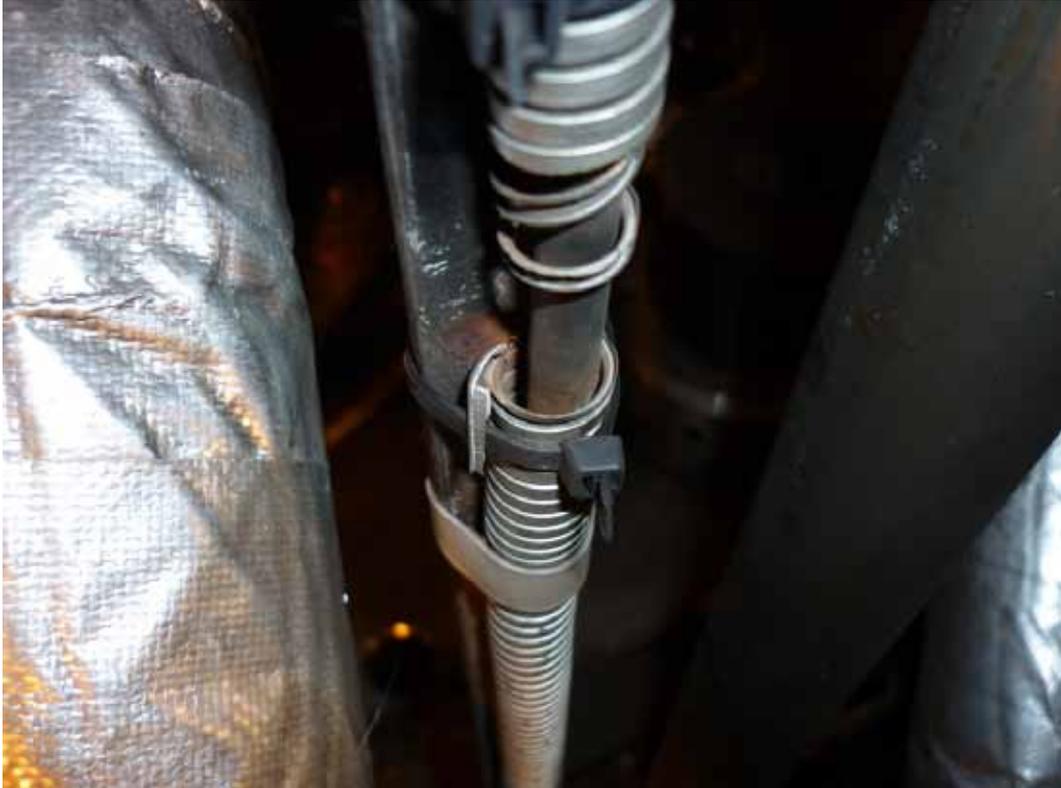
Figure 16: Wire protection broken; giving rise to sharp edges that can destroy the insulation of the wire.

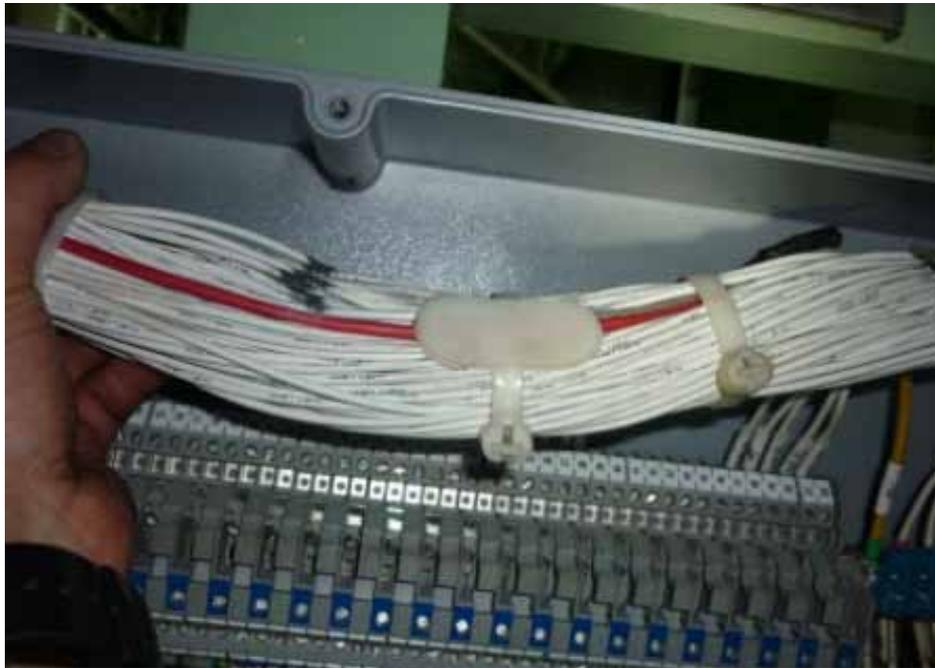
Figure 17: A long, unsupported wire bundle inside the junction box. Chafing against the side of the box.

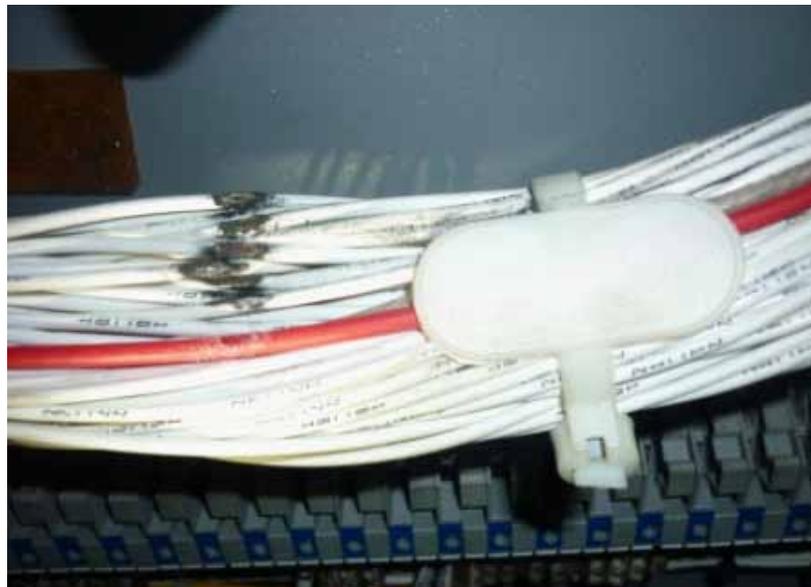
Figure 18: Close-up of the place where the insulation was worn off. Note this was on the rear side of the wires, therefore it was necessary to twist the bundle before the failure could be seen.

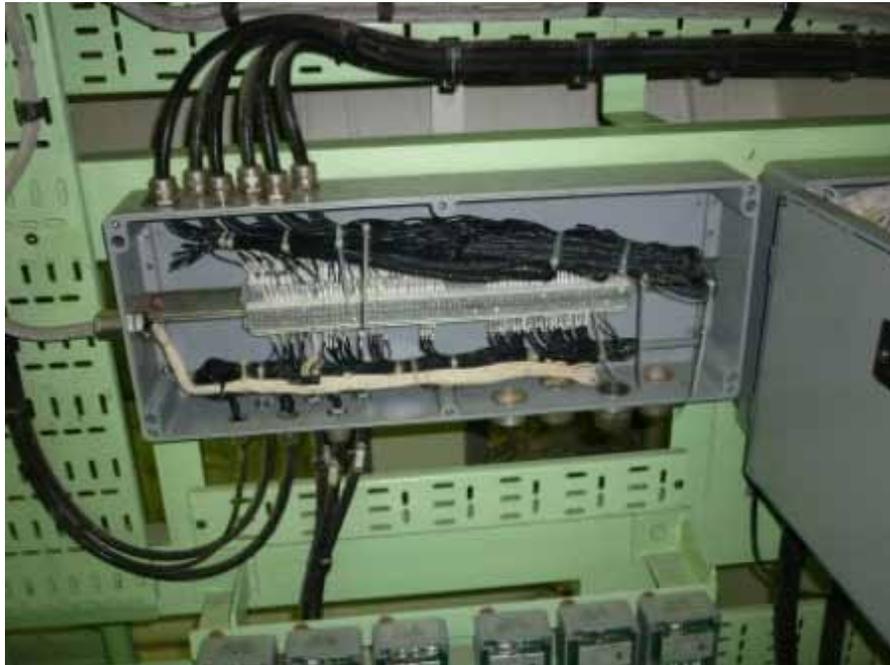
Figure 19: A junction box with a long unsupported wire bundle

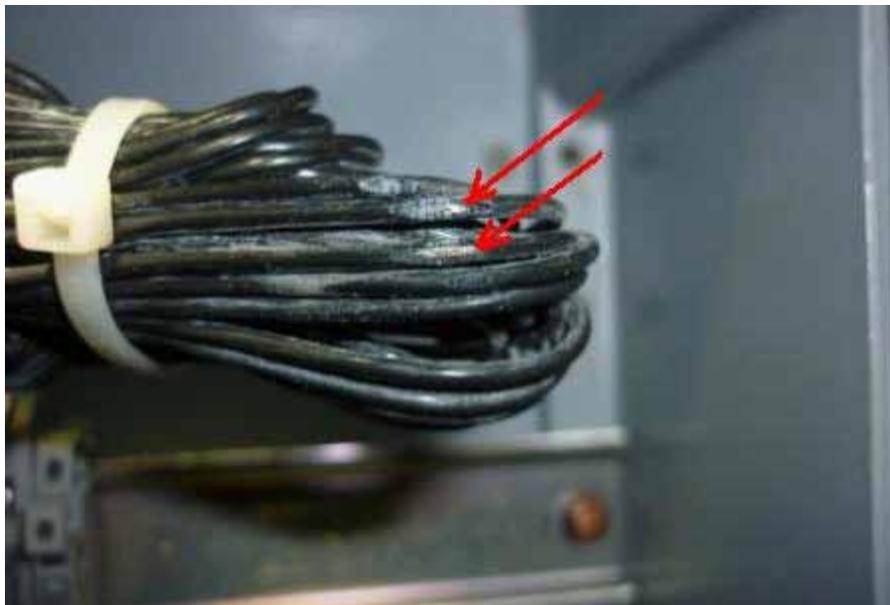
Figure 20: Red arrows indicating where the insulation was worn off.

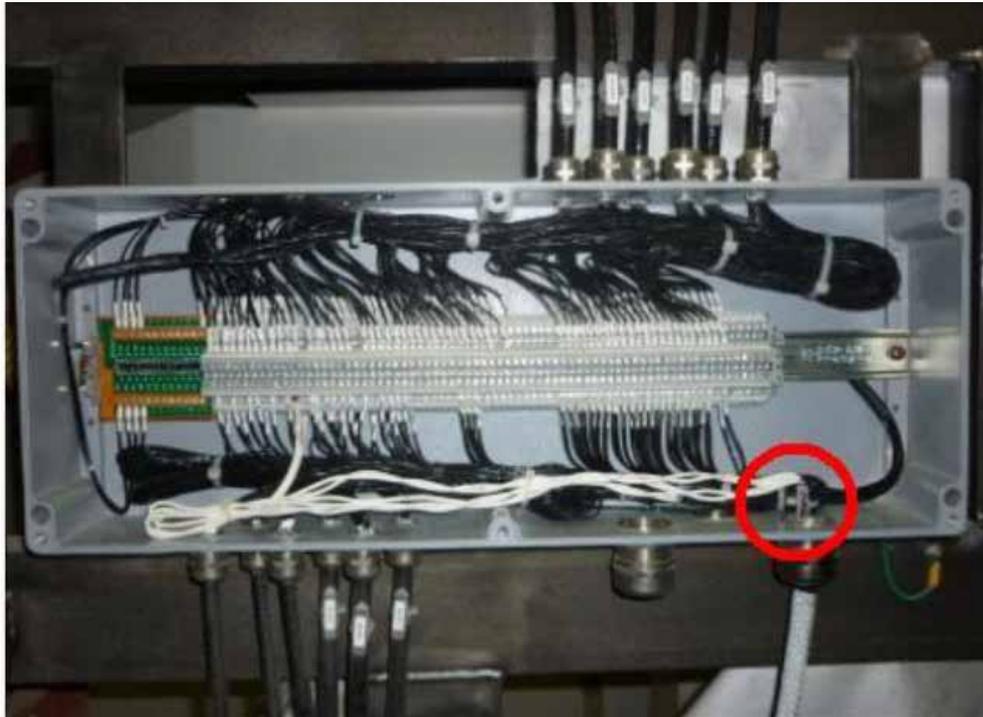
Figure 21: Junction box with a lot of unsupported wire bundles. The red circle indicates where chafing was most severe.

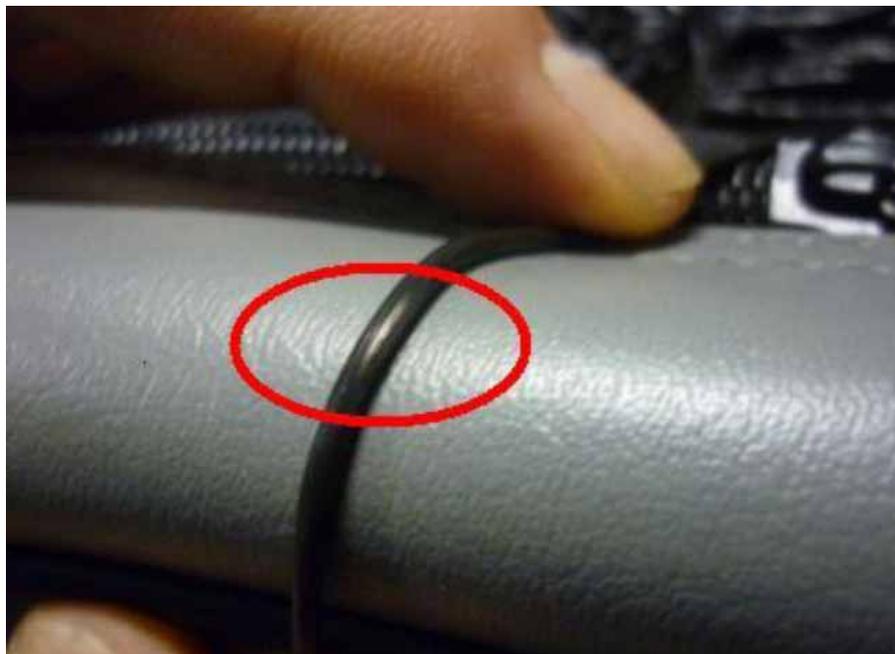
Figure 22: The resulting loss of insulation. Giving rise to the electrical noise.

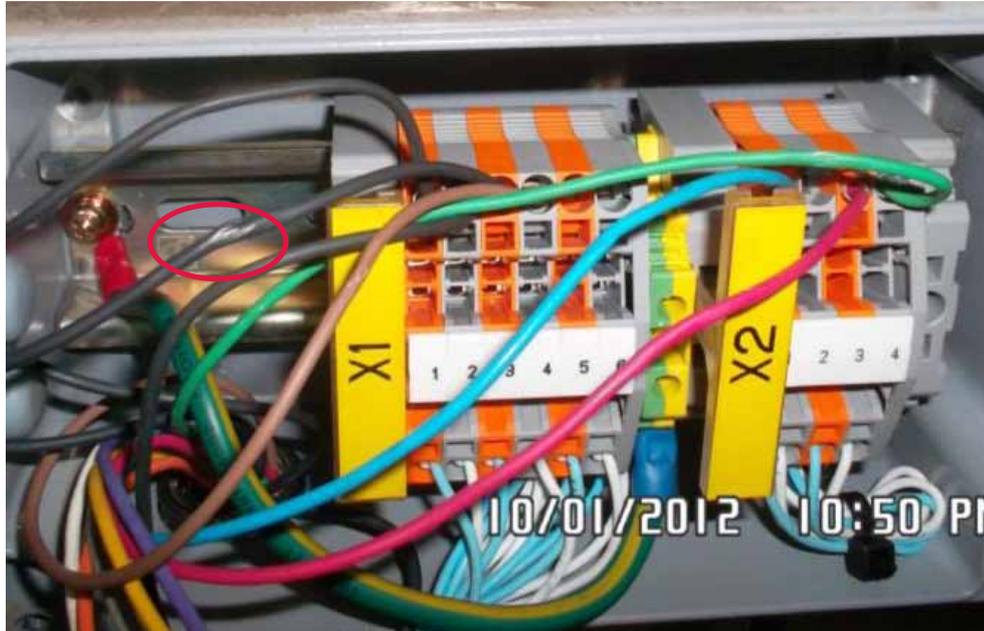
Figure 23: Unsupported wires. Leading to chafing and loss of insulation (red circle).

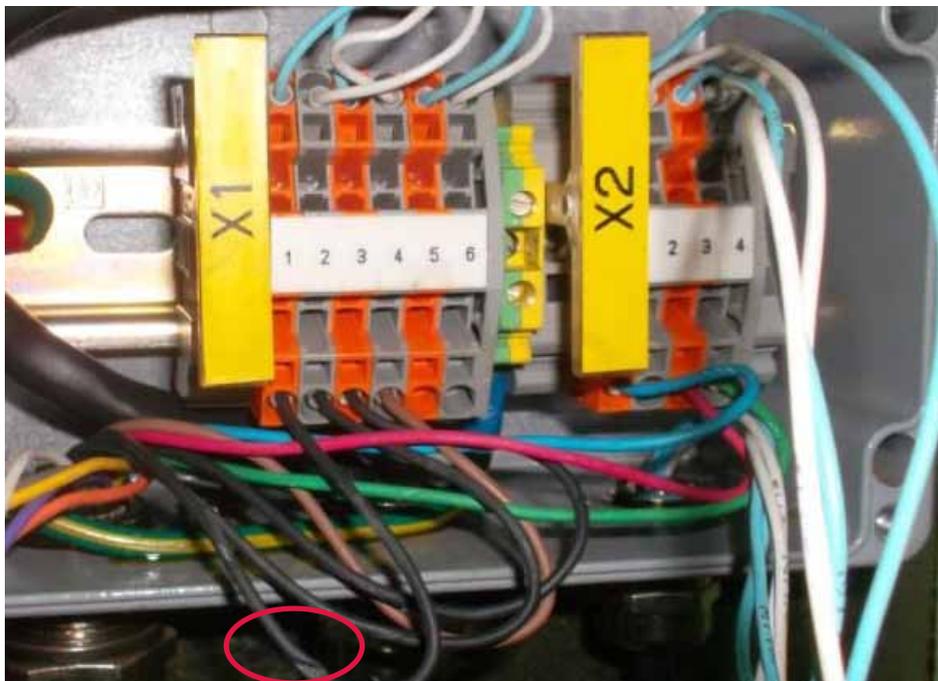
Figure 24: Unsupported wires. Leading to cables being pinched when the junction box is closed (red circle).
