Incidents in Air Transport

Operations in Winter Conditions

N° 7

October 2007

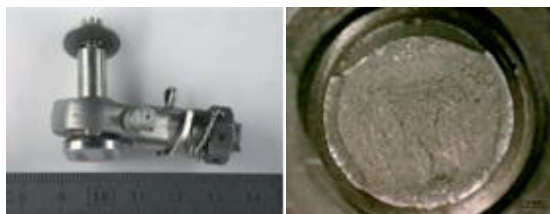
The axis of the left main landing gear lock hydraulic actuator was found broken. This was due to an overload compression failure. Immediately after landing, a significant amount of ice was found around the different parts up the landing gear.

Broken part of actuator

Failure profile

Finally, the manufacturer recommended slightly delaying retraction of the landing gear after takeoff from a contaminated runway to remove any snow or ice, which the crew did not think of doing, probably because they were surprised by the condition of the runway on takeoff.
