XC2200N Derivatives

16/32-Bit Single-Chip Microcontroller
with 32-Bit Performance
XC2000 Family / Value Line

Errata Sheet

V1.7 2013-06

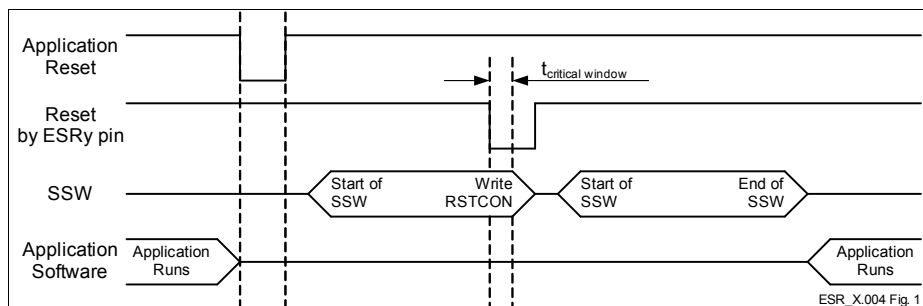
Figure 2 Critical application reset sequence

SCU_RSTCONx registers are reset only by Power-On, but they may be wrongly affected after a second application reset requested by an ESRy pin. This may lead to the SCU_RSTCONx register values being set to zero, which could unexpectedly disable reset sources within the user application. The conditions which lead to this behavior are:

1. First, an application reset by SW (software), CPU (Central Processing Unit), MP (Memory), WDT (Watchdog Timer) or ESRy (External Service Request y) occurs.
2. Following this, an application reset on an ESRy pin occurs.
3. If the above mentioned ESRy reset occurs during a critical time window of the SSW (startup software), then it's possible that the application will operate with the wrong SCU_RSTCONx register value. The critical time window occurs when the SSW is writing the SCU_RSTCONx registers, and at the same time, the ESRy reset request is processed by the reset circuitry. The width of this critical window $t_{\text{critical window}}$ is less than 13 cycles.

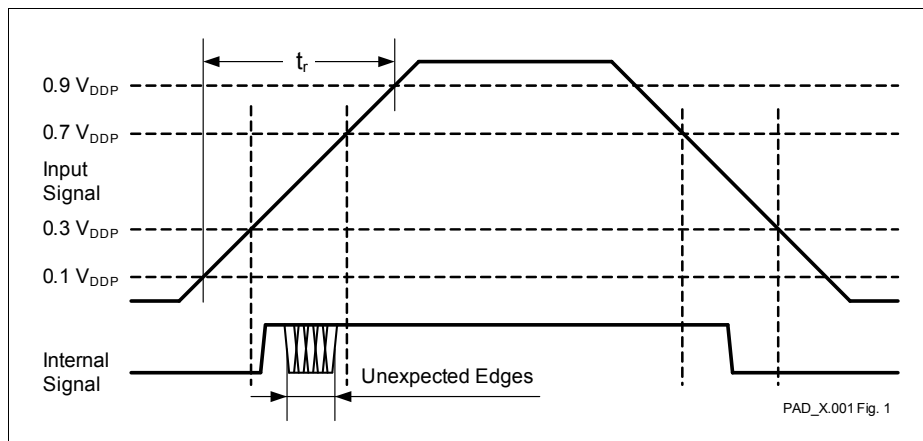
Figure 3 Example for a Slow Input Signal

The digital input- and I/O-pins are designed using Schmitt trigger input structures with hysteresis. Even with this structure, it is possible that very slow rising edges may generate spikes, resulting in unexpected additional edges at the input signal.

The next picture **Figure 3** is an example for a slow input signal, with spikes shown on the slow rising input signal.

The first rising edge in [Figure 3](#) of the internal signal is always valid. The edges which are marked with “Unexpected Edges” must be ignored.
