Customer: Generic Joe
Customer Address: 1234 Anyplace Street
City, State, Zip: Boise, ID 83705
Customer Phone Number: 411.555.1212
Inspection Address: 5678 Easy St.
City, State, Zip: Boise, ID 83713

Inspection Date: 10/3/2012
Inspection Time: 10:00 AM
Reporting Instructions:

General Description of Property

Overall Condition: Excellent
Type: Single Family
Plot size: 7775 Sq. Ft.
Approximate square footage: 2318 Sq. Ft.
Approximate date of construction: 2012
Main entrance faces: South

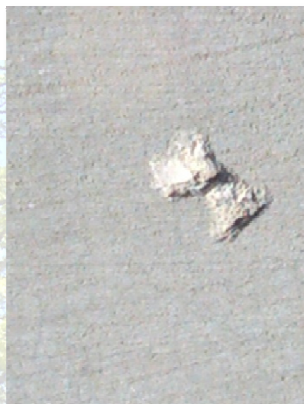
Chip in Driveway

There are several small chips in the driveway. There is a small shrinkage crack where the drive meets the porch. I recommend filling the chips and sealing the crack to prevent future weathering-related damage at these locations. There is a small deposit of cement on the drive, left from construction (see pictures).

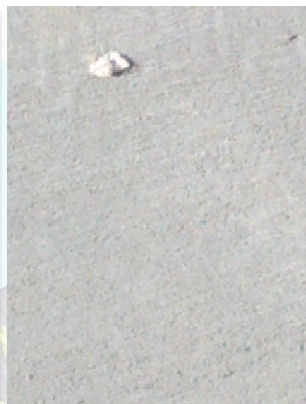
Chip in Driveway

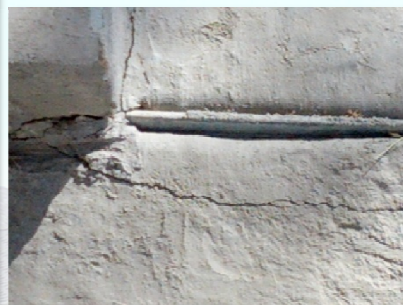
Crack in driveway

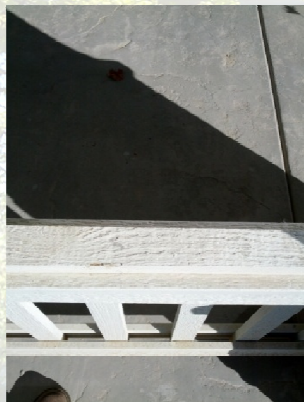
Touch up trim paint

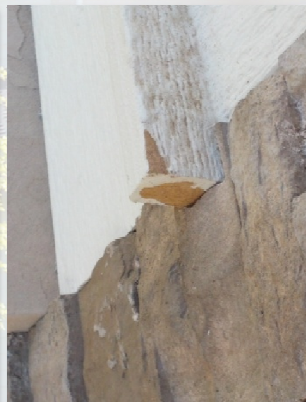
Touch up trim paint

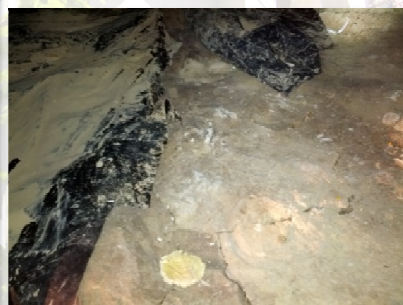
Crawlspace showing signs of water

There has been water in the crawlspace, although there is currently none. I believe that the water came from seepage under the west foundation wall due to over-watering of the yard next door. There are areas of ground not covered by the vapor barrier (see picture).

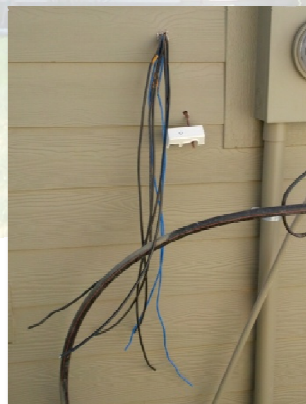
Data cables not terminated - exterior
