80C186EB/80C188EB AND 80L186EB/80L188EB EMBEDDED MICROPROCESSORS SPECIFICATION UPDATE

Release Date: April, 1997
Order Number: 272897-002

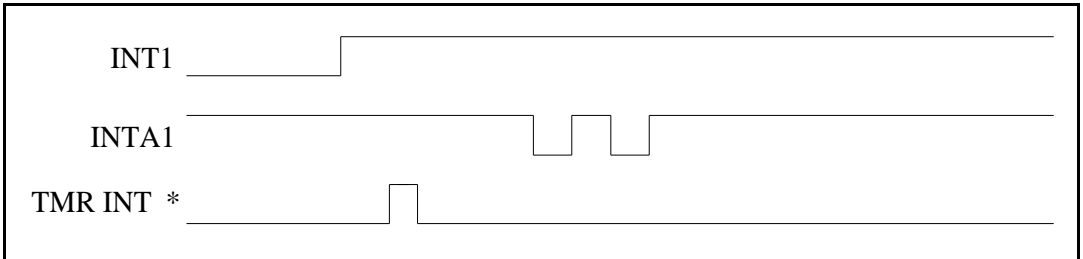
Correct operation of the device acknowledges the interrupt on INTA1# after an interrupt on INT1. Normally, this occurs even if there is a higher priority interrupt after INT1 but before the acknowledge (Figure 1).

Figure 1. Correct INT1 Acknowledge Sequence with Higher Priority Timer Interrupt

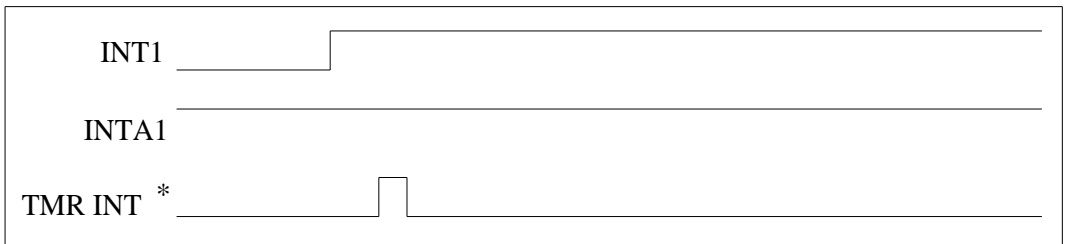
The errata occurs when a higher priority interrupt occurs between INT1 and its expected acknowledge. The processor completes internal interrupt acknowledge cycles as seen on the status lines but no acknowledge cycle is sent on the INTA1# output (Figure 2).

Figure 2. Incorrect INT1 Acknowledge Sequence with Higher Priority Timer Interrupt

| 1. Only INT1 is configured in cascade mode and is lower priority than at least one other interrupt. | Use only INT0 in cascade mode instead, or make INT1 the highest priority interrupt, or use hardware workaround. |

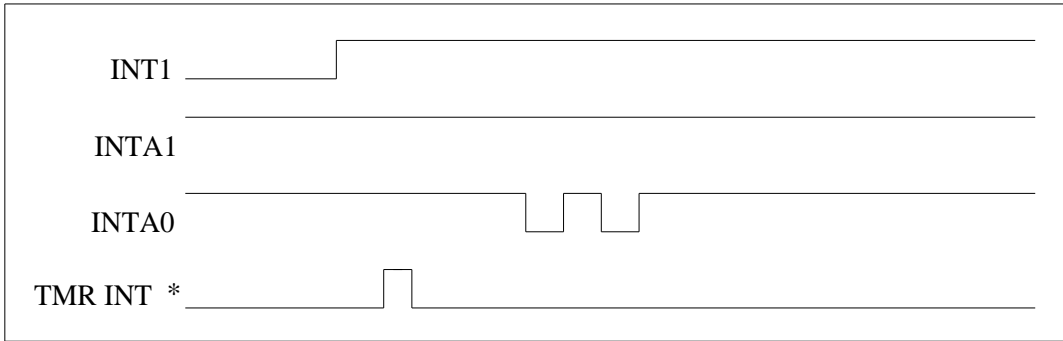
If INT0 and INT1 are configured in cascade mode and a higher priority interrupt occurs between INT1 and its expected acknowledge, then the acknowledge will appear on INTA0# instead (Figure 3).

Figure 3. INT0 And INT1 Acknowledge Failure due to Higher Priority Timer Interrupt

| 2. INT1 and INT0 are both in cascade mode. | Use only one interrupt in cascade mode, or use hardware workaround. |

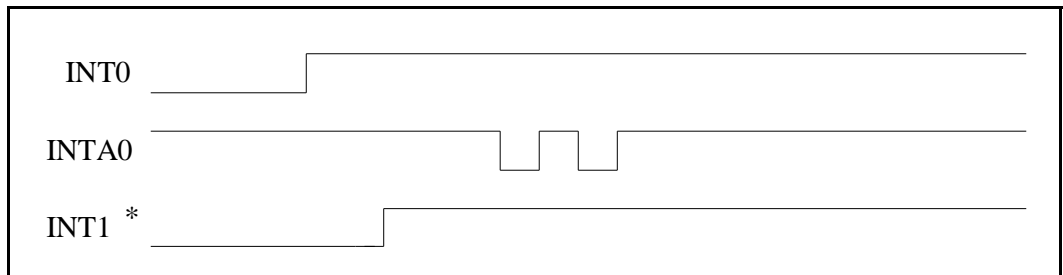
Correct operation acknowledges INT0 on INTA0#. Normally, this occurs even if there is a higher priority INT1 after INT0 but before the acknowledge (Figure 4).

Figure 4. Correct INT0 Acknowledge Operation with a Simultaneous INT1

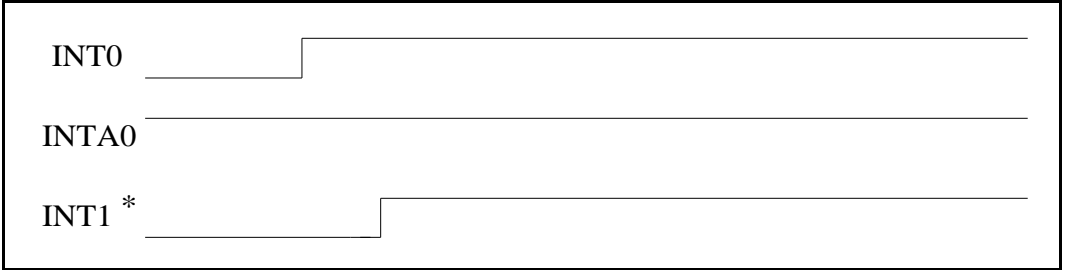
The errata occurs when INT1, which is higher priority than INT0, occurs between INT0 and its expected acknowledge. The processor completes internal interrupt acknowledge cycles as seen on the status lines but no acknowledge cycle is sent on the INTA0# output (Figure 5).

Figure 5. Incorrect INT0 Acknowledge Operation with a Simultaneous INT1

| 3. Only INT0 is configured in cascade mode and is lower priority than INT1. | Make INT0 higher priority than INT1, or use hardware workaround. |

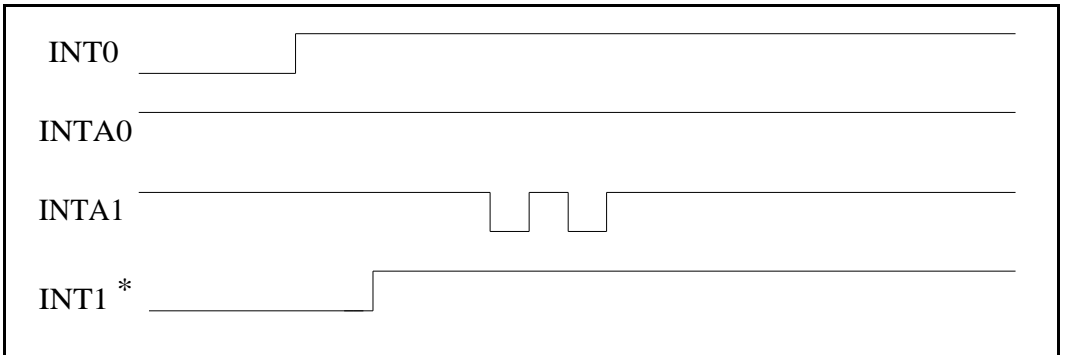
If INT0 and INT1 are configured in cascade mode and the higher priority INT1 occurs between INT0 and its expected acknowledge, then the acknowledge will appear on INTA1# instead of INTA0# (Figure 6).

Figure 6. INT0 and INT1 Acknowledge Failure Due to the Higher Priority INT1

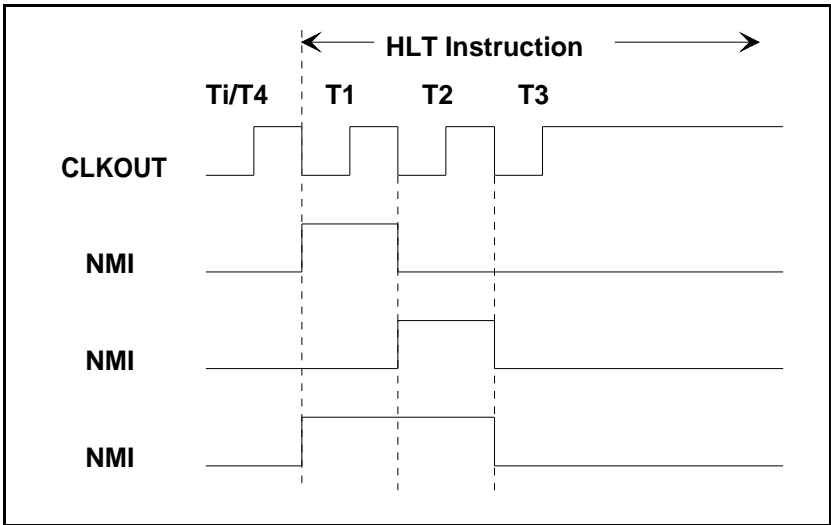
The problem occurs when an NMI occurs during execution of the HLT instruction. NMI is only serviced at valid instruction boundaries. The HLT instruction, when entering Powerdown, does not really have a boundary, it extends until Powerdown is exited. If NMI occurs between the beginning the T1 bus state and the end of the T2 state, but does not extend into T3, it will not be recognized, and the processor will enter Powerdown mode. The processor does not recognize the NMI request during the HLT instruction until the internal clock has stopped (at the end of T2).

Figure 7. NMI Ignored During HLT Entering Powerdown

If the system requires periodic NMI pulses, then the NMI pulse width must be long enough to ensure that it will extend into the T3 state of the HLT instruction. A NMI pulse width of three CLKOUT periods guarantees this.

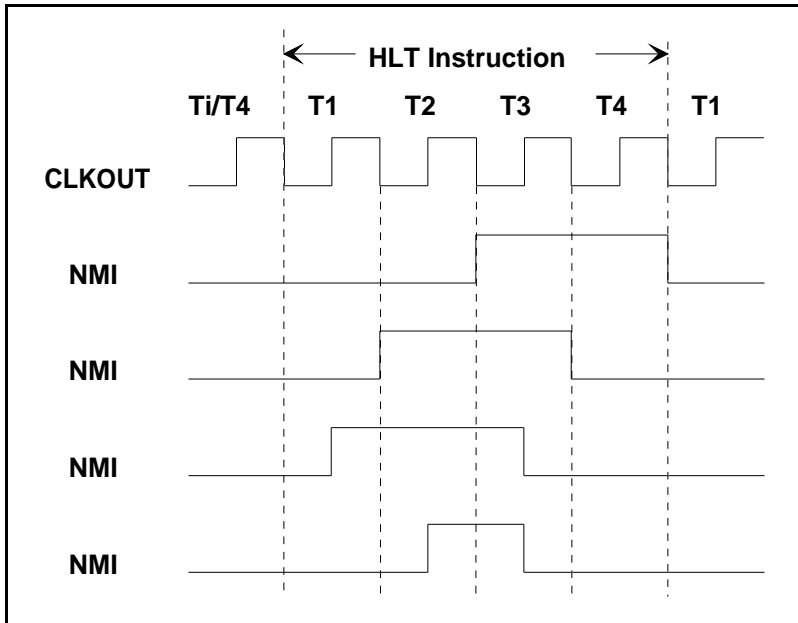
For the NMI to be recognized during the execution of the HLT instruction, the pulse must extend into T3. At this point, the processor has entered Powerdown and synchronized the NMI pulse. The NMI will be processed, but the processor will never enter Powerdown. Essentially, because NMI is active, the processor exits Powerdown as soon as it enters.

Figure 8. NMI recognized during HLT entering Powerdown
