Lifejacket Recalls (also see www.rnli.org/seasafety/safety_issues)

CREWSAVER Crewfit 290N Lifejackets – June 2011 to October 2012

Date: November 2012

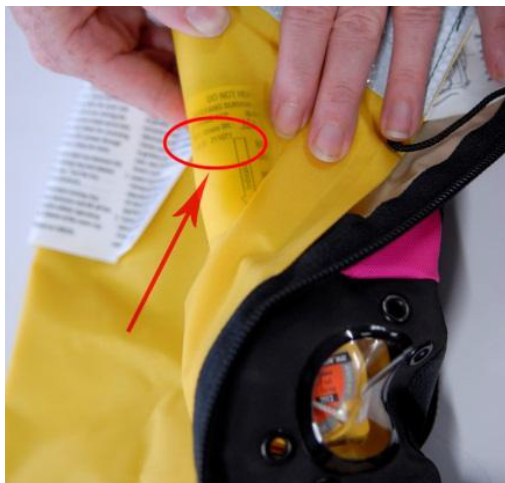
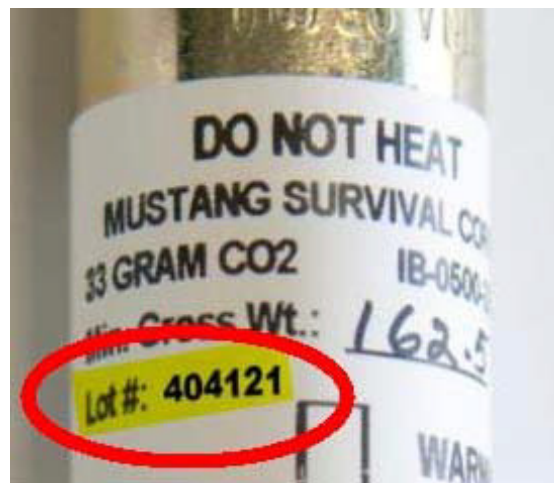
If you have a re-arm kit MA7214 or MA7218 you need only to check the lot number on the CO2 cylinder label. If your CO2 cylinder is marked with lot numbers 404121 or 404122 please contact Mustang Survival's customer service group at the number below.

Press the yellow bladder fabric against the cylinder to read the label to view the lot number through the fabric. If your CO2 cylinder is marked with lot numbers 404121 or 404122, please contact Mustang Survival's customer service group for instructions and to arrange for a replacement inflator assembly.

Photograph showing view of lot number through fabric. Lot number on cylinder label.

All other CO2 cylinder lot numbers are satisfactory. Repack your PFD so it is ready for use per the instruction manual. Mustang Survival Customer Service Group: 1-800-526-0532

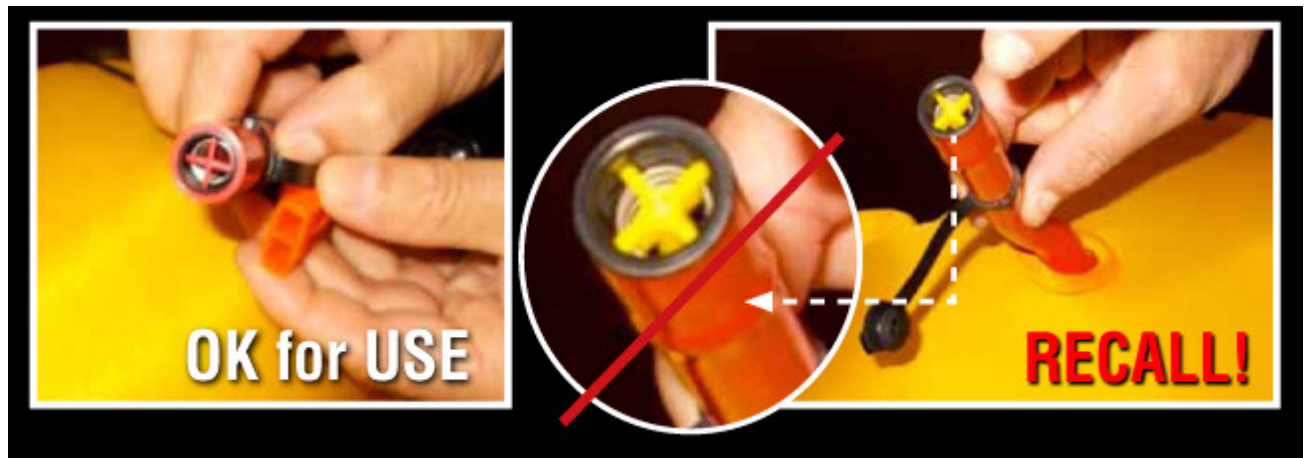
In order to avoid any potential safety issue, Mullion is recalling COMPACT-lifejackets which have been sold since 1st December 2011 if they have a **yellow** valve in the oral tube (see picture on the right below).

COMPACT lifejackets having a red valve in the oral tube are not affected and are not subject to this recall (see picture on the left below).

The problem with the lifejacket arose after a design change on the oral tube initiated by our supplier. Although this new design oral tube is a fully approved and certified product, we have noticed there may be a malfunction of the lifejacket upon inflation.

The affected lifejackets are being recalled as a precaution for inspection and, where appropriate, repair or replacement. Owners of affected lifejackets should:

1. **Do Not use them!**
2. **Return** them to [the nearest Mullion Lifejacket Service Station](#) or the [Mullion factory in Ireland](#).

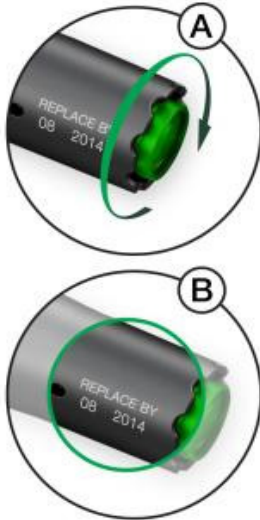
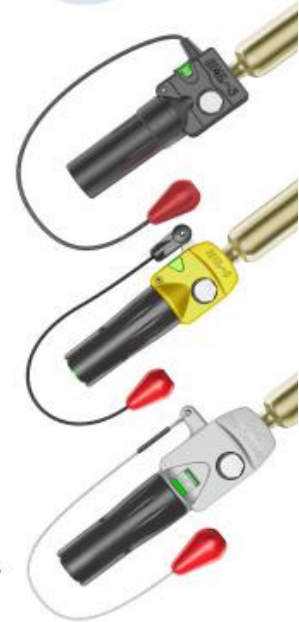
UML issued a safety check on all auto cartridges dated 08 2014. The problem is a loose screw thread on some cartridges. See below for details.

SAFETY CHECK THE TIGHTNESS OF YOUR 08-2014 CARTRIDGES

1. Hold the gas cylinder and head firmly in one hand.
2. With your other hand, firmly rotate the cartridge clockwise (See Image A).
3. If the cartridge 'clicks over' when you try to rotate it, (i.e. continues to rotate and will not tighten up fully) remove it completely from the firing head by turning the cartridge anti-clockwise.
4. Take a digital photo of the cartridge clearly displaying the replacement date as a record (See Image B).
5. Dispose of the cartridge as normal waste.
6. Send an email to the following address: dean@plascoat.com confirming your full name, postal address, country and contact telephone number, together with the lifejacket model, make, serial number and digital photograph of the cartridge 'Replace by date'.
7. A free of charge replacement cartridge will be sent to you by return.

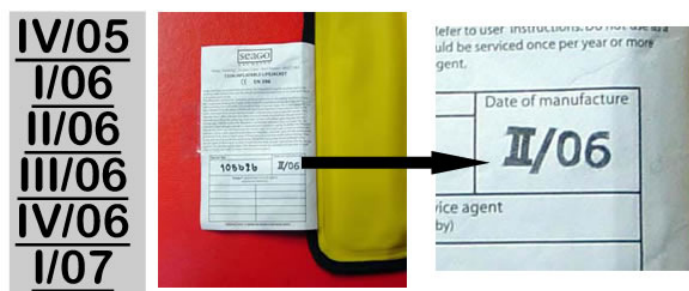
Some Mailspeed Charter Lifejackets & some Seago 150N & 175N Lifejackets **may** have a defect which could result in serious injury.

The Lifejackets are marked with a manufacture date in Roman numerals, for instance the last quarter of 2005 is shown as IV/05.

If you have an affected lifejacket then **PLEASE STOP USING IT IMMEDIATELY**. Please remove the gas cylinder manually and return the lifejacket only to:

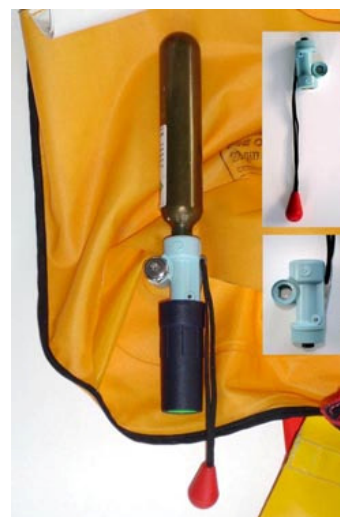
Manufacturers tests indicate this component to be at the end of its safe and usable life and should now be replaced.

To determine if the Lifejacket is affected please view the images on the left. If your Lifejacket is fitted with the **Mk3 Standard Automatic Head (shown left)**, then please contact Crewsaver.

We strongly recommend owners of Crewsaver Crewfit or Survivor Lifejacket with a **Mk3 Standard Automatic Head** fitted to contact Crewsaver direct on Tel. 02392 528621 or by email sales@crewsaver.co.uk to discuss the replacement process.

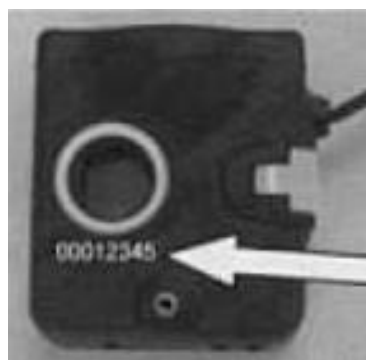
United Moulders have become aware that after extended use, the UML manual inflator may not function adequately. The products potentially affected were manufactured between 1999 and 2000; the inflators are easily identified, being printed with serial numbers in the following range:

The serial number is printed on the face of the inflator.

If you have one of the UML manual inflators then check the serial number printed on the front (pictured above). If it is in range of the serial numbers listed above, telephone the following number, (as soon as possible), and arrange to have it replaced, free of charge.

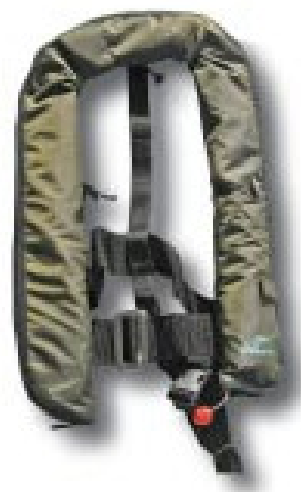
Remploy (the manufacturer) has brought to our attention that some of the **ENGLAND PROFESSIONAL LIFEJACKET** manufactured between the **6 October 1997 and 24 July 2006**, all of which have a green outer cover, may have been incorrectly assembled, possibly leading to an inflation failure in the event of manual operation.

No matter of concern has been raised regarding their automatic inflation. These lifejackets are being recalled as a precaution for inspection and, where appropriate, repair or replacement.
