## Customer Notification

# QB-V850ESSX2

## In-Circuit-Emulator

## Operating Precautions

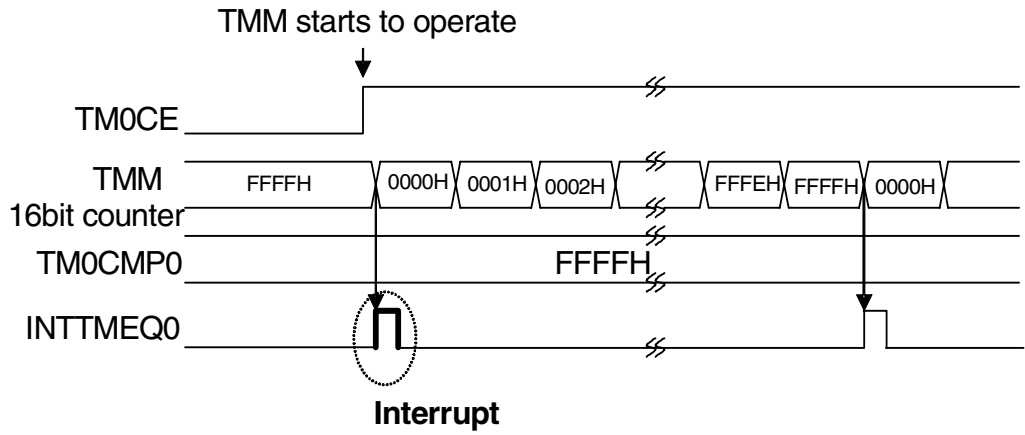
No. 3	Timer M compare interrupt (Specification change notice)
-------	--

An unexpected interrupt occurs after activation of timer M when the compare register TM0CMP0 contains the value 0xFFFF.

Do not set TM0CMP0 to 0xFFFF.

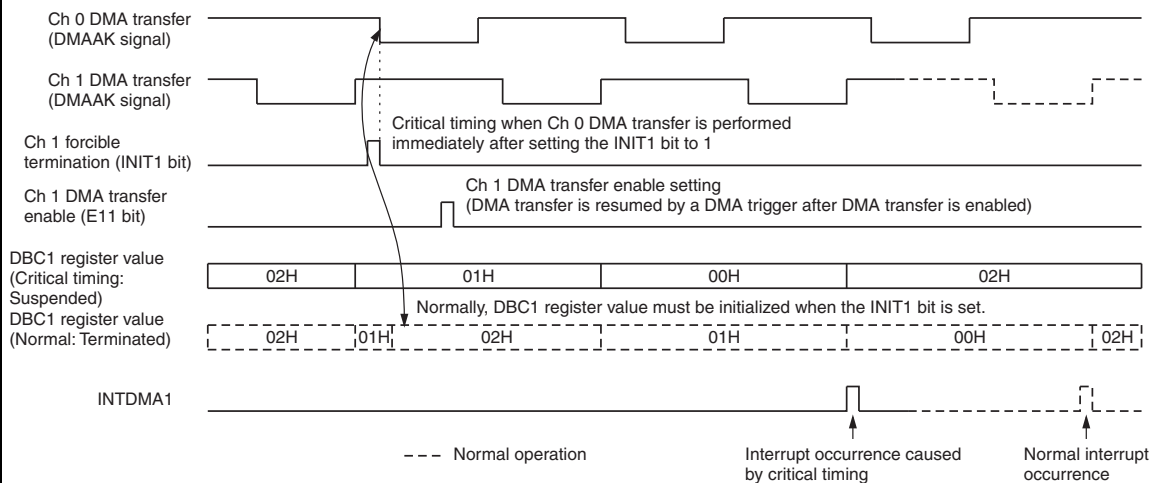
No. 12	DMA transfer forcible termination (Technical limitation)
--------	---

When terminating a DMA transfer by setting the corresponding INITn bit of the DCHCn register, the transfer may not be terminated, but just suspended, even though the INITn bit is set (1). As a result, when the DMA transfer of a channel that should have been terminated is resumed, the DMA transfer will terminate after an unexpected number of transfers are completed and a DMA transfer completion interrupt may occur. In addition, a DMA transfer of a channel n for which the INITn bit is set after forcible termination may be performed once again with the initialized value (n= 0 to 3).

The critical situation occurs if a DMA transfer is executed immediately after a forcible termination is set (by setting the INITn bit), refer to figure below.

Operation example: Both DMA channels, ch 0 and ch 1, are in single transfer mode, and ch 1 DMA transfer count is 3 (DBC1 register value = 02H).

No. 12	DMA transfer forcible termination (Technical limitation)
<p>(cont.) <u>Workaround</u></p> <p>The critical situation can be avoided by implementing any of the following procedures.</p> <p><b>&lt;1&gt; Stop all transfers from DMA channels temporarily.</b> The following measure is effective if the program does not assume that the TCn bit of the DCHCn register is 1 except for the following workaround processing. (Since the TCn bit of the DCHCn register is cleared (0) when it is read, execution of the following procedure b) under &lt;5&gt; clears this bit.)</p> <p>Procedure to avoid the critical timing:</p> <ul style="list-style-type: none"> <li>&lt;1&gt; Disable interrupts (DI state)</li> <li>&lt;2&gt; Read the DMA restart register (DRST) and transfer the ENn bit of each channel to a general purpose register (<u>value A</u>).</li> <li>&lt;3&gt; Write 00H to the DMA restart register (DRST) twice<sup>Note</sup>. By executing twice<sup>Note</sup>, the DMA transfer is definitely stopped before proceeding to &lt;4&gt;.</li> <li>&lt;4&gt; Set (1) the INITn bit of the DCHCn register of the channel that should be terminated forcibly.</li> <li>&lt;5&gt; Perform the following operations for value A read in (2) to obtain <u>value B</u>.             <ul style="list-style-type: none"> <li>a) Clear (0) the bit of the channel that is not terminated forcibly.</li> <li>b) If the TCn and ENn bits of the channel that is not terminated forcibly are 1, clear (0) the bit of the channel.</li> </ul> </li> <li>&lt;6&gt; Write value B in &lt;5&gt; to the DRST register.</li> <li>&lt;7&gt; Enable interrupts (EI state)</li> </ul> <p><b>Note:</b> Execute three times if the transfer target (transfer source or transfer destination) is the internal RAM.</p> <p><b>Remarks:</b> 1. Be sure to execute &lt;5&gt; to prevent the ENn bit from being set illegally for channels that are terminated normally during the period of &lt;2&gt; and &lt;3&gt;</p> <p style="padding-left: 40px;">2. n = 0 to 3</p> <p><b>&lt;2&gt; Repeat setting the INITn bit until the forcible DMA transfer termination is correctly performed (n = 0 to 3)</b></p> <p>Procedure to avoid the critical timing:</p> <ul style="list-style-type: none"> <li>&lt;1&gt; Copy the initial transfer count of the channel that should be terminated forcibly to a general-purpose register.</li> <li>&lt;2&gt; Set (1) the INITn bit of the DCHCn register of the channel that should be terminated forcibly.</li> <li>&lt;3&gt; Read the value of the DMA transfer count register (DBCn) of the channel that should be terminated forcibly and compare the value with the one copied in &lt;1&gt;. If the value do not match, repeat &lt;2&gt; and &lt;3&gt;.</li> </ul> <p><b>Remarks:</b> 1. When the DBCn register is read in procedure &lt;3&gt;, the remaining transfer count will be read if the DMA is stopped due to this bug. If the forcible DMA termination is performed correctly, the initial transfer count will be read.</p> <p style="padding-left: 40px;">2. Note that it may take some time for forcible termination to take effect if this workaround is implemented in an application in which DMA transfer other than for channels subject to forcible termination are frequently performed.</p>

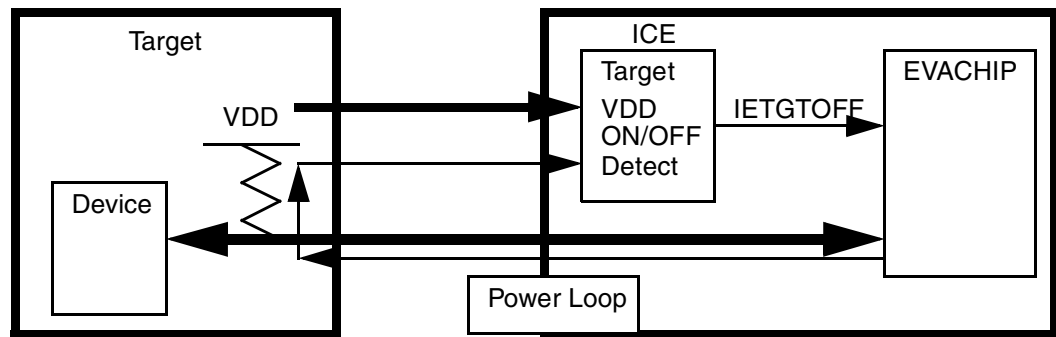
No. 15	Pin control with target power OFF (Direction for use)
--------	--

When power to the emulator is ON and that to the target is OFF, leakage current may flow from the emulator to the target.

Some external bus signals, however, drive a high level, and a current may leak into Vdd of the target via the pull-up resistor of the target.

The target supply voltage detector circuit of the emulator detects this VDD, and the emulator assumes that power is applied to the target. Consequently, reset is cleared and the external bus signals are driven. As a result, a leakage current flows.

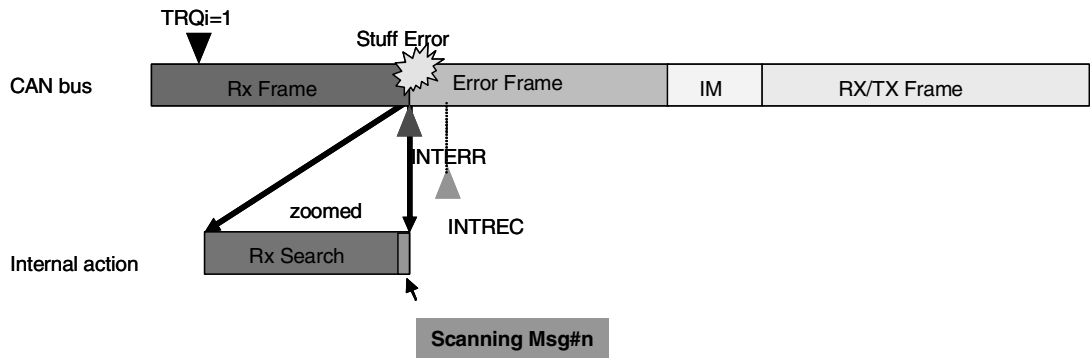
Figure 1: Behavior at pending TRQ

**1. Behaviour at pending TRQ (TRQi = 1)**

When the host processor has already submitted a transmit request (TRQ) for at least one buffer, the unexpected reception of the message will take place into the message buffer found by internal RX-search. This is the correct location to store the message i.e. the acceptance filter criteria are correctly fulfilled. However the data part will be updated with the contents of the shift register of the CAN protocol core. As this register is immediately stopped at detection of the bus error, the data provided to the message buffer can not be interpreted by the host processor.

No. 38	aFCAN: Rx limitation (Technical limitation)
<p>(cont.)</p> <p><u>Workaround</u></p> <p>NEC will update the affected products. NEC does not recommend a S/W workaround as first choice as it is fairly complex. On the one hand it is based on the control of submitting transmission requests only when the bus is idle. On the other hand a less complex algorithm can be used which does not prevent the unexpected reception but detects it safely and discards the unexpected reception in the CAN S/W driver. Any of these algorithms require that message buffer #0 is not used or that a 'dummy' TRQ in an unused buffer is set. This prevents behaviors as described in 2.</p>

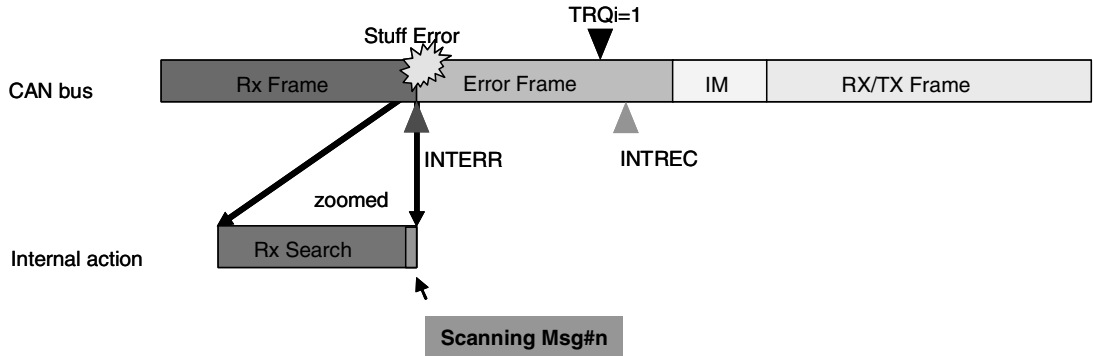
Figure 2: Behavior without pending TRQ

**2. Behavior without pending TRQ (TRQi = 0)**

In case the host processor has not submitted a transmit request (TRQ) for any buffer before the detection of the bus error but submits TRQ = 1 after that point in time (see figure below) before the re-transmission of the message interrupted by the stuff bit error started, the unexpected reception of the message will take place.

The unexpected storage of the message is issued in the particular message buffer that matches the acceptance filter criteria at the time where the bus error is detected (as described in 1.) or the message buffer #0 is overwritten independently of its configuration.
