# MCF5282 Device Errata

Supports: MCF5281 and MCF5282

MCF5282DE  
Rev. 2.0  
01/2006

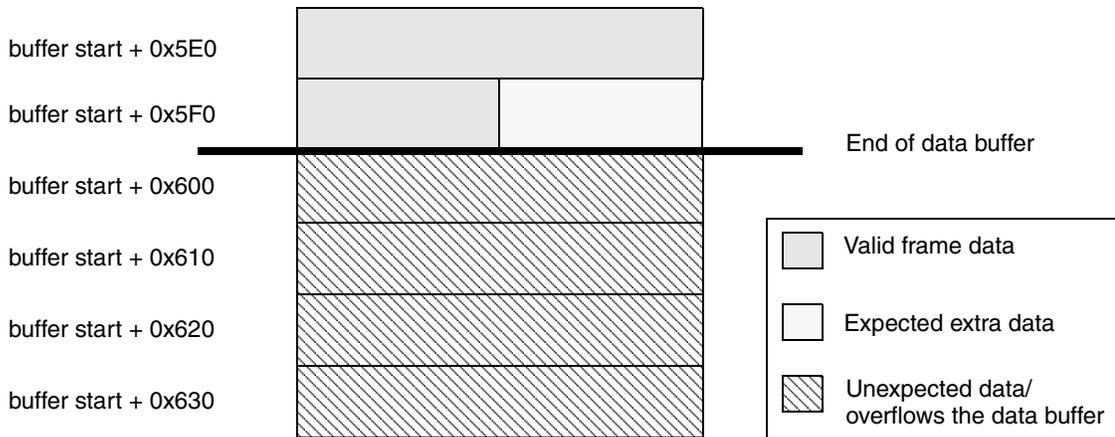
Figure 1. Buffer Overrun Example

When the FEC is connected to a 10BaseT network, if length of the data stored in a descriptor is not evenly divisible by 16 (not line-aligned), then the FEC will write extra lines at the end of the buffer—the entire line that contains the last valid data is written and at least one extra line, but up to four lines after the end of the valid data can also be written. In most cases this is not a problem, since the extra lines of data still fall within the limits of the buffer. However, if the valid data ends near the end of the buffer, then the extra lines written by the FEC might be outside of the data buffer. This leads to corruption of the next buffer, descriptor, data, or code stored in the adjacent memory.

For example, as shown in [Figure 1](#), if the max buffer size is programmed to 0x600 and a frame that is 0x5F8 bytes long is received, then a line is written starting at buffer start + 0x5F0. The first half of the line at buffer start + 0x5F0 is valid frame data that should be processed by the FEC driver; the second half of the line is additional data that is written because the FEC will only write complete lines. This data should be ignored by the FEC driver. So far, this is correct FEC behavior as originally specified. However, the FEC will repeat the last line of valid data a number of times. The line at buffer start + 0x600 will be written, and as many as three additional lines beyond the end of the data buffer could be written.

1. Only use 100BaseT.
2. Allocate extra lines for the receive data buffers. The actual allocated memory for each buffer should be equal to the receive buffer size programmed in the FEC's EMRBR register plus four lines (16 byte-sized lines).
3. Program the data buffer size one line larger than the max packet size (data buffer size = EMRBR + 0x40).
