This document contains errata and design notes that affect designs using the PPC405D5X1, PPC405D5X2 and PPC405F6X1. Each erratum includes an overview, a description of the system impact and a description of possible work-around(s). Design notes cover items that are not considered errata but need a description beyond what is provided in published documentation. Table 1 identifies errata affecting cores by version. Tables 2 and 3 contain a summary of all errata and design notes.

Errata

Xilinx

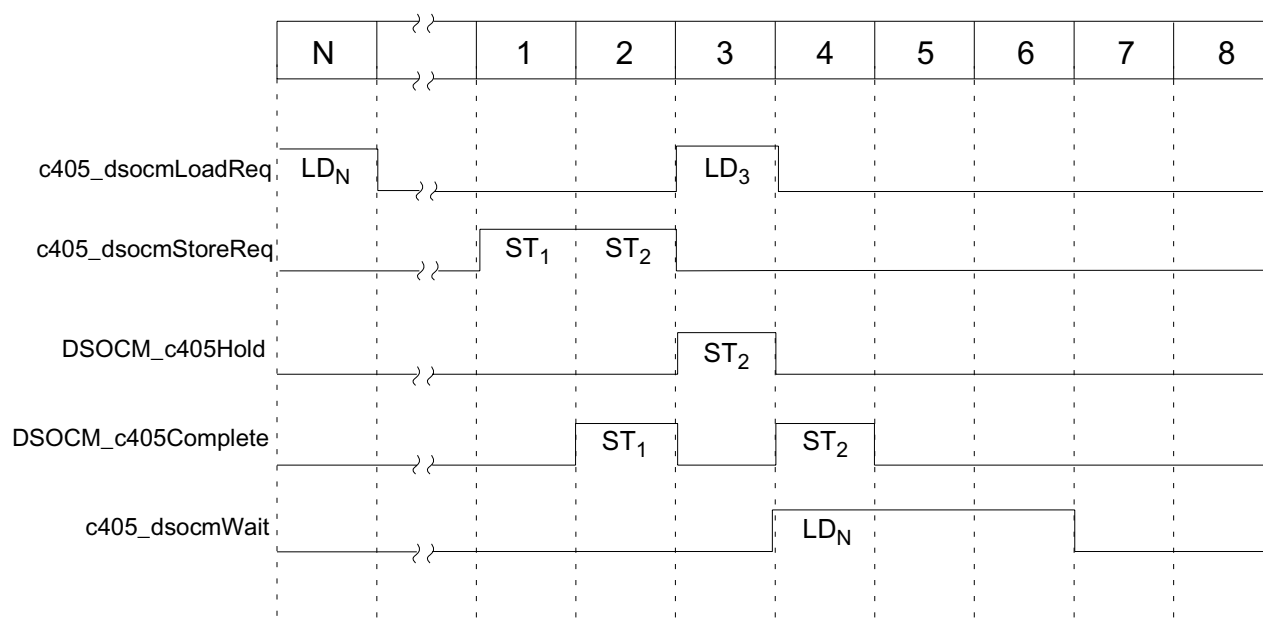
Figure 1. Example 1, LD_3 is a non-OCM access.

Figure 1 and 2 are two examples showing C405_dsocmWait asserted for a load (LD_N) in the same cycle as DSOCM_c405Complete for a store (ST_2). In example 1, the PPC405 does not detect the DSOCM_c405Complete for ST_2 and continues to wait for a complete. In example 2, the PPC405 interprets the complete for LD_3 as the complete for ST_2 . LD_3 is then treated as non-OCM access.

LD_N is a load from non-OCM memory.

ST_1 and ST_2 are stores to OCM memory.

LD_3 is a load from non-OCM memory in example 1 and a load from OCM memory in example 2.

When attached to a multi-cycle OCM controller, the PPC405 may assert the C405_dsocmWait signal during the assertion of DSOCM_c405Hold or DSOCM_c405Complete for an OCM store operation. The PPC405 will ignore a valid DSOCM_c405Complete signal for an OCM store while asserting C405_dsocmWait. The PPC405 will be left in a state with an incomplete OCM store operation, possibly causing future OCM operations to be missed or possible PPC405 hang conditions. A specific OCM controller design may not tolerate the inadvertent assertion of C405_dsocmWait during an OCM store operation.

1. Set bit 1 of CCR0 during initialization or prior to any OCM store accesses. Setting this reserved bit causes the PPC405 data cache unit (DCU) to block requests when there is a d-cache miss.

2. Execute a sync instruction prior to executing any OCM stores to create a barrier between any PLB load accesses and the OCM store operations.
3. When precise code sequences are known for a specific OCM controller, split these code sequences to eliminate the possibility of the problem occurring.
4. Design the OCM controller to react to C405_dsocmWait signal for store operations in a manner similar to that required for load operations.
