GREENER HOMES PILOT PROGRAM

ENERGY REDUCTION PLAN

Eastern Ave Apartments

Report Date: June 24th, 2010

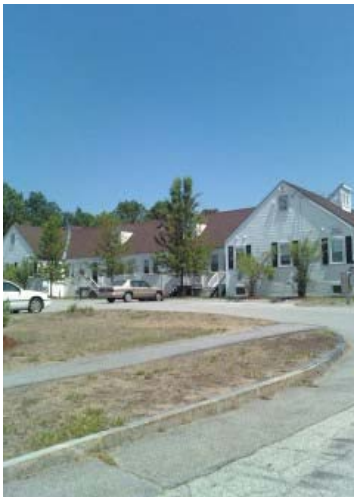
All buildings have pitch roofs with medium to dark asphalt shingles. The roofing appeared to be in excellent condition.

A CDX wooden roof deck supports the roofing and is securely fastened to the roof trusses. Soffit and ridge vents supply roof ventilation along with two non-functioning thermostatically controlled gable end fans.

Interior attic access is via two full size steel insulated doors on the top floor. The attic space, revealed approximately 3” inches of rock-wool fiber under about 11 inches of blown cellulose insulation. After examining the attic flat it was apparent that many gaps around plumbing and electrical penetrations were not sealed prior to insulating. Wall to ceiling connections and open knee-wall spaces also need to be sealed.

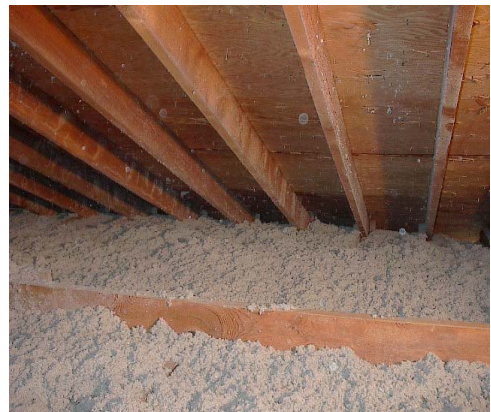
- minor cracks around windows
- units with missing drywall ceilings (above 2 x 4 drop down ceiling tiles)
- framing connections; base of walls and tops of interior walls
- electrical outlets installed on walls with interstitial space between them (infiltration occurs through the top plates of the wall)
- plumbing penetrations which are connected to the attic space

- around the kitchen exhaust fan ductwork
- knee-wall wall spaces on the attic side allowing air into the walls

Infiltration (in air changes per hour) at this facility is quite high and at least twice the ASHRAE standards. A great portion of the air leakage occurs due to the missing drywall ceilings that have been covered over with tiled drop down ceiling. Since air leakage in buildings can represent anywhere from 5% to 40% of the space-conditioning costs, it's important to control the infiltration while maintaining good ventilation. This will improve tenant comfort, reduce large temperature swings and will prevent ice dams.

- Reduce air infiltration into the building by use of expanding foam and transparent caulking to seal building penetrations such as: tops of interior walls in the attic, wall ceiling junctions in the attic, exposed plumbing pipe holes and chase ways both in attic and basement.
- Seal pipe holes under kitchen and bath sinks

- Seal missing drywall ceilings above acoustical tiled ceilings by taking down necessary 2x4 acoustical tiles and install 3/8" fan fold foam board above tiles so as to cause a solid air barrier to attic, sealing all edges and seams with expanding foam in units where applicable.

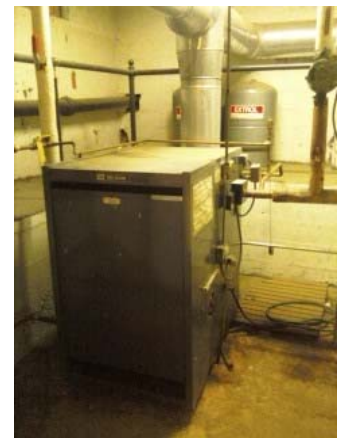
All mechanical equipment is in its own self contained area in the basement. Well McClain model # CGB-6 650,000 BTU water filled atmospheric boiler is used for space heating and runs a continuous loop to feed the apartments units. This boiler is greatly oversized at the building's current heating requirement. It lacks proper indoor /outdoor controls to operate the boiler. This boiler should be upgraded to an ENERGY STAR boiler, sized for the building's heating load and along with the appropriate boiler control system. This boiler does not provide

Existing Conditions: One oversized and tired boiler exists that is currently short cycling and has no controls to reduce excess fuel consumption and runtime.

- Replace existing boiler with a modulating, 95% thermal efficiency or greater condensing boiler system according to plans and specifications provided by a design professional using standard methods such as ACCA manual J, or ASHRAE. The maximum input capacity of each new condensing boiler shall be sized to provide at least 60% of the estimated peak design heating load for the buildings that it serves

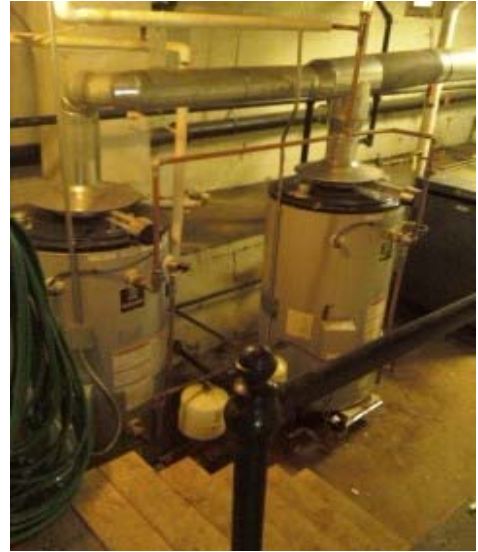
In the same mechanical room, two old 80- gallon natural gas independently fired atmospheric hot water storage tank provide DHW and these vent into the chimney. These tanks run a continuous loop with circulator pumps. Each tank rated at 180,000 Btus is oversized for the building's current DHW needs and are very inefficient compared to an indirect fired domestic hot water setup. The water temperature in the apartment units ranges between 125 to 130 degrees. All showerheads were 2.5 gallons per minute (GPM), all kitchen faucets were 2.2 GPM and bathroom faucet aerators were 2.0 GPM. Approximately half of the apartment toilets have been upgraded from 3.5gpf to 1.6gpf.

- Disconnect and remove both existing hot water heaters and install a new indirect stainless steel tank in line with the boiler. New boiler to feed a new insulated stainless steel storage tank (indirect fired).
- Provide aquastat recirculation control between boiler and storage tanks. The Aquastat set point should be set at a temperature not higher than 130°
- Replace existing manual mixing valves with electronically controlled automatic mixing valves to ensure controlled and accurate delivery at the faucets within the temperature range of 120-125°. Ensure a storage tank temperature of 130° or per New Hampshire Mechanical Code
- Insulate the uninsulated DHW hot water pipes in the basement with 1” fiberglass insulation and according to New Hampshire State Energy Conservation Construction Code
- All work should be performed as per New Hampshire Building Code

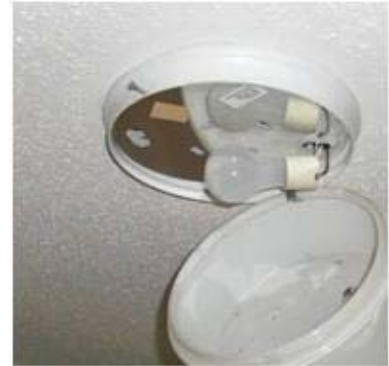
The apartment light fixtures were mainly fluorescent with twin biax bulbs, though some older incandescent fixtures are present in certain units as noted below. All units had around one to four table or floor lamps using incandescent light bulbs that should be upgraded to fluorescent.

- Replace all existing incandescent ceiling mounted fixtures within the units with a 2 to 1 ratio of wattage using pin based fluorescent fixtures. Glass domes should be either lightly frosted or spiral type for maximum light output.
- Measure and record existing light level with a hand held light meter held at the mid-point between lighting fixtures. If only one fixture is in the room, measure at the mid-point between the fixture and farthest wall. The meter should be held 30 inches above the floor.
- Submit product information and obtain owner approval prior to ordering.
- Dispose the light bulbs off-site in compliance with state and local solid waste regulations, unless otherwise instructed by the owner.

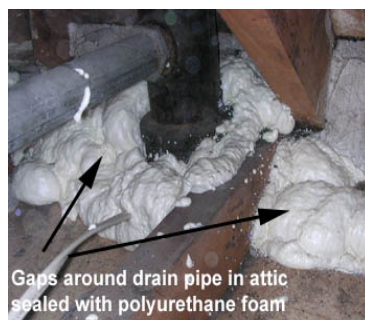
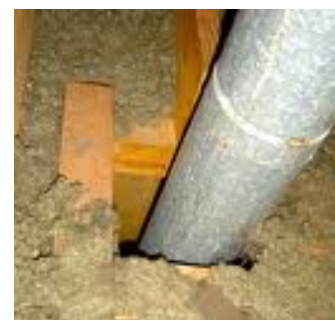
Some general building construction details have not been air sealed, a few units are missing drywall above their 2' x 4' ceiling tiled ceiling. Overall, there is excessive air leakage into the building.

Approximately 28 existing window openings are single-pane original wood-framed windows.

Replace existing quantity of (28) single pane wood windows in the heated basement area, with white vinyl Energy Star windows with low/e and argon or krypton gas and a U-value of .30 or less.
