**TECHNICAL BULLETIN**  
**CS 250ci/300ci400ci/500ci**

<b>Bulletin #</b> CS 250ci/300ci/400ci/500ci-10	<b>Model</b> CS 250ci/300ci/400ci/500ci	<b>Date</b> 02/11/11
<b>Updated Serial Number</b> N/A		
<b>Subject</b> <b>500ci SERIES TROUBLESHOOTING GUIDE</b>		
This technical publication is confidential information that is the property of Kyocera Mita America, Inc. It is solely for the use of Kyocera Mita's authorized dealers. This information may not be published, reproduced, sold, or copied in any media. Its unauthorized use is prohibited. Copyright © 2011 by Kyocera Mita America, Inc. All rights reserved.

# 500ci Series Troubleshooting Guide

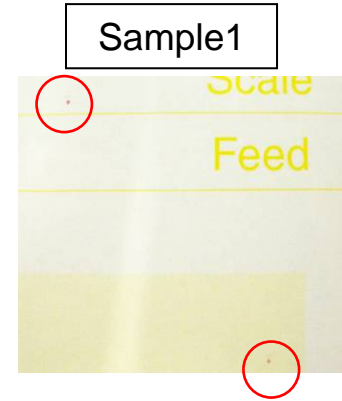
Donut dot (random color dot), see Sample 1

- Update Firmware to the latest Version on KMAconnect.
- Identify the color of the dot.
- U464 AC CALIBRATION TYPE, set from "0" Normal setting to "2" Color Dots Mode 1.
- This sets the Dev ROLL2 DUTY to 317 and the AC Calibration Magnification to -5.
- Next perform U464 AC Calibration execution for the color of the dot.
- Check for dots.
- If not resolved, set from "2" Color Dots Mode 1 to "3" Color Dots Mode 2
- Next perform U464 AC Calibration execution for the color of the dot.
- If not resolved, replace the DLP Unit that matches the color dot and set to "4" Default Mode and execute AC Calibration for that color.

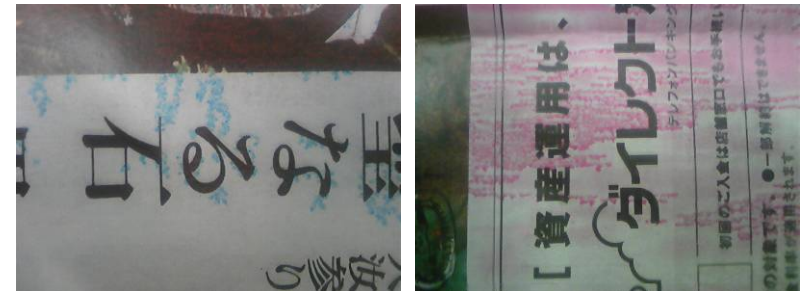
Dev/toner leaking (a cloud of random dots), see Sample 2

- Update Firmware to latest Version on KMAconnect
- U464 perform AC Calibration execution for the color of the dot.

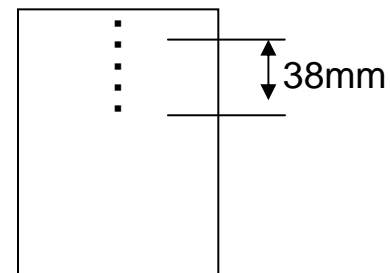
Sample3

Dots in sub-scan direction, MC roller pitch (38mm) repeating, see Sample 3

- Replace the Charge Roller matching the color if the dot

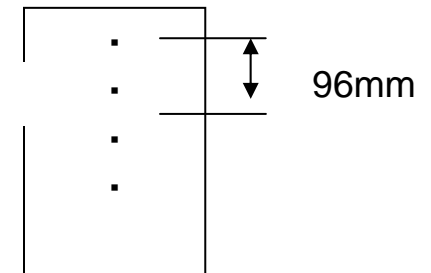
Sample4

Dots in sub-scan direction, Drum pitch (96mm) repeating, see Sample 4

- Replace the Drum Unit that matches the color of the dot.

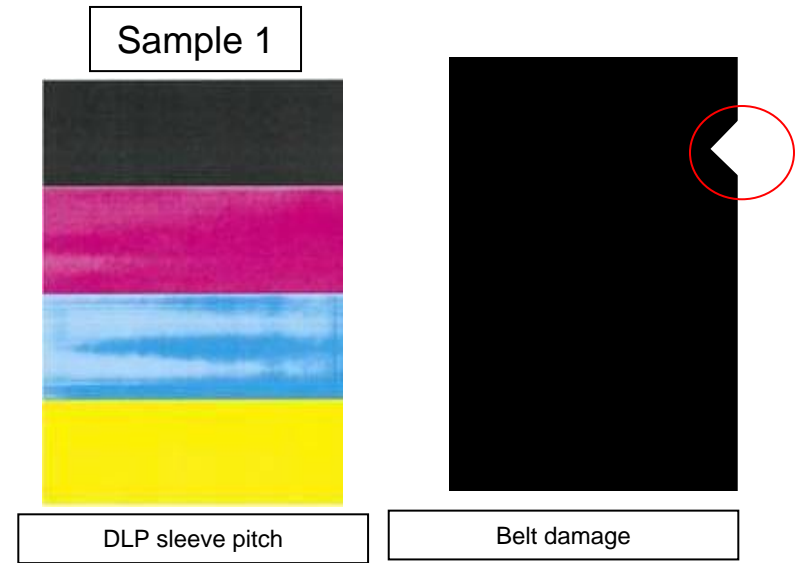
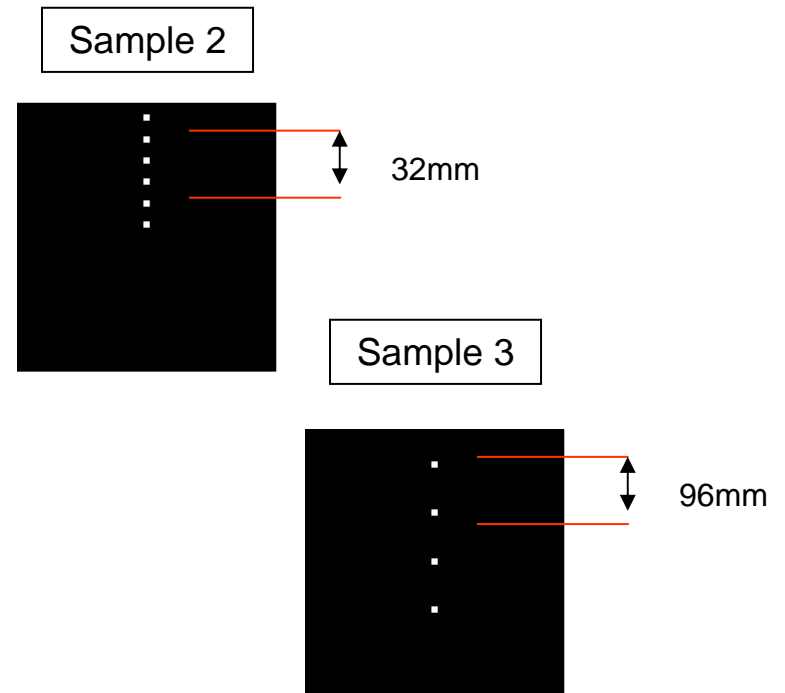
Sub-scan direction, 32mm pitch

Sub-scan direction, 96mm pitch.

- Update Firmware latest Version on KMAconnect
- Execute Developer Refresh
- Replace the color DLP Unit which is causing the problem when the developer refresh does not help.

- Clean **DLP sleeve roller** with a clean dry lint free cloth.
- Replace the color DLP Unit which is causing the problem when cleaning does not help.

- Clean the **Drum** area with a clean dry lint free cloth.
- Replace the Drum Unit for the color when cleaning does not help.

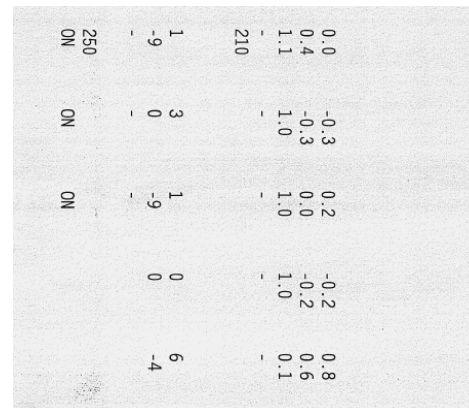
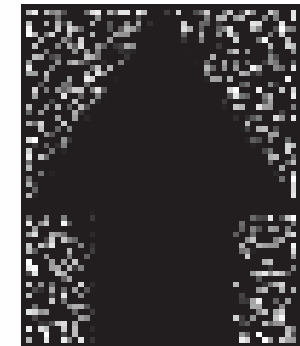
Sample1

## 1. Background appears on the image.

- a. Update Firmware to latest Version on KMAconnect.
- b. Run Developer refresh.
- c. Run Color calibration.
- d. Replace the DLP unit that corresponds to the color of the background when developer refresh does not help.
- e. Check the original coverage ratio on the status page.
- f. If the original coverage ratio is between 5% to 10%, change the setting of U325 to Mode4.
- g. If the original coverage ratio is between 10% or more, change the setting of U325 to Mode5.
- h. If background still occurs, set U147 to Mode1 or Mode2.

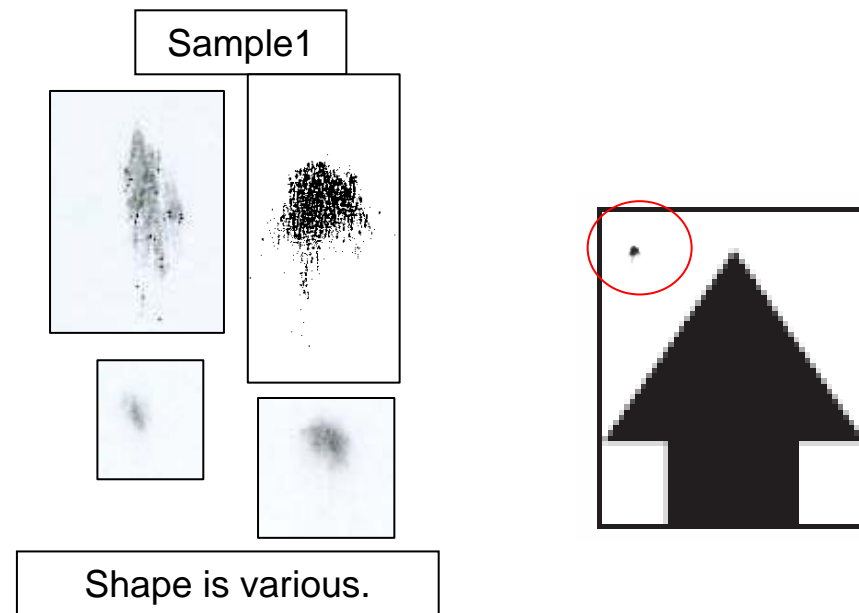
## 1. Smudges appear on the image.

- a. Update Firmware to latest Version on KMAconnect.
- b. Run Developer refresh.
- c. Run Color calibration.
- d. Replace the DLP unit that corresponds to the color of the smudges when Developer refresh does not help.
- e. Check the original coverage ratio on the status page.
- f. If the original coverage ratio is between 5% to 10%, change the setting of U325 to Mode 4.
- g. If the original coverage ratio is between 10% or more, change the setting of U325 to Mode 5.

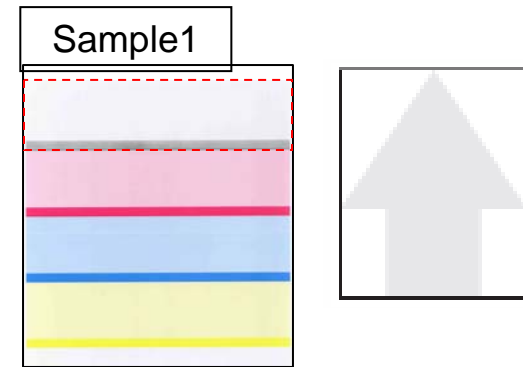
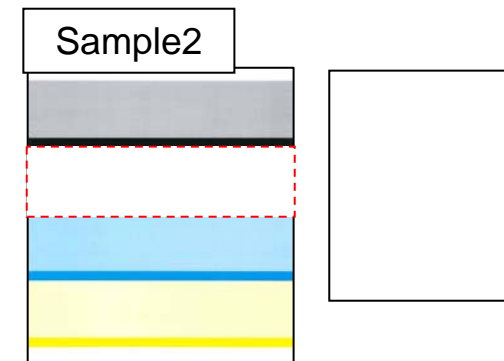
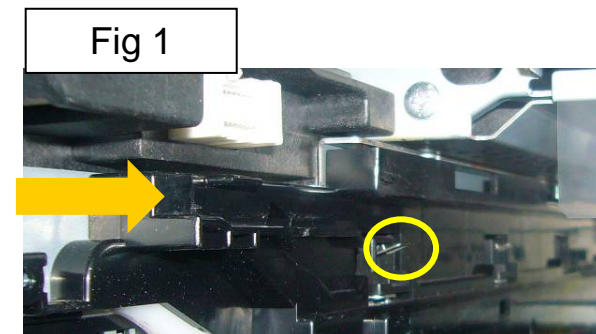
### 1. Light image, Toner is over charged (Sample 1)

Low toner usage environment

Transfer belt ground contact problem

Primary transfer voltage problem

### 4. Light image, developing bias (Sample 2)

Developing bias problem

- Update Firmware to latest Version on KMAconnect
- Execute Developer refresh
- Replace the DLP unit corresponding to the color problem when the developer refresh does not help.
- If it occurs on a color DLP, set U486 from Mode2 (Default) to Mode1.

- Check the ground contacts for the Driving roller on the Transfer belt.

- Check the ground contacts between the Primary high voltage unit and Primary Transfer roller on the Transfer belt. (Fig 1)
- Remove the Transfer belt Unit in accordance with the Service Manual.  
Note: If you do not remove the "Left Eject Assy" first, you can destroy the contacts on the HV Unit for the Primary Transfer Belt roller on the Transfer Belt. Primarily the Black which is at the front and is circled in the (Fig 1)

- Run U464, AC Calibration
- After completing AC Calibration, if a error 11~14 appears, check the following areas.
- Check the Contact area between the DLP Unit and the Main HV PWB.
- Check the Wire harness and connector between the ENGINE PWB/MAIN HV PWB
- Replace the Main HV PWB if the problem still exists.

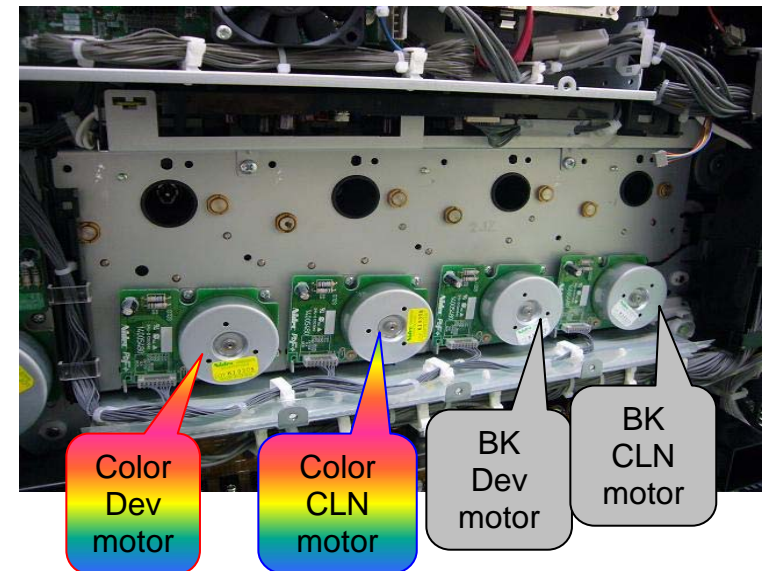
### 1. C2101/C2102 (Developing Motor Trouble) (C/M/Y/K)

- Remove the Developing Unit and manually rotate the Dev Unit gear by hand.
- If the Gear is hard to turn, shake the unit back and forth and check if the gear is easier to turn. Repeat this a few times.
- If the gear turns, the unit is OK.
- If the gear does not turn or is difficult to turn, replace the Developing Unit.

- Turn the Motor Drive Unit Gear in question after removing the Developing unit for each color.
- If the Motor Gear is hard to turn, replace the Parts S Main Drive Unit.

- Check the Motor connection, connector/wire.
- Check if the Fuse is bad. See TB#6 for fuse check procedure.
- Locate the loose connector or pinched wire.
- Insert the connector or replace the harness.

- Locate the loose connector or pinched wire.
- Insert the connector or replace the harness.
- Replace the Dev motor if no pinched wires are found.

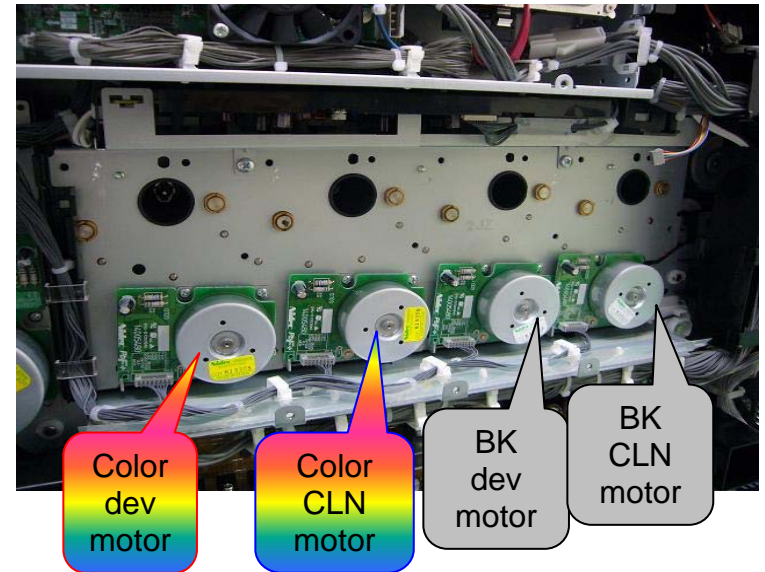
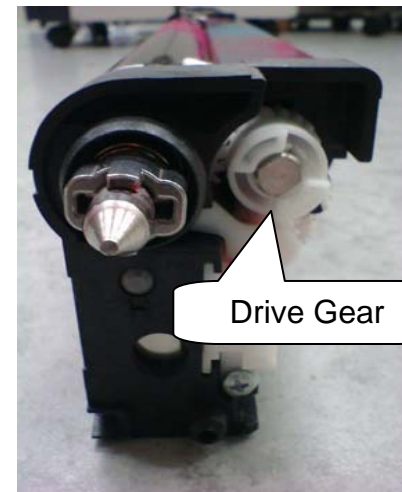
### 1. C2351/C2352, Cleaning Motor Trouble (CMYK)

- a. Remove the Drum Unit and Rotate the Cleaning Roller Drive Gear.
- b. If the Gear is hard to turn, replace the Drum Unit.

- a. Turn the Drive Unit Gear for each the developing unit
- b. If the Drive Unit Gear is hard to turn, replace the Parts S Main Drive Unit.

- a. Check the Motor connection, connector/wire
- b. Check if the Fuse is bad. See TB#6 for fuse check procedure.
- c. Locate the loose connector or pinched wire
- d. Insert the connector or replace the harness

- a. Locate the loose connector or pinched wire
- b. Insert the connector or replace the harness
- c. Replace the Friction motor if no pinched wires are found
- d. Replace the Engine PCB

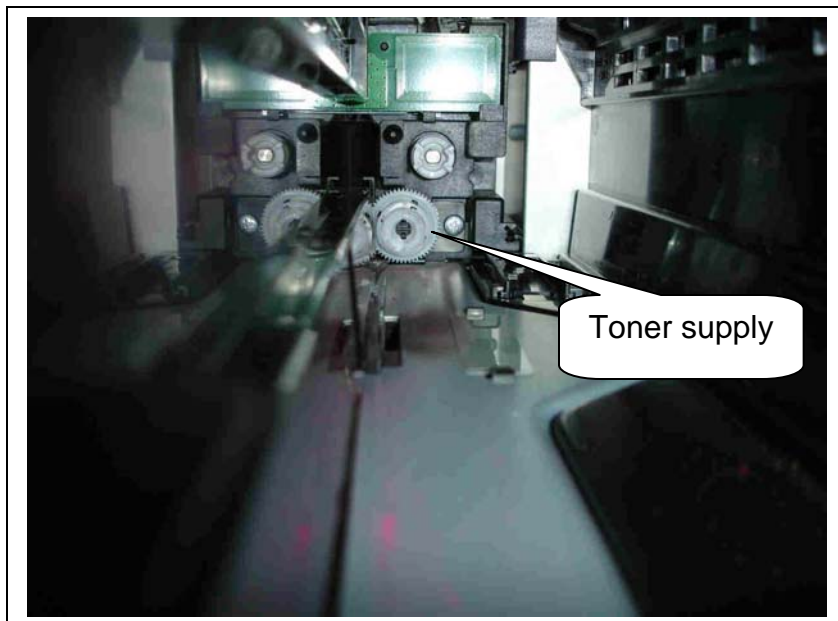
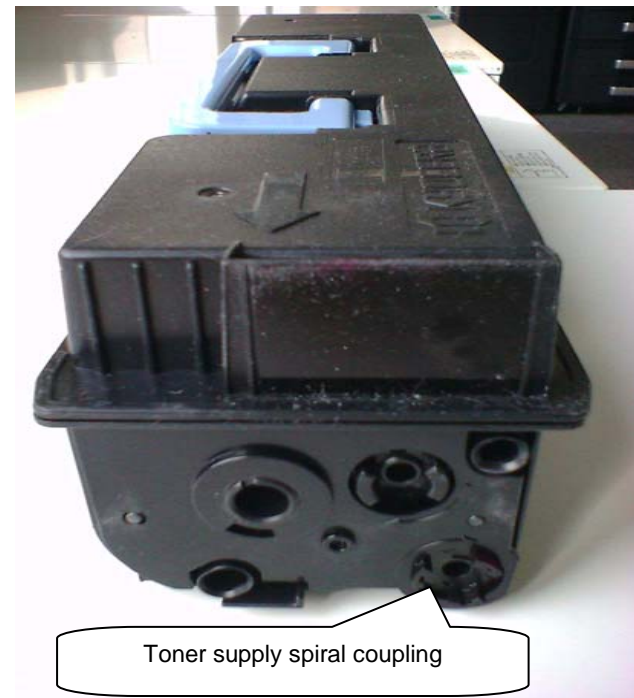
### 1. C7000 (Toner Motor Trouble)

- a. If it seems bound, replace the Toner container.

- a. Check the motor connection, connector/wire
- b. Locate the loose connector or pinched wire
- c. Insert the connector or replace the harness
- d. Problem with the Motor, Replace the Toner motor
- e. Problem on the Engine PCB, Replace the Engine PCB
- f. Problem with the Drive unit, Replace the Drive unit

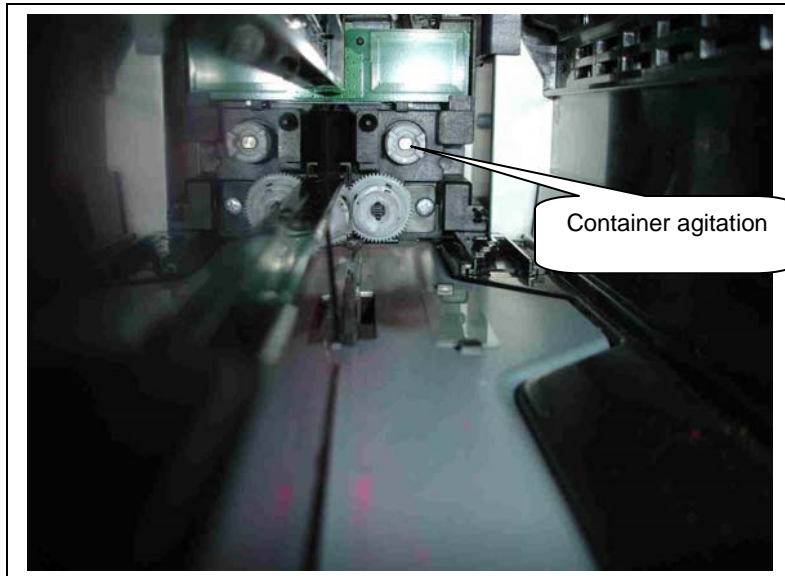
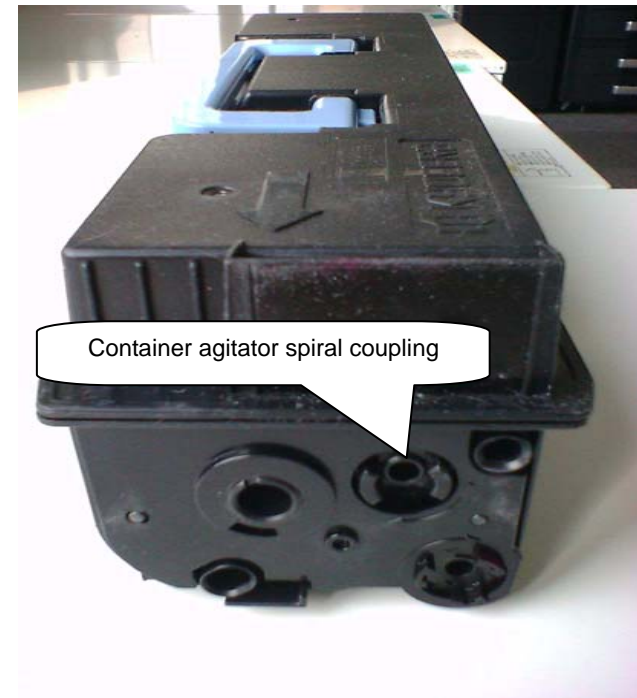
### 1. C7100 (Toner Container Motor Trouble)

- a. If it seems to be bound, replace the Toner container.

- a. If one is rotating and other is not rotating, replace the Drive unit on machine rear side.

- a. Check the motor connection, connector/wire
- b. Locate the loose connector or pinched wire
- c. Insert the connector or replace the harness
- d. Problem with the Motor, Replace the Toner motor
- e. Problem on the Engine PCB, Replace the Engine PCB
- f. Problem with the Drive unit, Replace the Drive unit

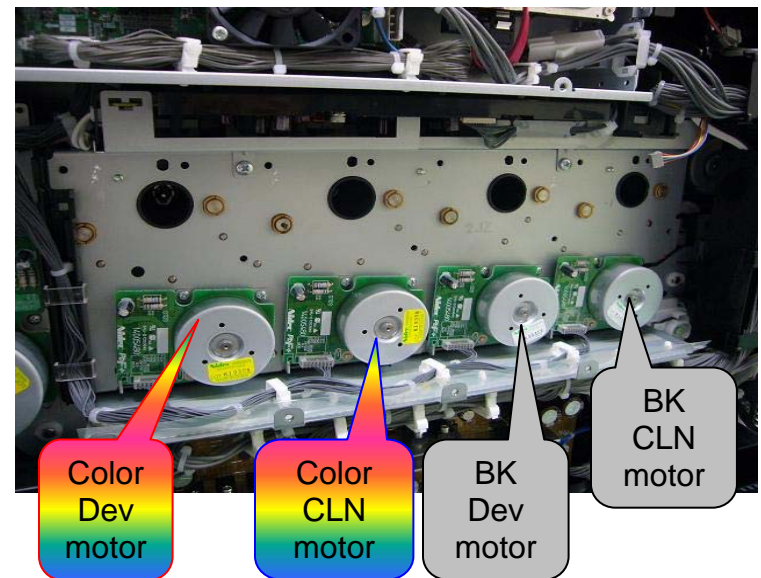
### 1. C7101/7102/7103/7104 ( Toner Control Sensor Trouble (CMYK)

- Remove the Developing Unit and manually rotate the Dev Unit gear by hand.
  - If the Gear is hard to turn, shake the unit back and forth and check if the gear is easier to turn. Repeat this a few times.
  - If the gear turns, the unit is OK.
  - If the gear is does not turn or is difficult to turn, replace the Developing Unit.
- Note: If the new Developing Unit is not shaken back and forth to loosen developer, the C code can occur again.**

- Remove the front cover and check the Front PCB/ Front sub PCB connection connector/wire
- Locate the loose connector or pinched wire
- Problem with the Front PCB/ Front sub PCB:
- Replace the Front PCB/ Front sub PCB

- Locate the loose connector or pinched wire
- Problem with the Engine PCB, Replace the Engine PCB

- Check the Motor connection, connector/wire
- Check if the Fuse is bad. See TB#6 for fuse check procedure.
- Locate the loose connector or pinched wire
- Insert the connector or replace the harness

- Locate the loose connector or pinched wire
- Insert the connector or replace the harness
- Replace the motor
- Problem with the Engine PCB, Replace the Engine PCB
