CRITICAL SERVICE BULLETIN

CSB94-15

SUBJECT: CRANKCASE STUD INSPECTION

AFFECTED: O-470, IO-470, IO-520, IO-550, TSIO-520, TSIO-550, TSIOL-550 and GTSIO-520 model engines listed below and these engine models that contain affected service replacement crankcases.

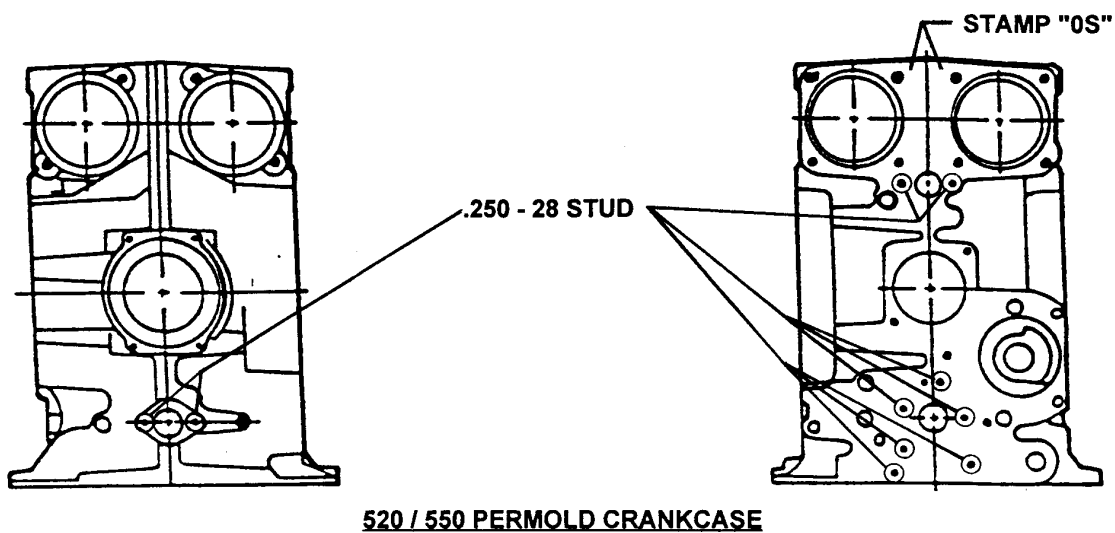
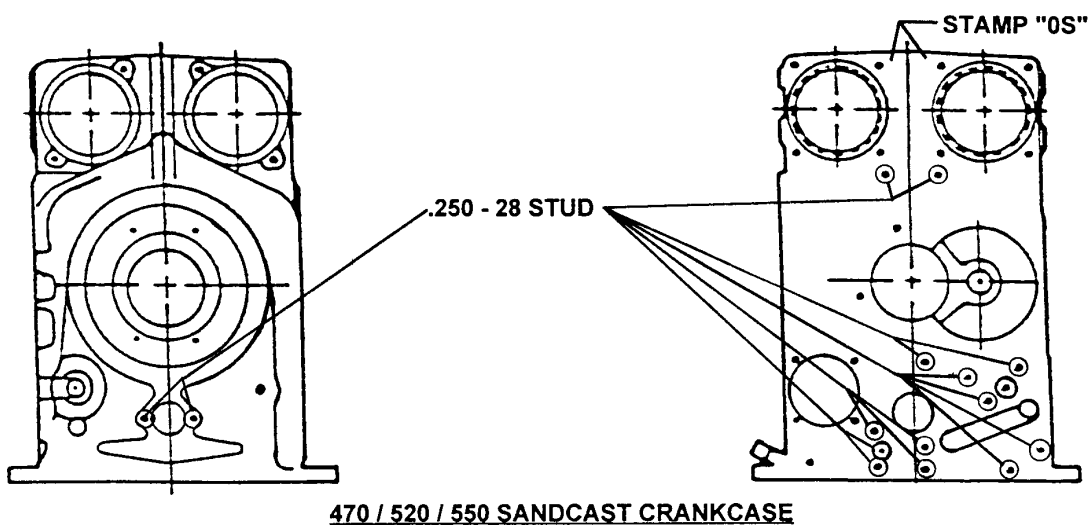
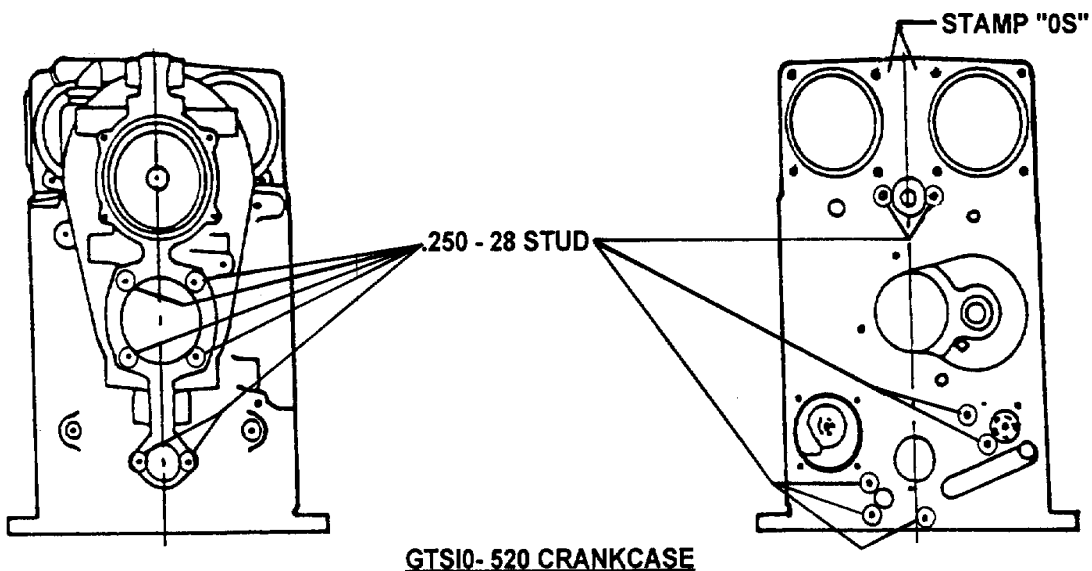
FIGURE 1 .250 - 28 STUD LOCATIONS

1. Open or remove the cowling necessary to gain access to the rear of the engine.
2. Remove the two sets of nuts and washers from the idler gear support pin studs. These studs are positioned on the rear (accessory section) of the crankcase, just below the left and right accessory drives. See Figure 1. DO NOT remove the idler gear support pin.

8. Measure all of the .250" stud extension heights and record their locations. See Figure 1. This is necessary for proper installation of the replacement studs. Remove all .250"-28 studs from the front and rear of the crankcase using an appropriate stud removal tool and record their lengths as they are removed so that the same length stud is installed in the same location. Discard the old studs.

9. Add a small amount of clean grease to the 1/4-20 GH7 tap (supplied in the stud kit) to prevent aluminum material generated during tapping from entering the engine. Run the 1/4-20 GH7 tap into and then out of each .250" stud hole location (except the idler gear pin stud holes) indicated in Figure 1. Thoroughly clean grease and debris from the stud holes by saturating a clean cloth with Loctite Primer "N" and cleaning each hole until threads are clean. Final cleaning and preparation of the threads is accomplished by spraying a light film of Loctite Primer "N" into the stud holes.

Figure 3. Use a .250"-28 stud driver and install the appropriate length studs in their proper locations, to the recorded extension heights. Allow at least 30 minutes for the Loctite to cure prior to component installation. Stamp the letters "OS" on each side of the crankcase split line using a 1/8" metal stamp. See Figure 1 for approximate location.

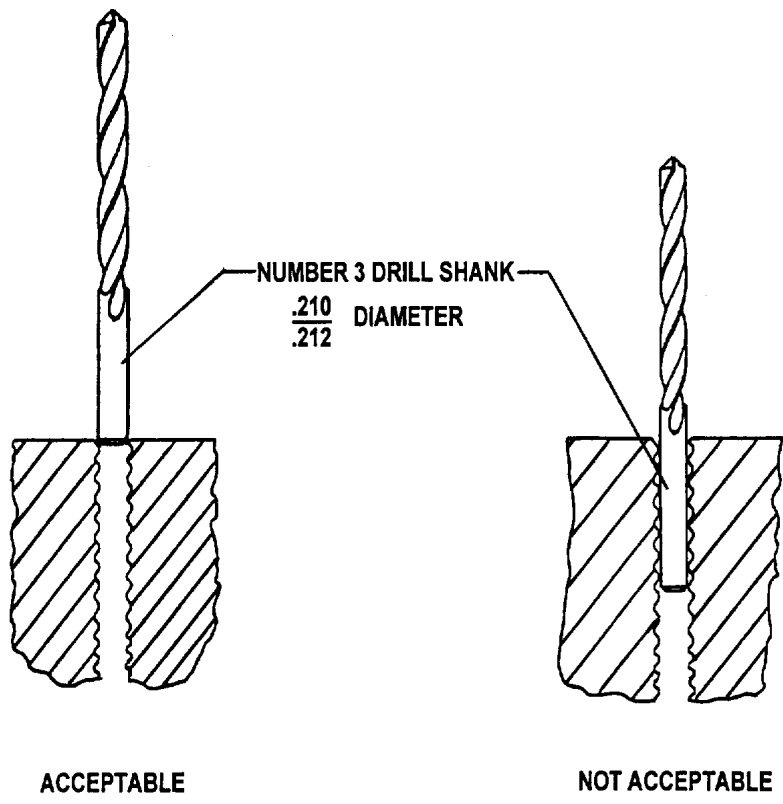
FIGURE 2 INSPECTING .250 - 20 TAPPED HOLES

3. Measure the stud height extending out of the crankcase and record. Using a suitable stud remover or double nuts, remove the two .250" studs.
4. Check these tapped holes in the crankcase to determine if they are oversize by using a #3 (.2130) drill bit. See Figure 2. This will be accomplished by first measuring the shank of the drill bit with a calibrated micrometer. The diameter of the shank must measure .210" - .212". Insert the shank end of the drill bit into the tapped .250"-20 hole. The shank should not extend into the tapped portion of the hole. If it does not, reinstall the two studs to the recorded height using Loctite Primer "N" and 271 Stud Lock. Allow at least 30 minutes for the Loctite to cure prior to the installation of the idler gear pin attaching hardware. Torque nuts to 90 - 110 inch pounds. Make a log book entry as to compliance with this service bulletin as no further action is required. If the shank of the drill bit extends into the tapped portion of the hole, proceed as follows.
