# Walker Property Evaluation Services

## INSPECTION OVERVIEW

**Client:** Tav Rotondale  
**Inspection Address:** 2318 Buena Vista Avenue, Belmont, CA 94002  
**Inspection Date:** 11/25/2008 Start: 9:00 am End: 12:30 pm  
**Inspected by:** Skip Walker

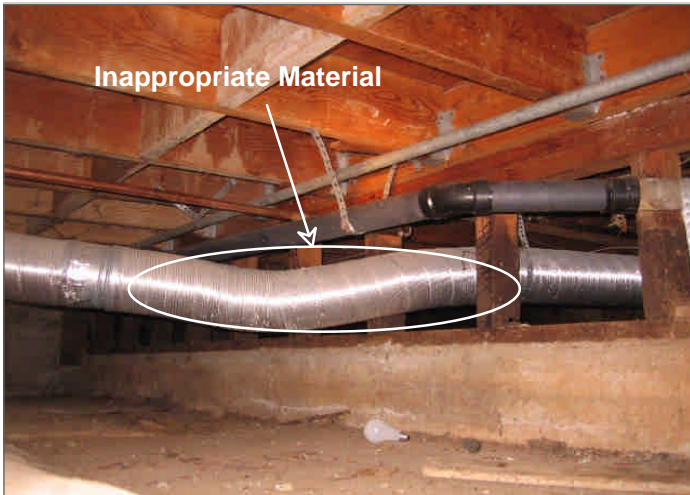
- q The kitchen exhaust fan vent has been improperly installed using a flexible/non-rated material. Current standards require the use of smooth wall, non-combustible materials to minimize the accumulation of grease and risk of fire. We recommend that a qualified HVAC contractor evaluate and service the installation as necessary for safety reasons.

The kitchen exhaust fan vent has been improperly installed using a flexible and or non-rated material - *Continued*

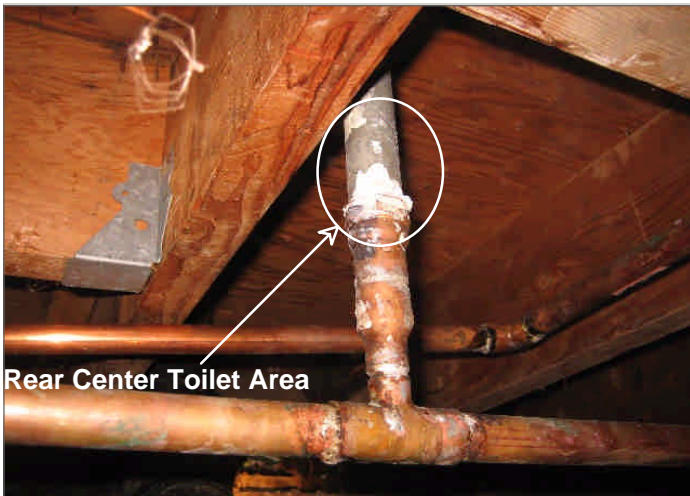
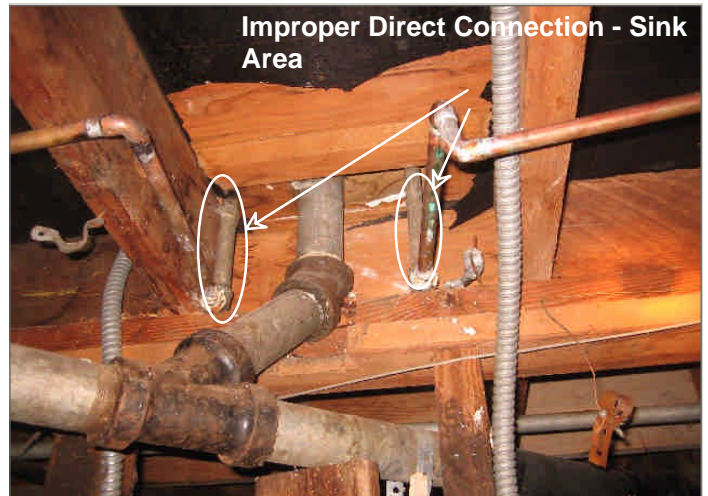
- q Copper and galvanized water supply pipes within the crawlspace appear to have been directly and or improperly connected at several areas. The direct connection of dissimilar metals creates an electrolytic condition that will result in accelerated corrosion on the galvanized pipe material. This will eventually result in deterioration and or leaks at the galvanized piping. We recommend further evaluation and service as necessary by a qualified plumbing contractor.

Copper and galvanized water pipes appear to have been directly and or improperly connected at several areas - *Continued*

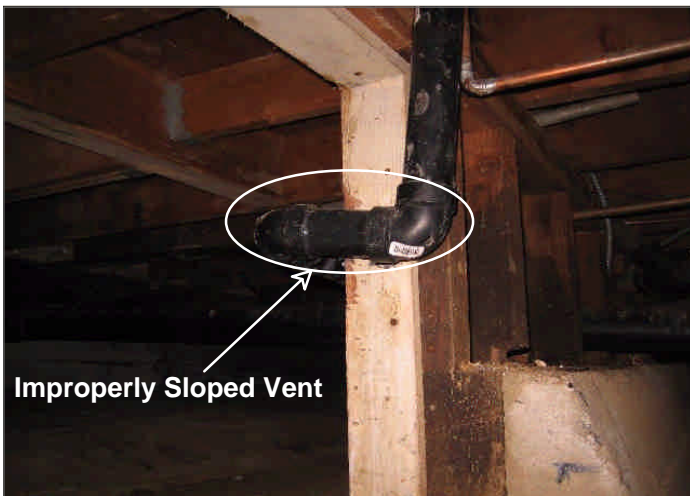
- We noted an apparent "flat" and or improperly sloped vent installation at the Jack & Jill bathroom drain area. Generally speaking, current standards require plumbing drain system vents to be installed with a minimum 45 degree slope from horizontal until the vent is above the floor level/flood rim of the highest fixture served. This is to insure that if a blockage occurs in the drain line, that any effluent will drain properly back into the sanitary sewer system. We recommend that a qualified plumbing contractor evaluate and service as needed.

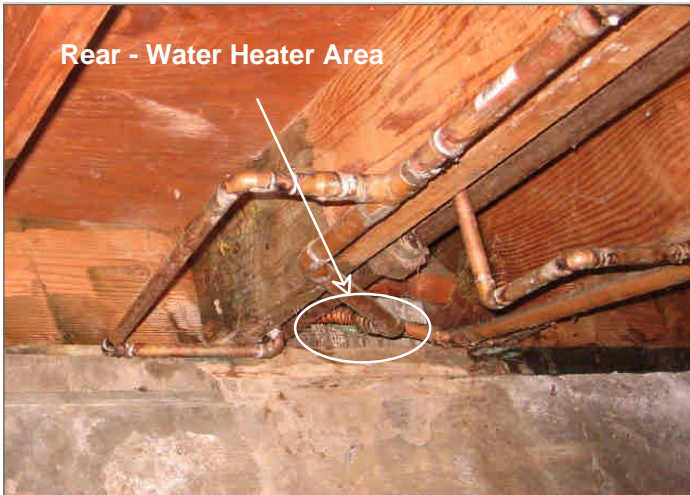
Flex Copper in Supply Piping - *Continued*

- Portions of the supply piping have been improperly installed using a flexible/non-rated material. Generally accepted construction practices require that all potable water piping be installed using materials listed/approved for that purpose. Flexible copper material such as this is designed for connecting water heaters, storage tanks, etc to the potable water system. They are not listed for general piping applications. Interested parties should consult with a qualified plumbing contractor for further information and or service.

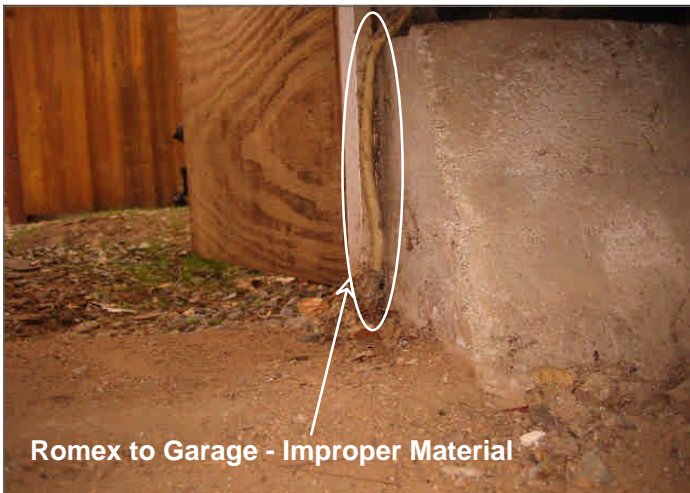
- Portions of the electrical wiring within the crawlspace appear run underground. The visible portions of the material used do not appear to be a type rated for underground/ground contact use. The use of non-rated materials for this application may result in degradation of the insulation and could pose a potential safety risk should the insulation fail. Any underground wiring should be rated for this application. We recommend that a qualified electrician evaluate and service as necessary.

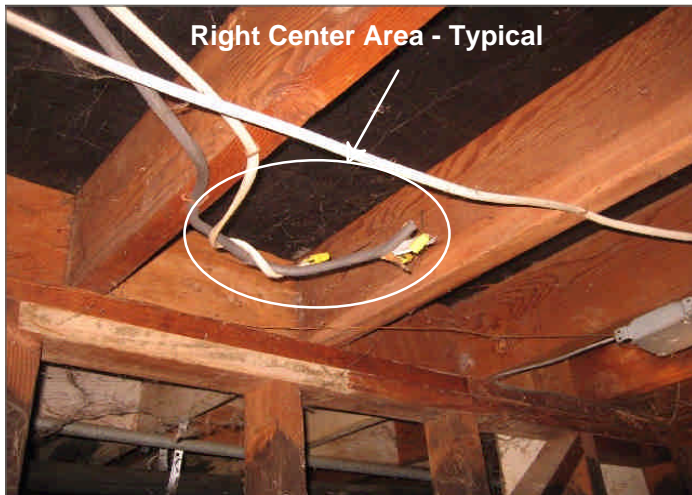
- o There several improperly terminated electrical wires within the crawlspace. We could not determine if these were live connections. Unless both ends of an electrical wire are visible, it is assumed that any such wires could become energized and pose a shock hazard. For safety reasons, we recommend that a qualified electrical contractor properly terminate any such wiring within a junction box to minimize any potential

electric shock hazard.

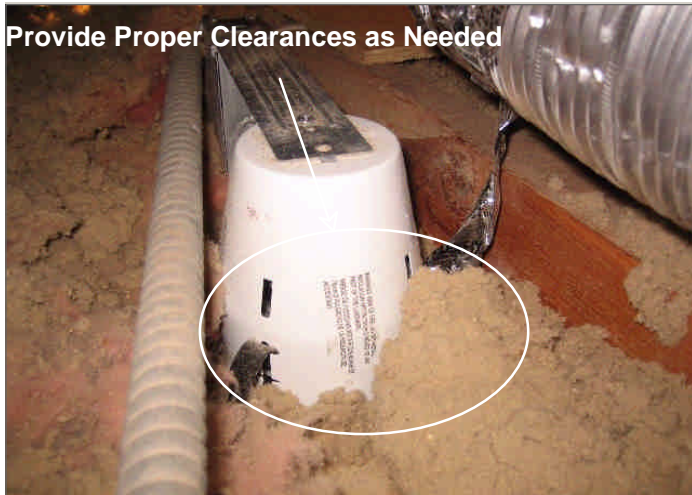
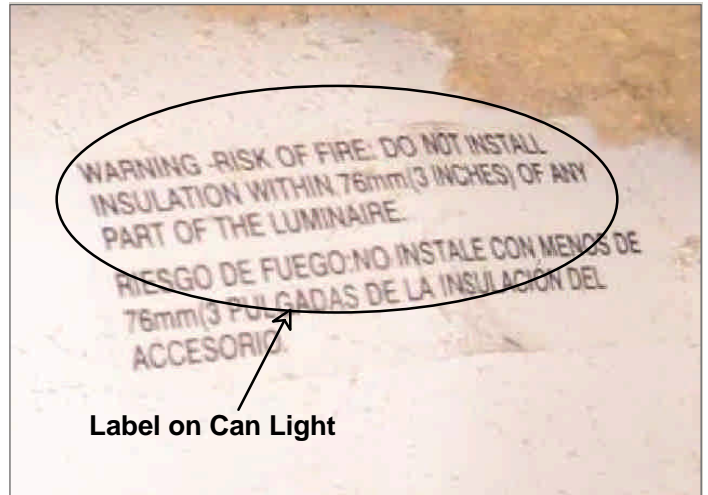
- q We noted attic insulation in contact with several recessed lighting fixtures. Some types of recessed lights are rated for insulation contact, while other recessed lights are designed to cool by convection and may pose a significant fire safety hazard if air-flow is restricted by insulation, etc. The manufacturers listing label on the light will typically recommend specific clearances where the units are not rated for insulation contact. This is for fire-safety reasons. It is beyond the scope of a general property inspection to verify the manufacturers listing requirements for any such devices. We recommend verifying the fixture ratings for all installed lighting and modifying the installations as needed to provide the necessary clearances.

We noted attic insulation in contact with several recessed lighting fixtures - *Continued*

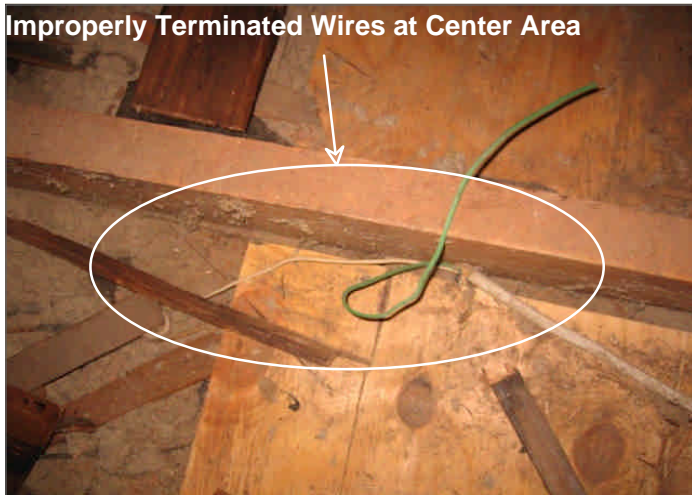
- q We noted one or more improperly terminated electrical cables and or wires in the attic. We could not determine if these were live connections. Unless both ends of an electrical wire are visible, it is assumed that any such wires could become energized and pose a shock hazard. For safety reasons, we recommend that a qualified electrical contractor properly terminate any such wiring within a junction box to minimize any potential electric shock hazard.

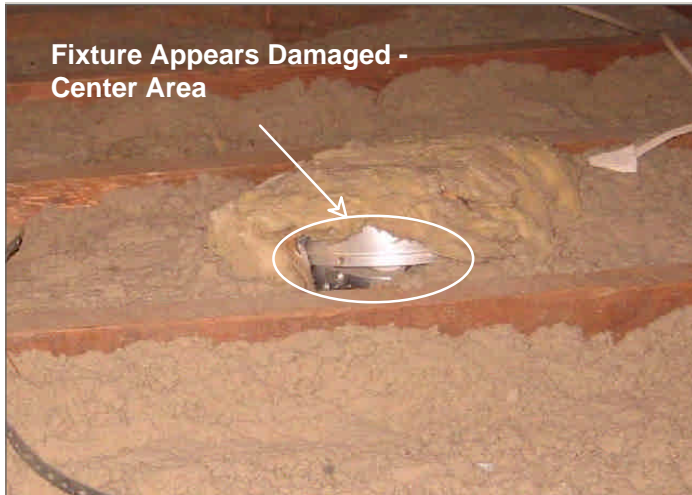
- There are several open electrical junction boxes, which should be sealed for safety reasons. We suggest that a qualified electrician evaluate and service as necessary.
- We noted one or more apparently damaged light fixtures within the attic. We recommend that the fixtures be fully evaluated and serviced as necessary by a qualified electrical contractor.

We noted one or more apparently damaged light fixtures within the attic that should be serviced - *Continued*

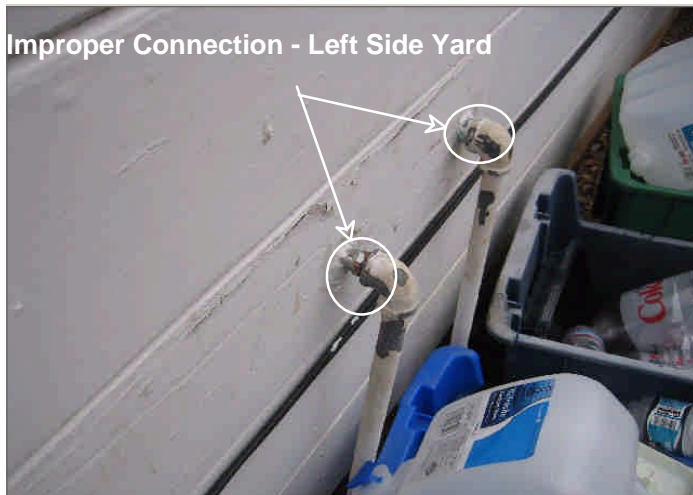
- q Galvanized and copper pipes have been directly and improperly connected that the left exterior. The direct connection of dissimilar metals creates an electrolytic condition that will result in accelerated corrosion on the galvanized pipe material. This will eventually result in deterioration and or leaks at the galvanized piping. We recommend further evaluation and service as necessary by a qualified plumbing contractor.

Galvanized and copper pipes have been directly and improperly connected that the left exterior - *Continued*

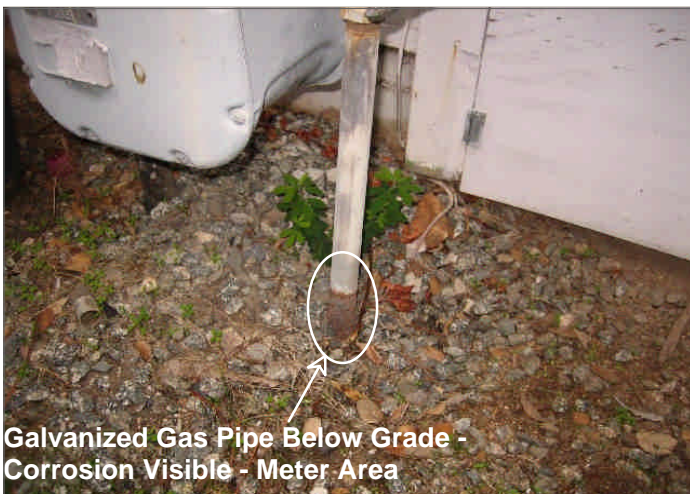
q A portion of the gas supply pipe at the left side area appears improperly installed below grade. Current standards require that any galvanized gas pipe be factory wrapped if it is closer than six inches to or below grade due to the possibility of corrosion. We recommend that the pipe be evaluated and serviced as necessary by a qualified plumbing contractor.

Galvanized Gas Pipe Below Grade - Corrosion Visible - Meter Area

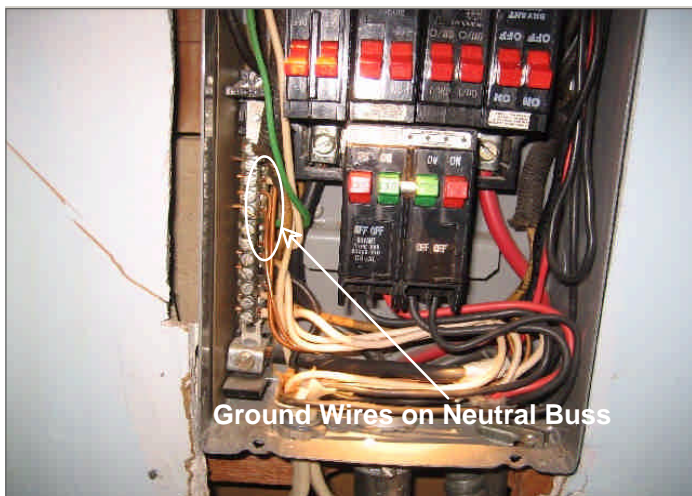
- Several circuit ground wires have been improperly terminated on the neutral bus bar. The neutral bus bar in the sub-panel is required to "float" or be independent of the ground system at a sub panel. Under normal operating conditions, the neutral wires carry any system load electrical current imbalance or random currents back to the power pole. By attaching ground wires to the neutral, a condition is created where it is possible for connected devices "downstream" of the panel to become energized through the ground system, which creates a potential safety hazard. We recommend that a qualified electrician evaluate and repair the installation as necessary.

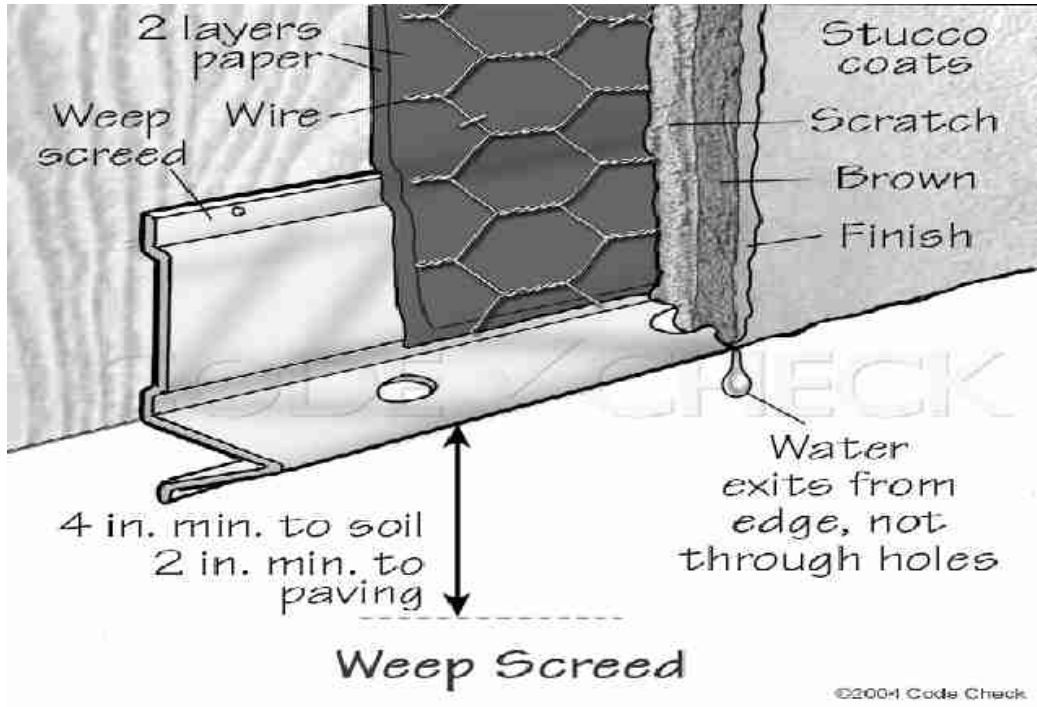
Illustration - 3 Portions - Stucco No Weep-Screed

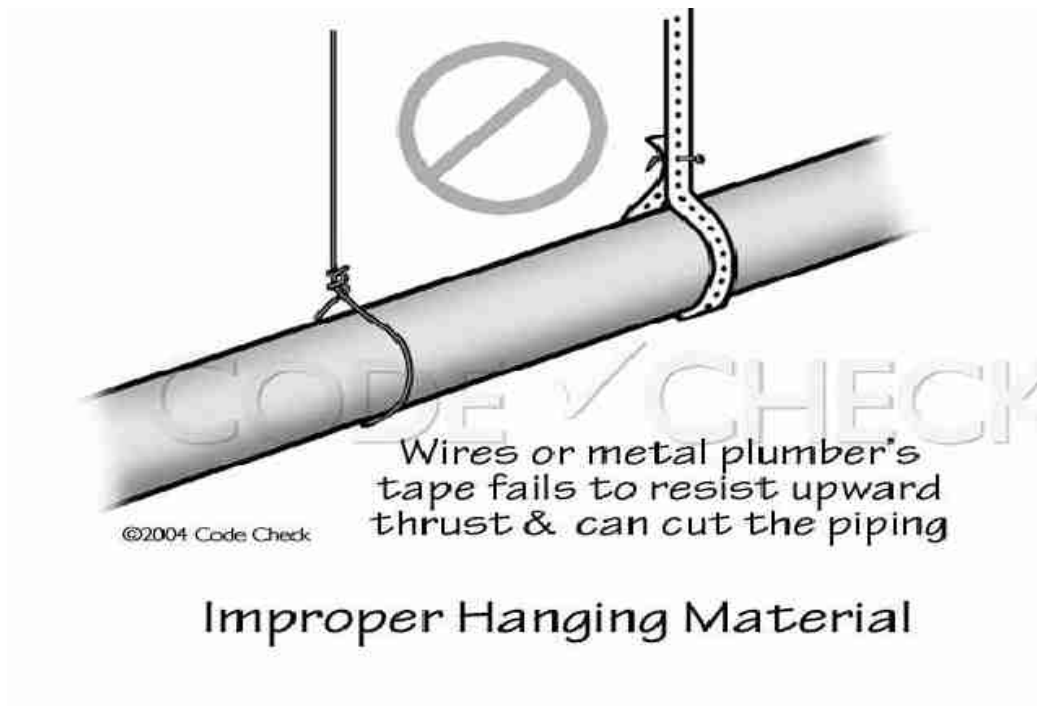
Illustration - 4 ABS - Crawlspace Improper Hanger Materials

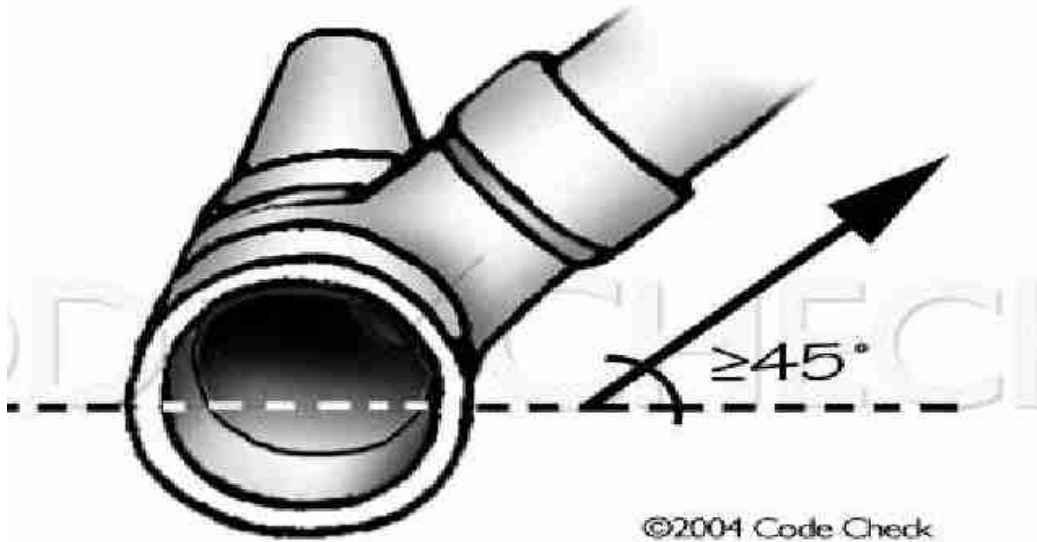
Illustration - 5 Flat Venting - Crawl

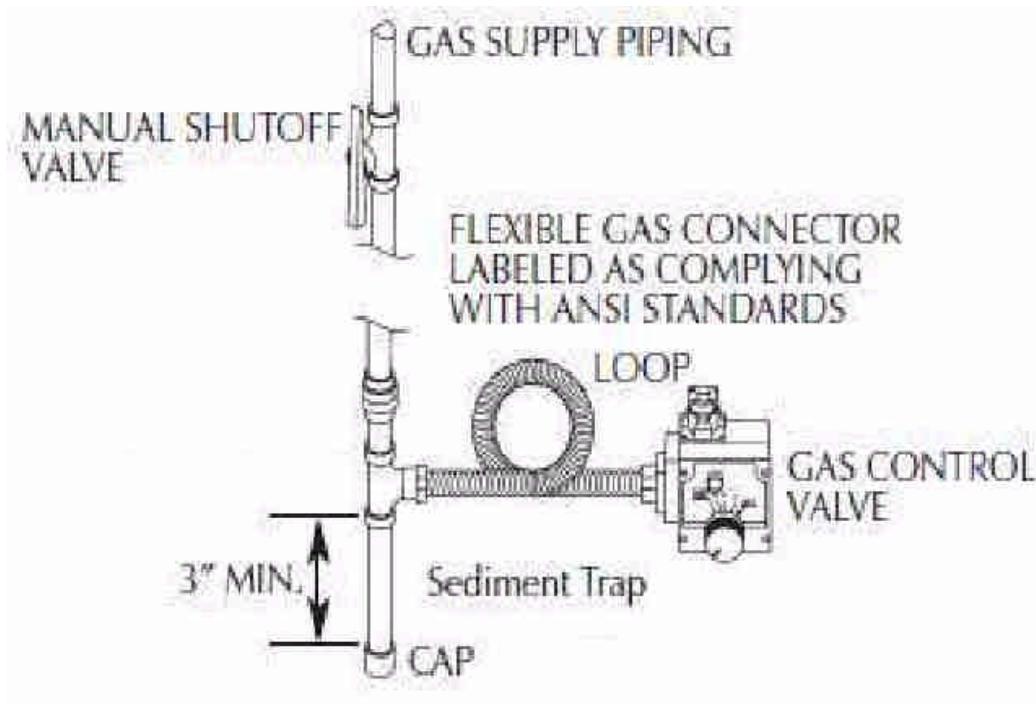
Illustration - 8 No Sediment Traps Installed

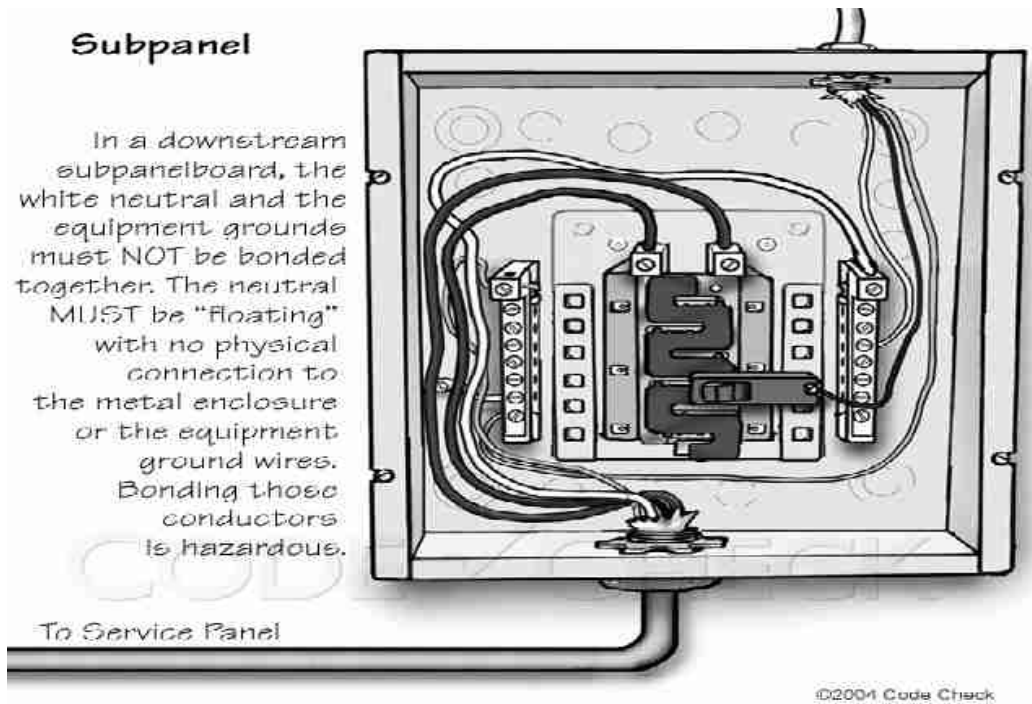
Illustration - 9 The panel grounding appears improper for the standards in effect at the time of apparent installation

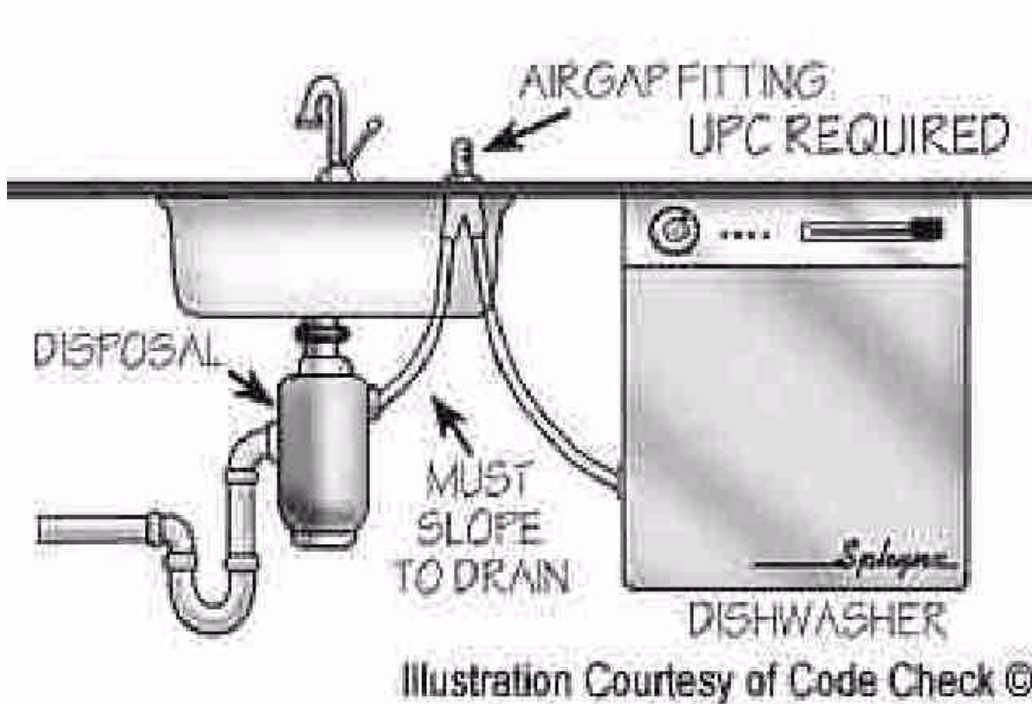
Illustration - 10 The dishwasher does not appear equipped with the required countertop air-gap assembly
