BULLETIN NO: M_04_017

TITLE/ PRODUCT NAME: Aristo MA6 – Persistent 19/0 Error Code

Aristo MMC T4, T6, MA4, MA6, & U6

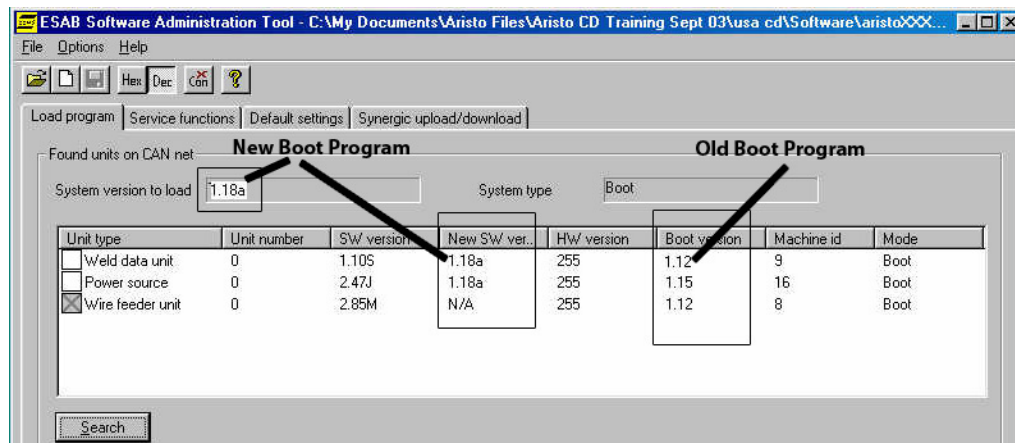
Connect ESAT software and enter the boot mode by powering up the welding system then clicking the “Search” button within 5 seconds. Check the version number of the MMC boot program.
