Information on Software Update
BERNINA 8 Series, V29.39.00

BERNINA 830 / 820

The Release Note V29.39.00 is in addition to the Release Note V29.21.40 (6/2009).

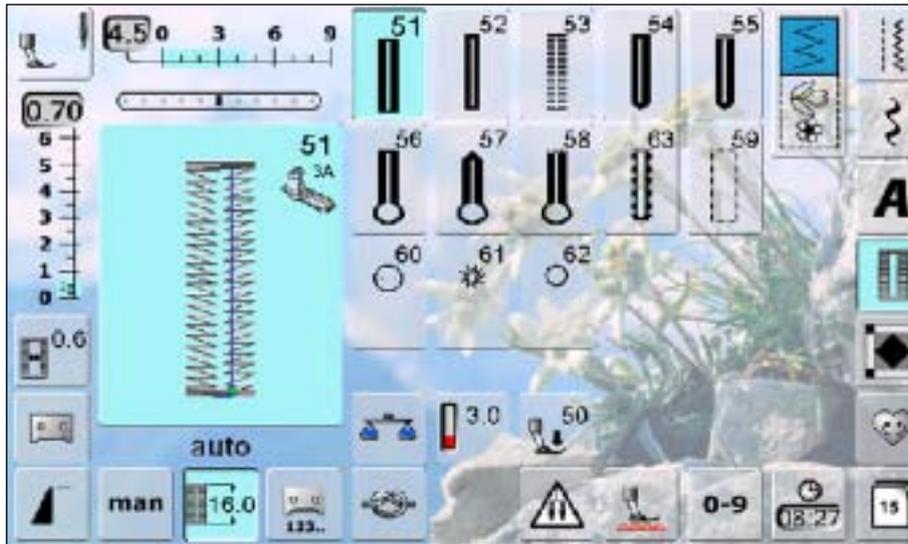
2.1 Thread tension for the underlay segments (buttonholes)

To eliminate possible thread loops, the thread tension for segments with short step stitches is increased from 2.0 to 3.0.

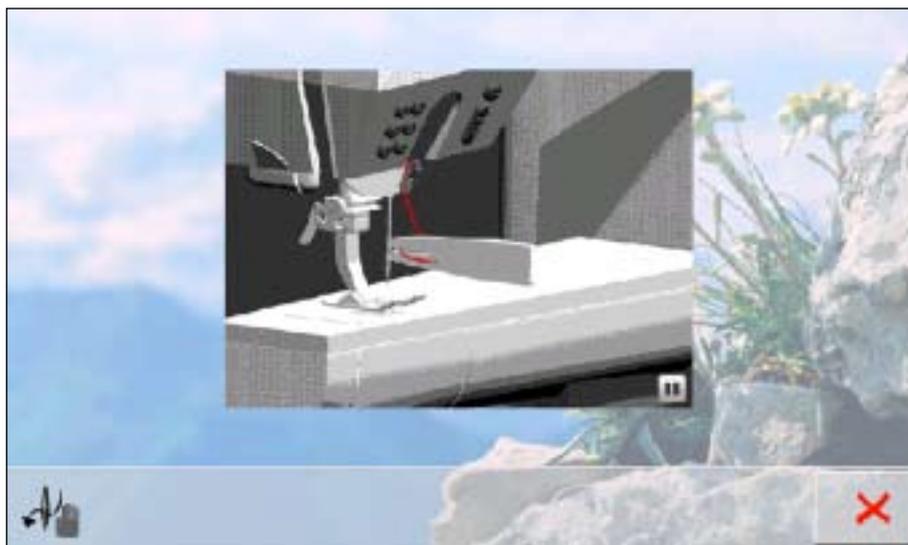
2.2 Manual threading

In some cases during manual threading, the thread swing support mechanism can be blocked. This update avoids this issue without performing any mechanical readjustments.

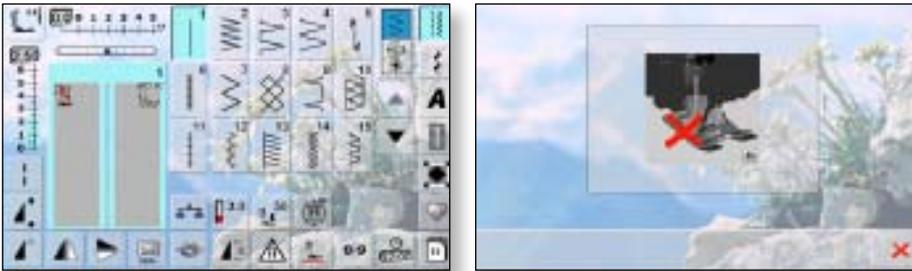
2.3 The use of straight stitch feet with thread cutting

The opening of the straight stitch foot is 0.4mm on both sides. The “tie on” stitch after cutting is 0.4mm to the left side. After thread cutting, the first stitch failed resulting in the animation “needle will penetrate presser foot” due to the narrow tolerance in the foot opening. This has been resolved.

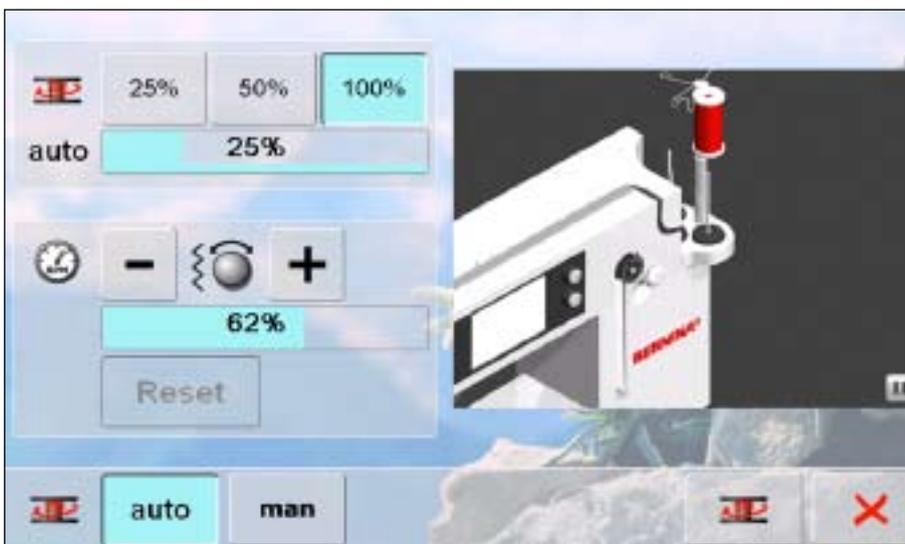
2.6 “Manual” winding of the lower bobbin thread

The filling process stops at a detection of 100% fill level. As a result of mechanical tolerances, it is possible that the bobbin does not fill to the maximum capacity.

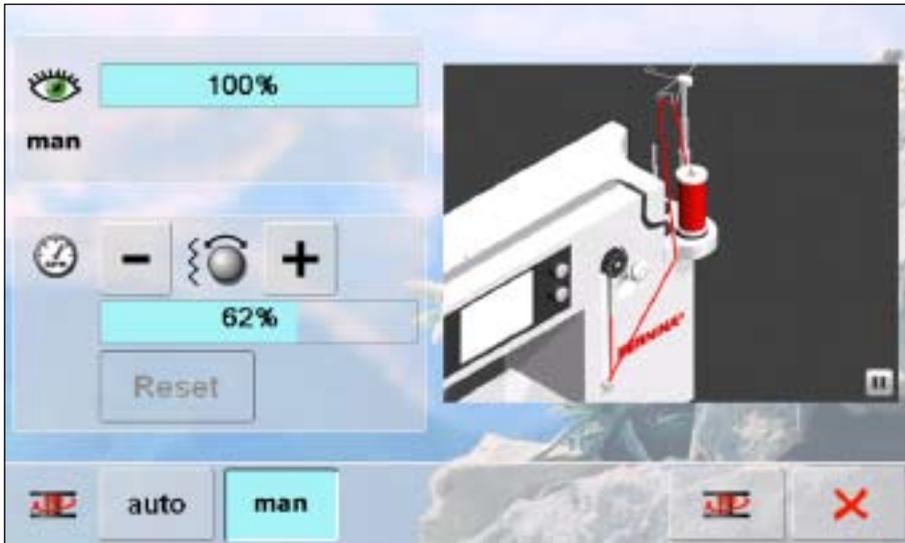
In addition to the "automatic" mode, an extended manual mode is implemented.

This mode gives the user the opportunity to start and stop the winding process by holding and releasing the winding button.

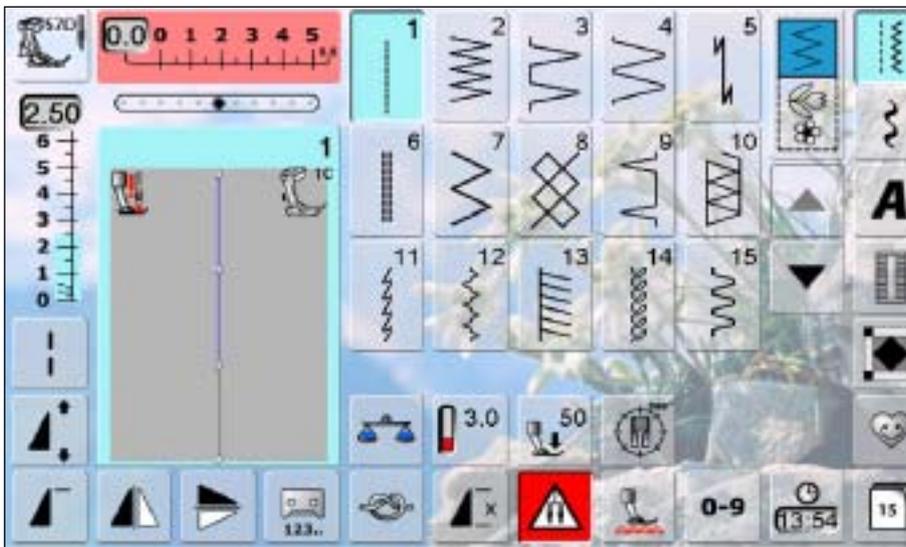
2.10 Problem with Foot #57D and straight stitch compatibility

Select stitch #1, attach and select the foot #57D (Patchworkfoot with guide). Open the securing function and select the straight stitch plate.

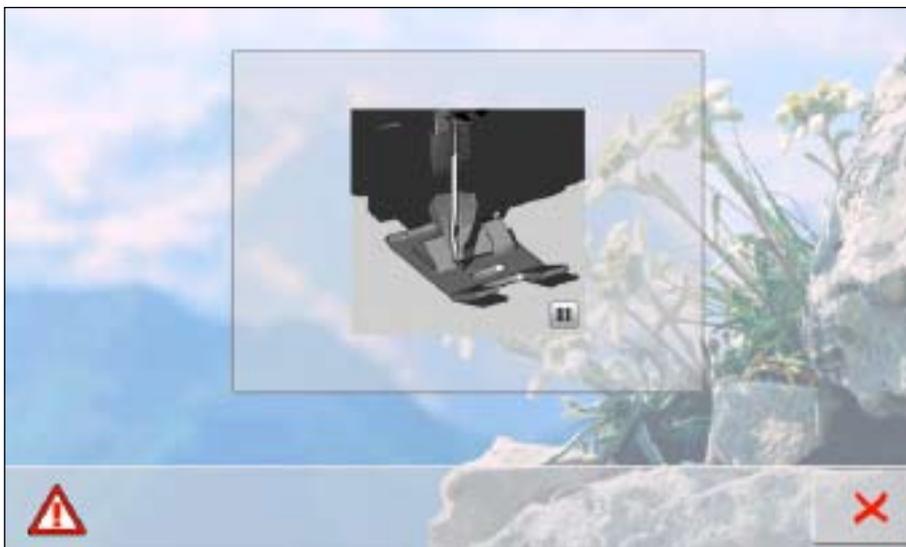
Now, it is possible to start the sewing process, without the warning message appearing:

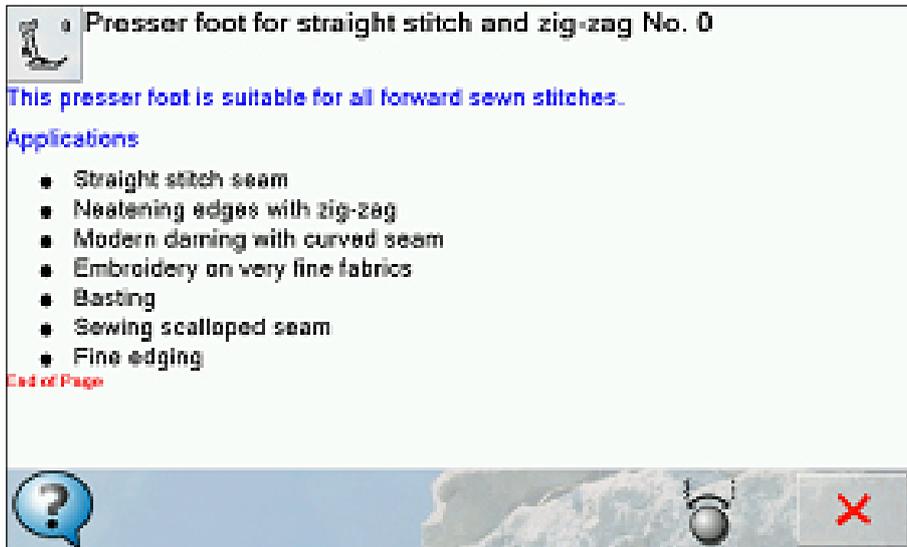
2.11 Presser Foot #0 can be used for automatic threading. With the “Walking foot” automatic threading is not possible

The original help text mentioned that the machine cannot be threaded automatically with foot attached. New help text implemented:

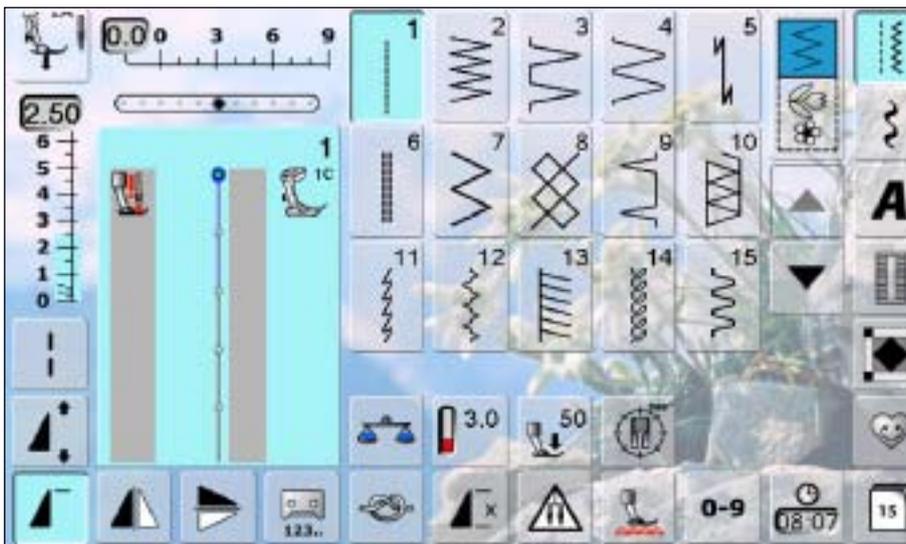
2.12 Information Foot #2a corrected

Data correction of the dimensions of the presser foot sole.

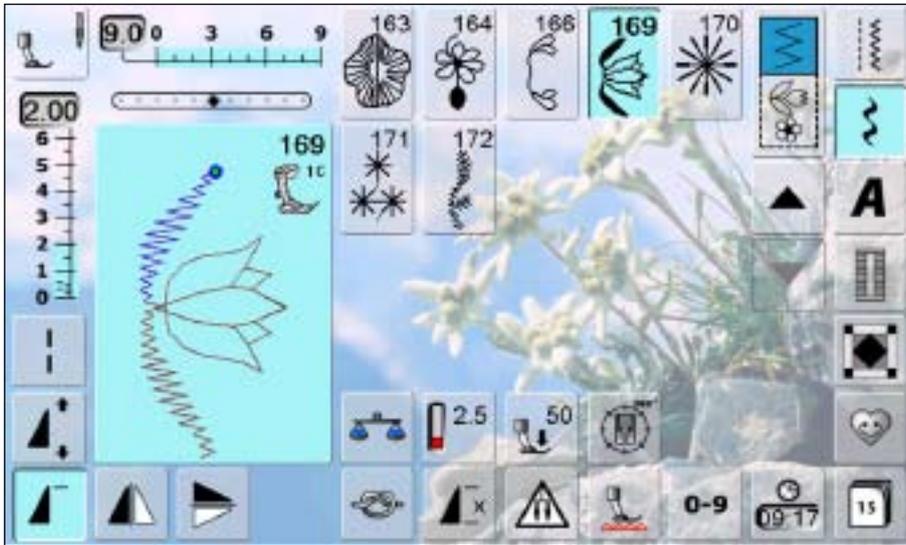
2.13 Pattern #169 improved

Elongation limited to a maximum value of two for optimal results.
