Troubleshooting: C130, 140, 150 or 160 Error for e-STUDIO205L/255/305/355/455 Series

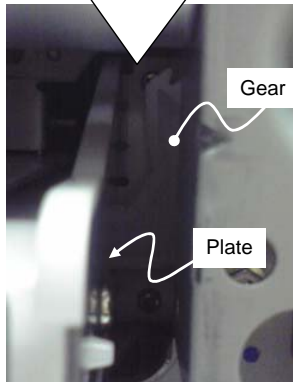
Picture 1

If there is a clearance (A) between the gear and the plate as shown in Fig. 2, the gear condition is normal.

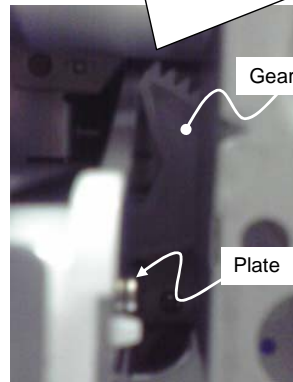
Picture 2

If the gear and the plate contact as shown below, the error may occur again and the gear may be damaged.

If "Yes", replace the gear with the new one.
Moreover, since the gear in the drive unit of the drawer tray-up may be damaged, refer to "8.6.25 Upper tray-up motor (M11)" in the Service Manual (page 8-27 and 28) and check whether the gear tooth flank is damaged.

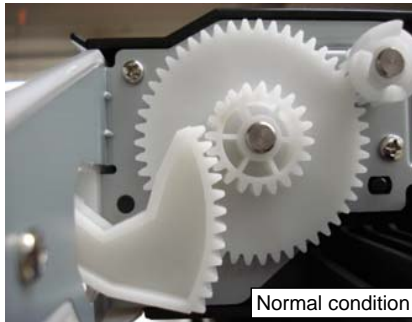
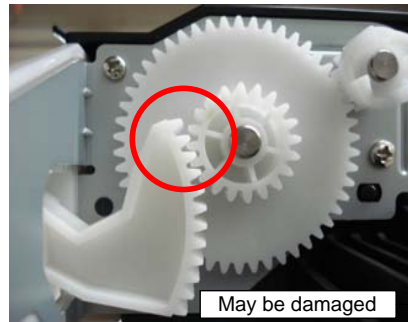
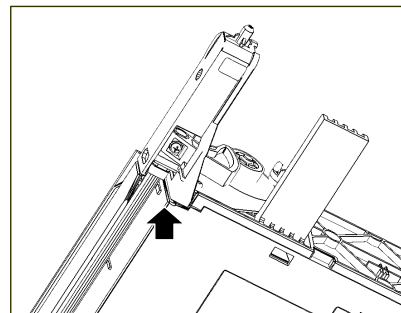
Fig. 3

- 1) Check the drawer
 - 1)-a Check the condition of the fan-shaped gear.
Check it while the tray in the drawer is at the lowest position.

If "Yes", the fan-shaped gear in the drawer may be damaged.

Check whether the gear fixing screw is loose or not.
If the screw is loose, tighten it firmly.

Check whether the gear is damaged or not by referring to [1]-1.-4).

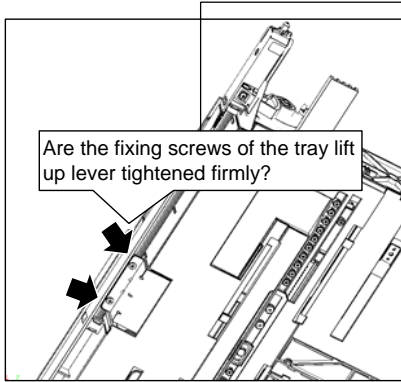
If the tray lift up lever does not contact thoroughly on the bottom of the drawer, the screws in Fig. 4 may become loose or the lever may be deformed. If the lever is not bent at a right angle, replace it with a new one.

If the screws are loose, tighten them firmly.

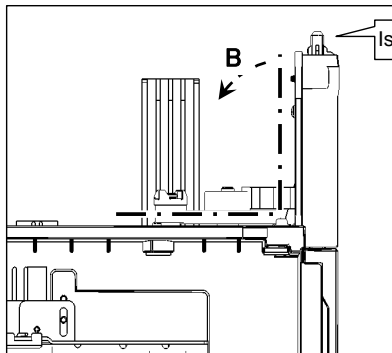
Fig. 6

The bracket at a right angle is good.

If the bracket is slanted in the direction of B, it may contact the fan-shaped gear and become damaged during the lifting of the tray.

To avoid this, replace the bracket with a new one.

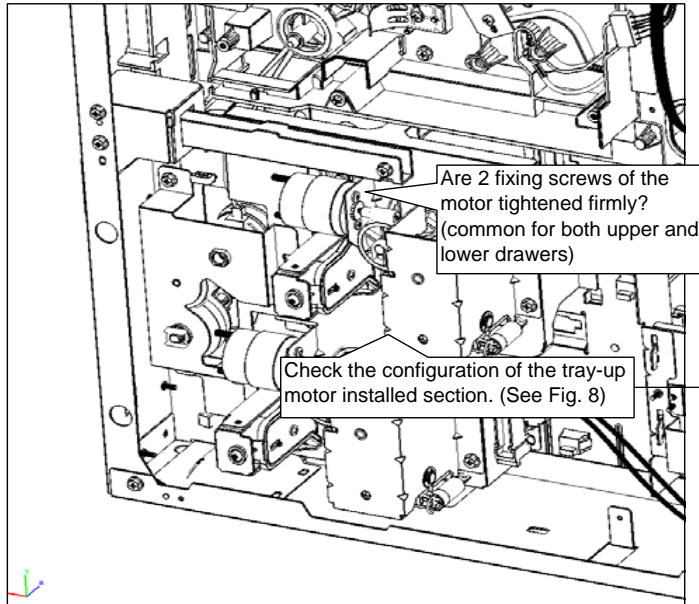
Fig. 7

→ The configuration of the tray-up motor installed section has been changed due to the countermeasure to unmeshing.
 The applicable production lots for each destination are as follows.
 If unmeshing occurs, even if any problem is found after checking [1] and [2], replace the drive unit of the drawer tray-up with a new one.
 (Refer to BSI No. G09H114 for details)

→ If the screws are loose, tighten them firmly.

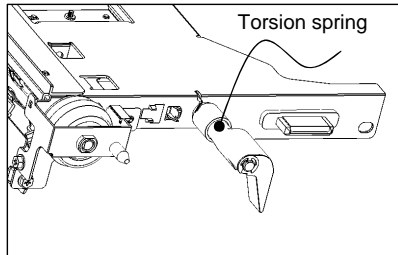
Fig. 9

3)-d Is the torsion spring in the rear side of the unit installed correctly? (Fig. 9)

Install the torsion spring correctly.
