**No.: 09 TS-10**  
April 4, 2009

SUBJECT: **EPA07 MBE 900 Smart Remote Actuator Fault Codes:**  
**SPN 615/FMI 7 - Smart Remote Actuator 2, Failsafe Mode, Motor On**  
**SPN 615/FMI 9 - Smart Remote Actuator 2, Failsafe Mode, Motor Off**  
**SPN 615/FMI 14 - Smart Remote Actuator 2, No Failsafe Mode, Motor Off**

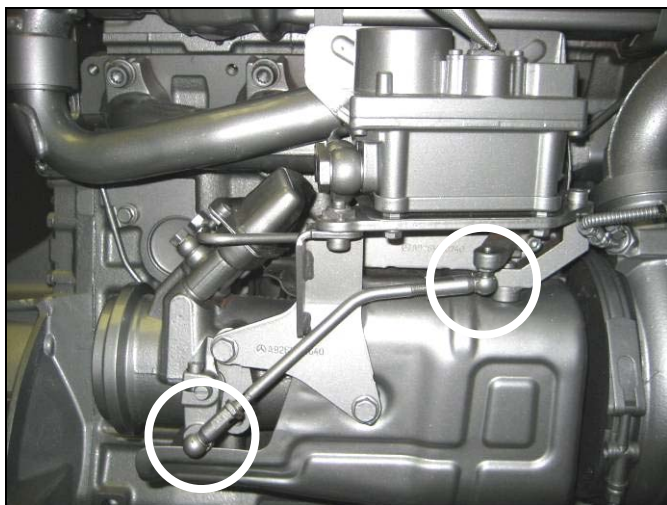
**Figure 1 - Actuator Linkage**

1. Make sure vehicle ignition is OFF. Remove retaining clip and carefully remove the linkage from the exhaust flap lever arm and the SRA. See Figure 1.

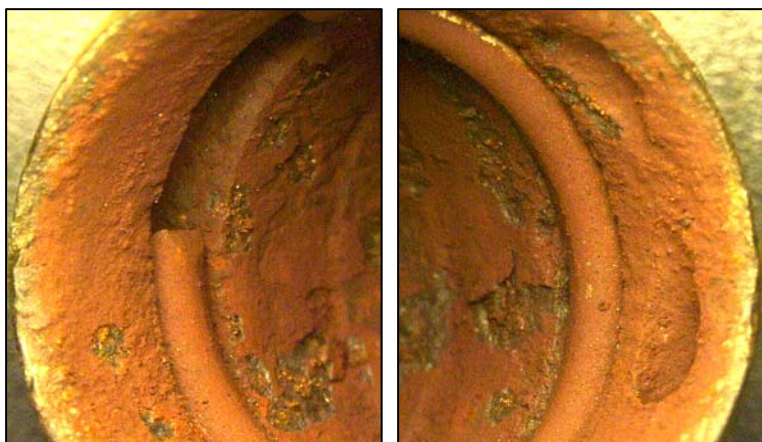
2. **SPN 615/FMI 9 - Smart Remote Actuator 2, Failsafe Mode, Motor Off:**  
This fault code may be caused by a seized exhaust flap actuator rod (linkage). Corrosion builds up inside the ball sockets on both ends of the rod, stopping the assembly movement. Every time the key is turned on, the SRA performs a quick check by commanding the exhaust flap to close and open. If no movement is detected, AWL/CEL and fault code become active.

**Figure 2 – Ball Socket – Corrosion on the Internal Walls**

2. Inspect the area inside of rod ball sockets for corrosion built up. If inside walls of the ball socket had indication of corrosion, replace rod (linkage) using list of materials provided in Table 1.
3. Use Figure 2 as reference for evaluation of the ball socket internal walls:

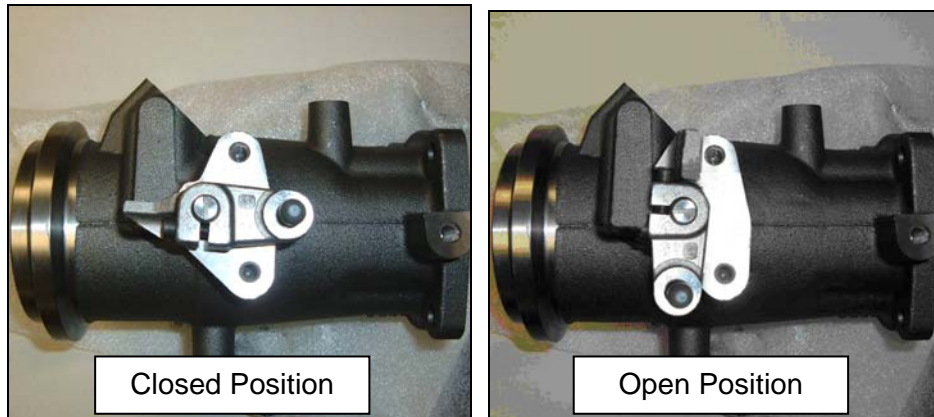
**Figure 3 – Exhaust Flap Lever Positions**

1. With the exhaust flap rod removed, rotate the flap from stop to stop to check for unrestricted movement.

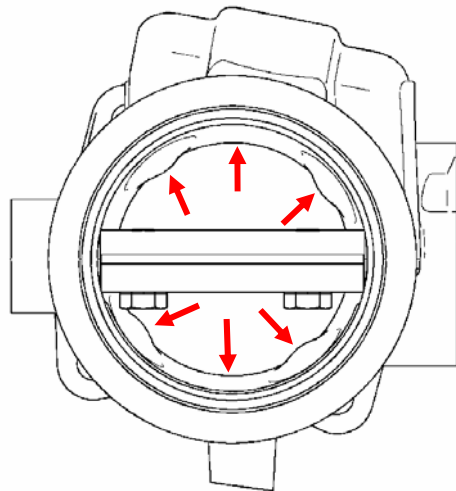
**Figure 4 – Exhaust Flap Housing – Internal Walls Must be Clean of Soot Deposit**

- a. If flap opens and closes smoothly, remove the exhaust pipe attached to the end of the housing and clean any soot build-up from the internal walls and flap. See Figure 4.

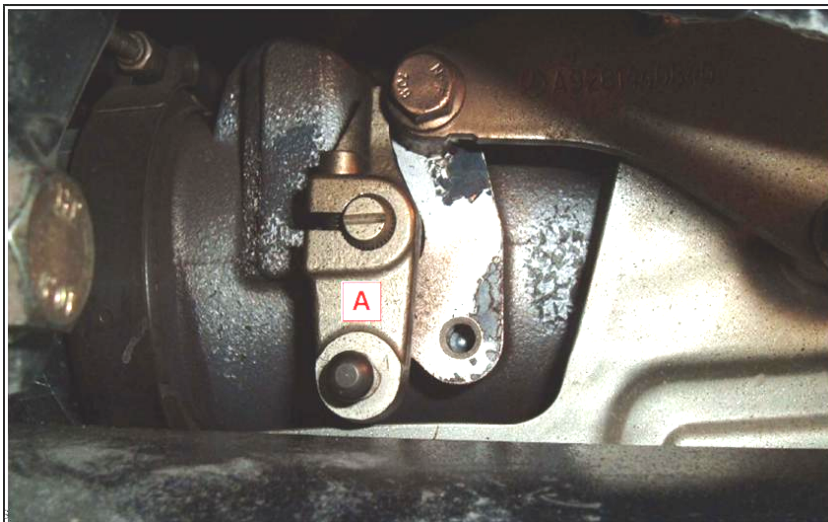
**Figure 6 – Exhaust Flap Lever Adjustment**

2. Using an emery cloth, carefully clean any rust from the ball studs on the exhaust flap lever arm and on the SRA lever.
3. Rotate flap to full open position, the lever "A" should point downward. See Figure 6.

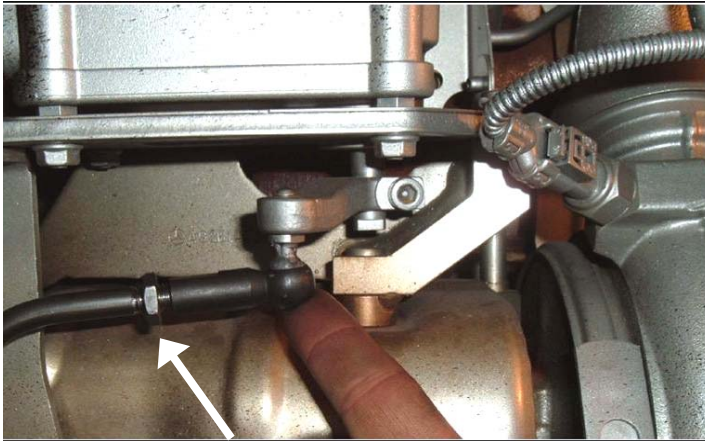
**Figure 7 – Smart Remote Actuator Lever Adjustment**

6. At the SRA, loosen the adjustment nut adjust ball socket to fit on the SRA actuator lever as shown in Figure 7. The SRA lever should be in the full open (neutral) position when this adjustment is performed.

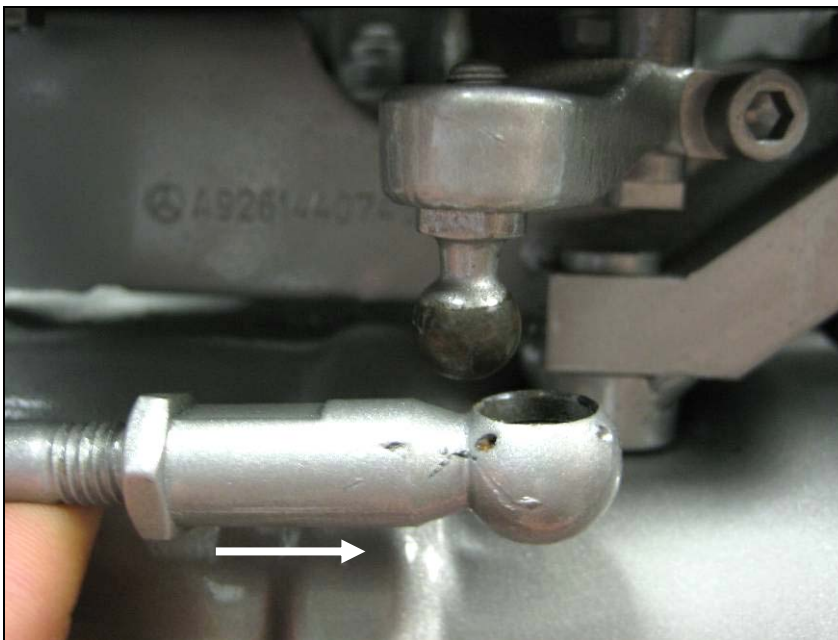
**Figure 8 – Smart Remote Actuator Lever Adjustment**

7. Remove rod from SRA ball joint.
8. Adjust the ball joint socket on the actuator end of the linkage rod by extending it three complete turns as shown in Figure 8.

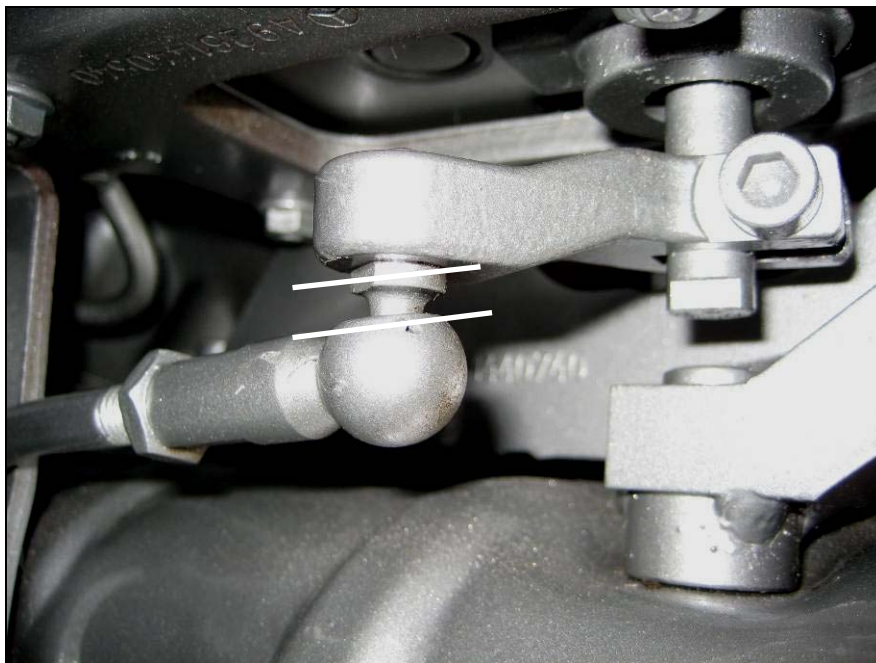
**Figure 9 – Smart Remote Actuator Lever Adjustment**

8. Reinstall the ball joint socket onto the SRA lever and align the flats of the ball joint sockets with the actuator and exhaust flap lever arms. See Figure 9.

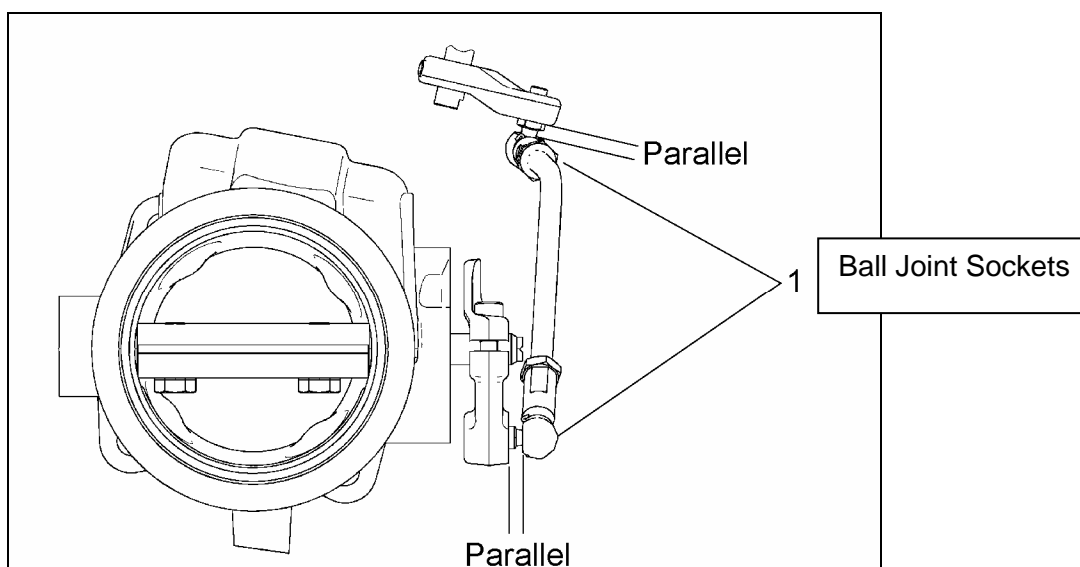
**Figure 10 – Parallel Ball Joint Sockets**

9. Tighten the locknut against the ball joint socket to 12.5 N·m (9 lb·ft), being careful not to damage (bend) the linkage or the SRA lever. See Figure 10.

NOTE: Verify flats on ball joint socket are parallel with the exhaust flap lever.

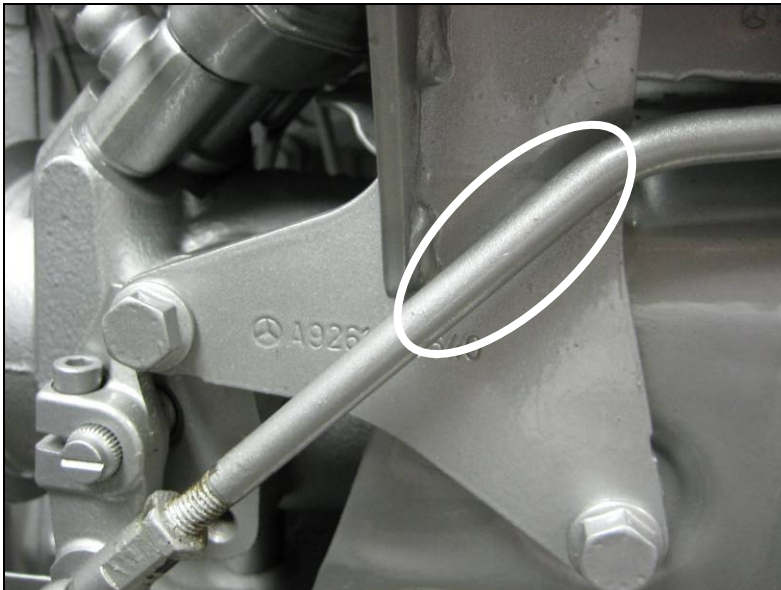
**Figure 11 – Clearance Check between Linkage Rod and Bracket**

10. Check for adequate clearance between the linkage rod and the bracket. See Figure 11.
