Walker Property Evaluation Services

INSPECTION OVERVIEW

Client: Ken & Barbie Doll
Inspection Address: 111 Doll House Lane, Malibu, CA 94066
Inspection Date: 12/3/2012 Start: 9:00 am End: 2:30 pm
Inspected by: Skip Walker

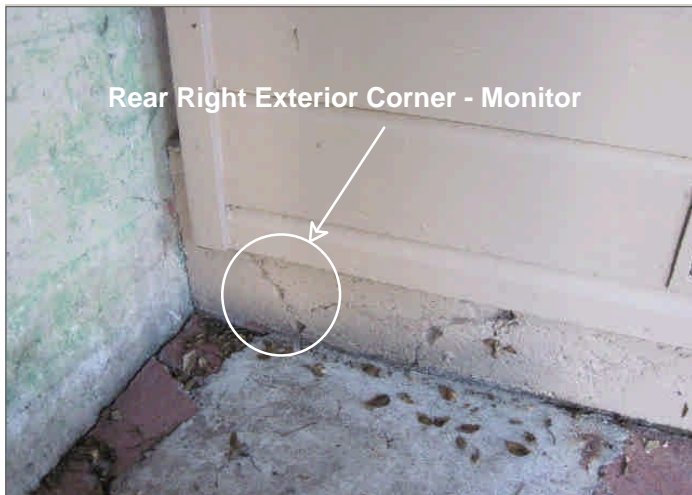
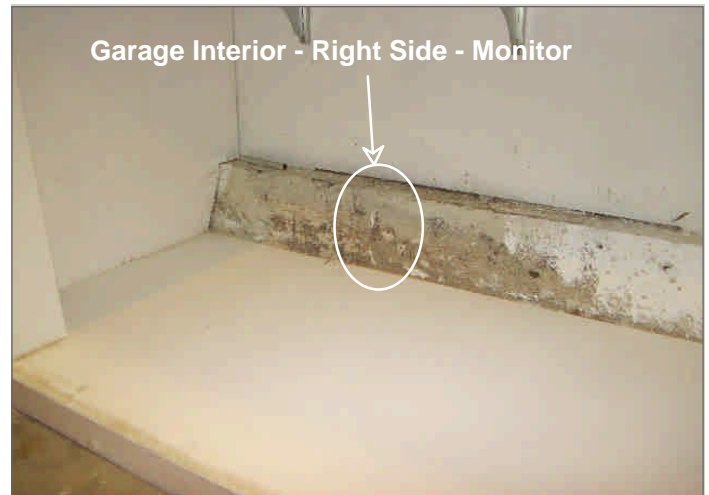
Stem - Cracks Monitor - *Continued*

- PERIODIC INSPECTION: There are several vertical cracks in the poured concrete walls that appear to be from hairline to less than 1/8". These may be attributable to shrinkage, age related settling, site movement and or other related issues. Generally speaking, cracks that are less than 1/8" and do not exhibit rotation and or other signs of active movement are not generally regarded as being an area of concern. It is recommended that the foundation be inspected periodically for any change in condition - especially any existing cracks - as they may move imperceptibly over time. In our opinion, given the limitations of the inspection, the age and conditions observed - no service to the existing cracks appears required/necessary. I recommend periodically inspecting/monitoring the foundation for change over time. I am a generalists and am not a specialist/registered design professional. Interested parties that are concerned about this issue and or that desire further information should consult with an appropriate registered design professional.

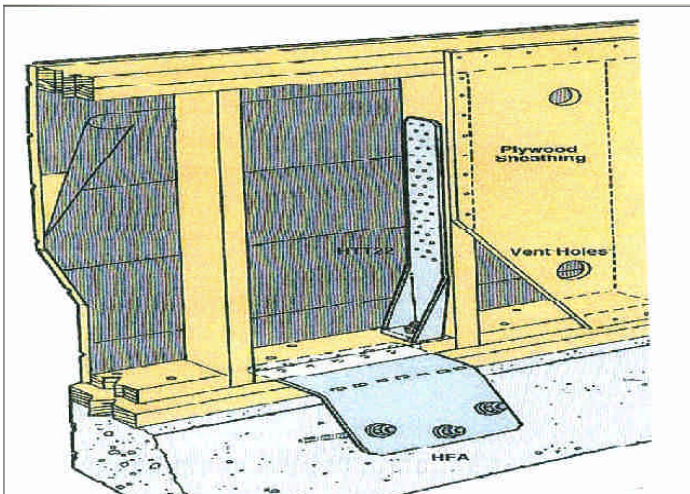
- Portions of the cripple walls appear to have shear-panels/sheathing installed. Cripple walls are the wood framed extension walls that run from the top of the foundation stem walls to the underside of the living area - they may be as little as a few inches to many feet on a steeply sloped site. Shear panels are typically plywood or OSB panels nailed to the inside portions of the cripple walls to provide additional strength and stiffness to the walls. I am not qualified to comment on the structural adequacy of the installation. Interested parties desiring further information should consult with a design professional.

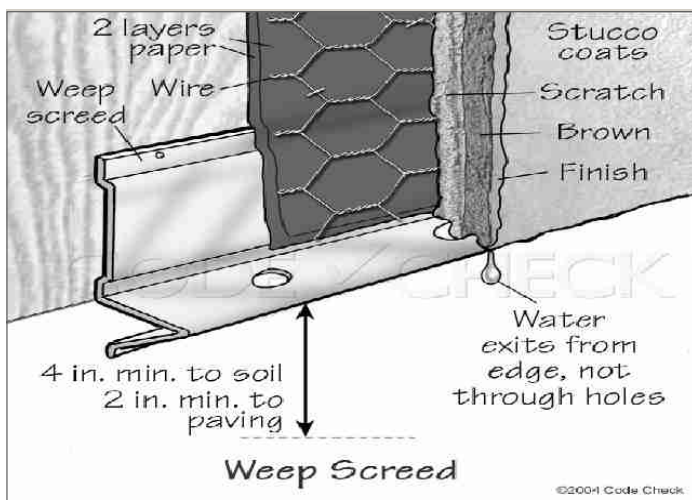
- The stucco extends down to the soil without the benefit of a weep-screed. The weep-screed allows any moisture behind the exterior walls to drain to the exterior. Isolating the stucco from grade also helps to prevent wood destroying organisms from entering the dwelling and isolates the stucco from the soil which inhibits the wicking effect of moisture being drawn up into the stucco. This also allows the stucco to move independently of the foundation, and helps to minimize plate-line cracks that are often seen near the base of many stuccoed walls. While common in older installations, current standards require the installation of a weep screed for all stucco installations. This condition may be noted in the WDO report. I recommend that the installation be upgraded as repairs and or renovations are undertaken. Interested parties desiring further information should consult with a qualified general contractor.

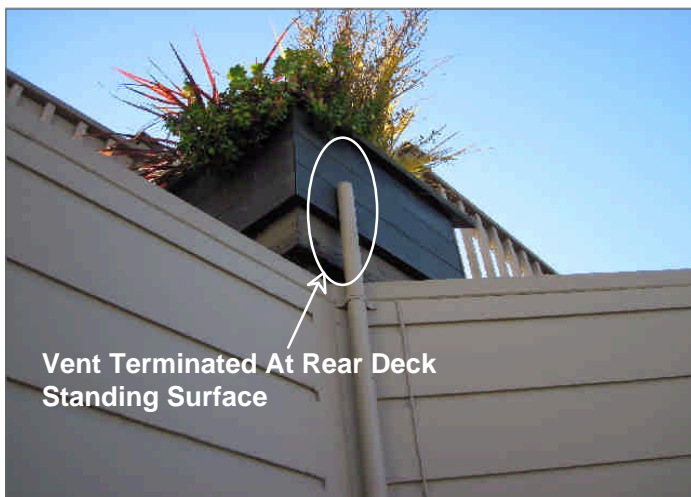
- There is an plumbing vent riser at rear area that terminates too close to the standing surface. Generally accepted plumbing standards require plumbing vents to terminate at least seven feet above the adjacent walking surface. I recommend that a qualified plumbing contractor evaluate and service as necessary.

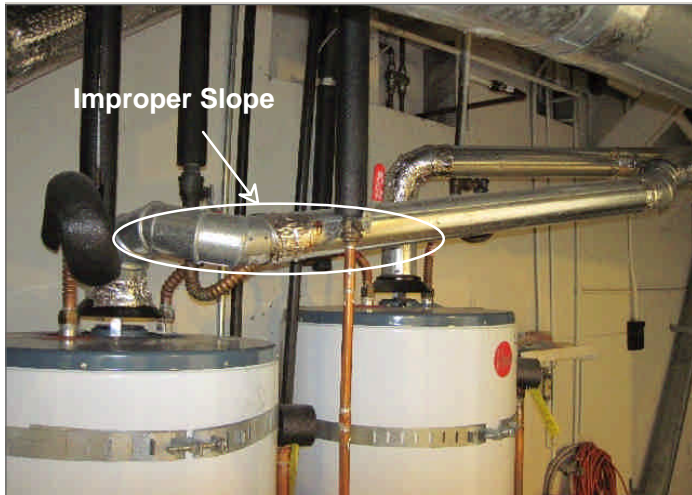
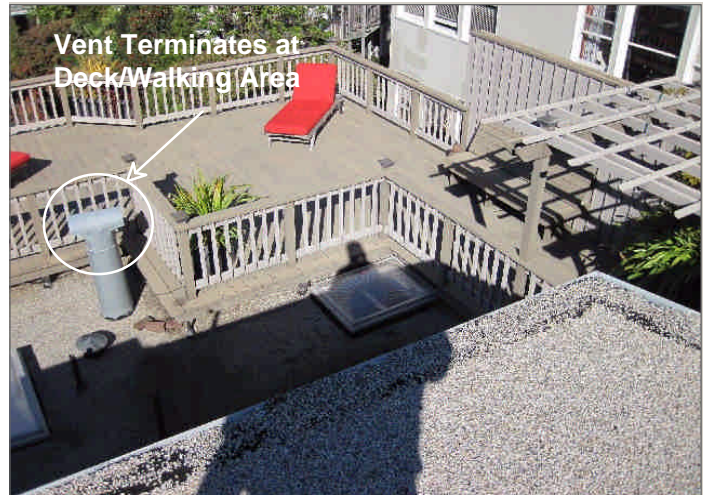
Vent Terminated Less than 7 feet off Walk - FE - Continued

- – The gas appliance vent is terminated less than 7' off the adjacent walking surface - Service Suggested

- Q [SR]: Portions of the gas vent or connector are installed with insufficient slope; i.e. neutral to negative pitch. To ensure a positive draft, generally accepted venting standards require that the vent system should be installed with a minimum of 1/4" rise per foot - a positive slope - to ensure proper drafting.
- [SR]: The gas appliance vent is terminated less than 7' off the adjacent walking surface. This does not appear to conform to current standards. I recommend modifying the installation for safety reasons. Please consult with a qualified plumbing or HVAC contractor for additional information, evaluation and or service.

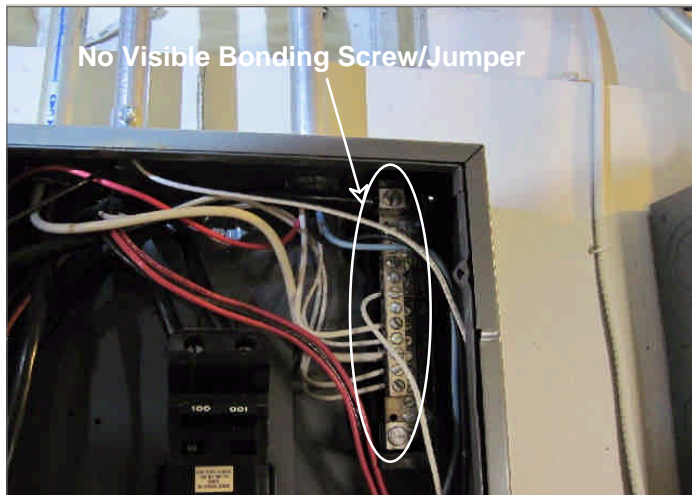
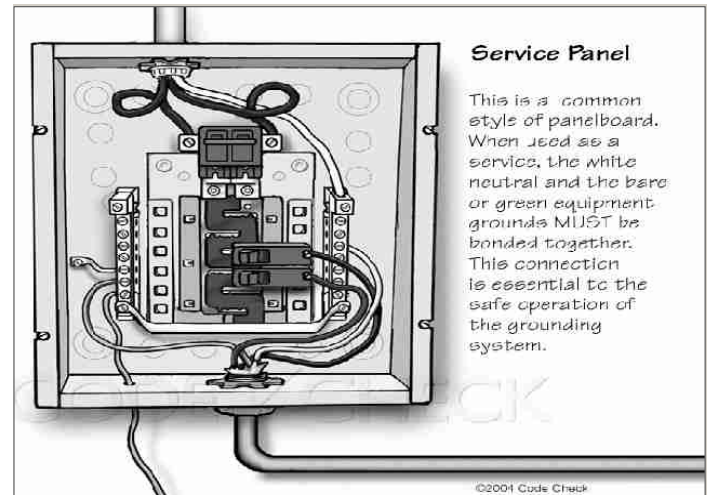
The panel case and neutral buss do not appear to be bonded as required and should be serviced - *Continued*

- q The panel case and neutral buss do not appear to be bonded as required and should be serviced

- q The panel case and neutral buss do not appear to be bonded as required. Generally accepted electrical safety standards require the neutral buss and panel case to be electrically bonded for safety reasons. I recommend that a qualified electrician evaluate and service as necessary.

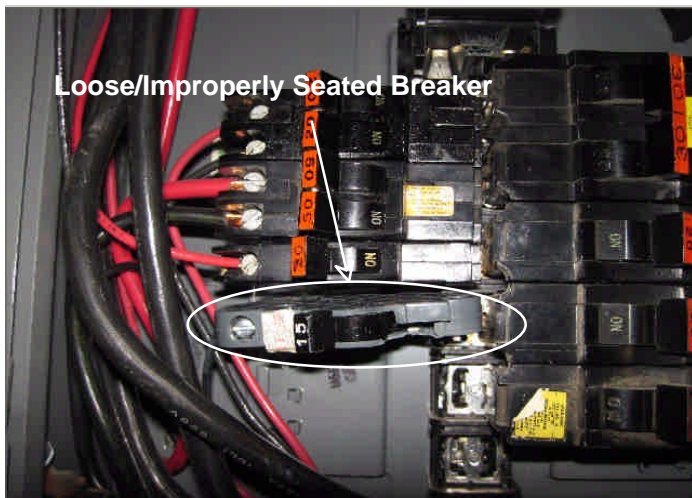
There are one or more loose or improperly seated FPE Stablok breakers - Service Recommended - *Continued*

- q There are one or more loose or improperly seated FPE Stablok breakers - Service Recommended

- q There are one or more loose or improperly seated FPE Stablok breakers in the panel. Loose breakers is a chronic problem with this type of electrical panels. Additionally, certain panel slots may only accept certain breaker types. Using the wrong breaker in the wrong slot will not work properly. Improperly seated breakers may not make proper electrical contact that may result in overheating of the breaker and or arcing at the connection. I recommend evaluation of the installation and service as necessary by a qualified electrician.

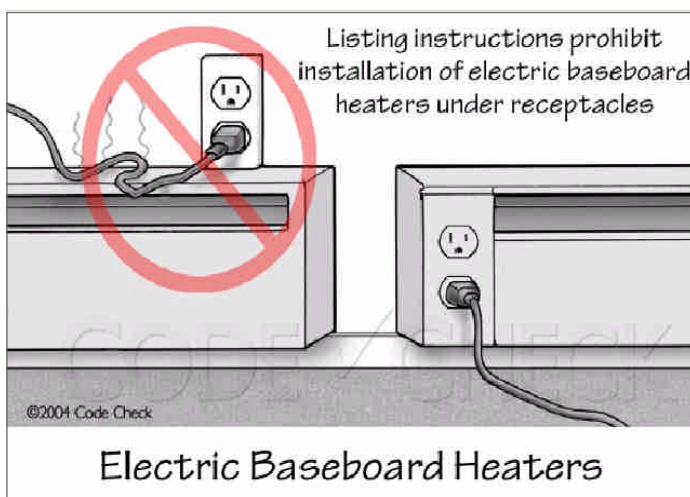
- One or more receptacles are installed with insufficient clearances to a baseboard heating unit. Please refer to the body of the report for the location and or additional commentary. While this may have been an acceptable practice at one time, current safety standards would no longer allow this installation as the insulation on electric cords may become damaged if they contact the heater. Caution is recommended in this area. Relocating the receptacles to provide safe clearances to the unit is recommended. Interested parties are encouraged to consult a qualified electrician for further information and or service.

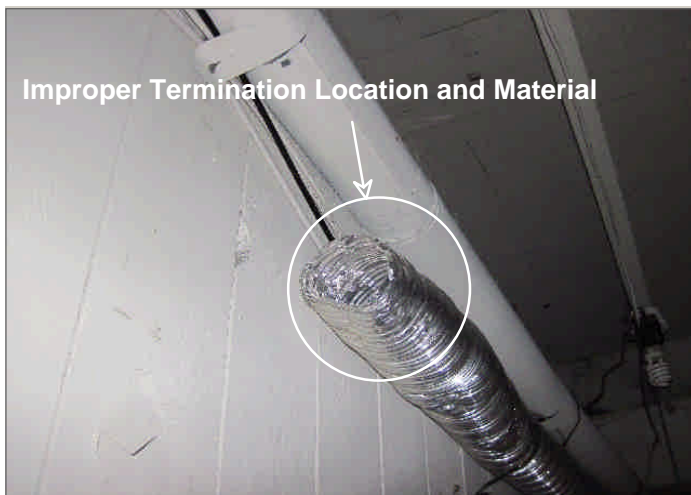
- q The bathroom exhaust appears improperly terminated in the garage

- q The bathroom exhaust appears improperly terminated in the garage. This may allow damp bath area air to exhaust onto portions of the wood framing and creates a void in the garage/living space fire separation. All exhaust fan vents should terminate at the exterior using an approved vent termination. I recommend that a qualified HVAC contractor evaluate and service as necessary.
