Service Information Bulletin

NUMBER: 8–10–13 **S.M. REF.:** Listed in Table **ENGINE:** EPA07 Series 60 **DATE:** August 2013

SUBJECT: DOUBLE HYSTERESIS TEST

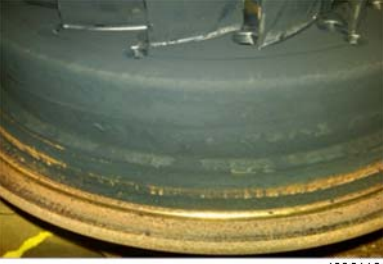
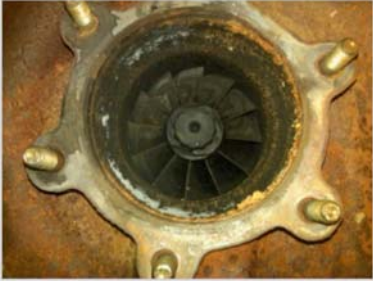
d090113	Carbon Build up on the VG Vanes	Poor combustion: Plugged Air Filter, Turbo Actuator, Engine Sensor, Fuel Injector, Low Compression	Find the source of the excessive soot and repair. Replace the Turbo as progressive damage.

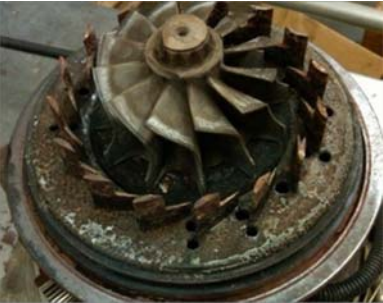
d090115	Rust and White Residue	Progressive damage from Coolant entering the Exhaust track: Cracked Cylinder Head Leaking EGR Cooler	Find the source of the coolant and repair. Replace the turbo as progressive damage.

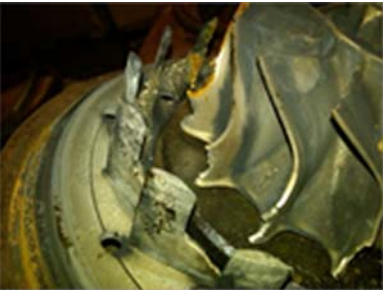
d090116	Vanes are Bent, Turbine Wheel Blades are Damaged	Progressive Damage from debris: Dropped Valve Broken EGR Valve Butterfly Debris Stored in the EGR Cooler from another Failure	Find the source of the debris, repair. Replace the turbo, EGR Cooler and exhaust manifold inner tube as progressive damage. Refer to Service Letter 13TS1

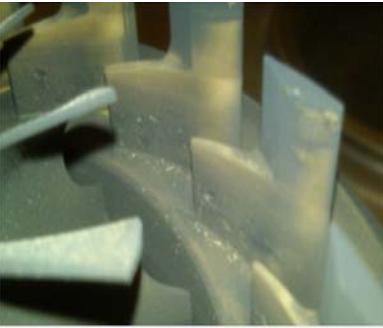
d090117	Light Impact Damage on the Vanes
