Model: Kingfisher 2		Date: 15-Sep-99	No.: RA298001
Subject: Differences from Kingfisher		Prepared by: K. Miura	
From: Technical Service Dept., GTS Division			
Classification:	<input type="checkbox"/> Troubleshooting	<input type="checkbox"/> Part information	<input type="checkbox"/> Action required
	<input type="checkbox"/> Mechanical	<input type="checkbox"/> Electrical	<input checked="" type="checkbox"/> Service manual revision
	<input type="checkbox"/> Paper path	<input type="checkbox"/> Transmit/receive	<input type="checkbox"/> Retrofit information
	<input type="checkbox"/> Other ()

This RTB clarifies the differences between the base copier and Kingfisher 2 and Grand Kingfisher 2 (based on the style of the service manual).

Model: Kingfisher 2		Date: 29-Feb-00	No.: RA298003
Subject: Overtoneing and toner drops on copies		Prepared by: M. Ishihara	
From: Technical Services Dept., GTS Division			
Classification:	<input checked="" type="checkbox"/> Troubleshooting	<input type="checkbox"/> Part information	<input checked="" type="checkbox"/> Action required
	<input type="checkbox"/> Mechanical	<input type="checkbox"/> Electrical	<input type="checkbox"/> Service manual revision
	<inpu

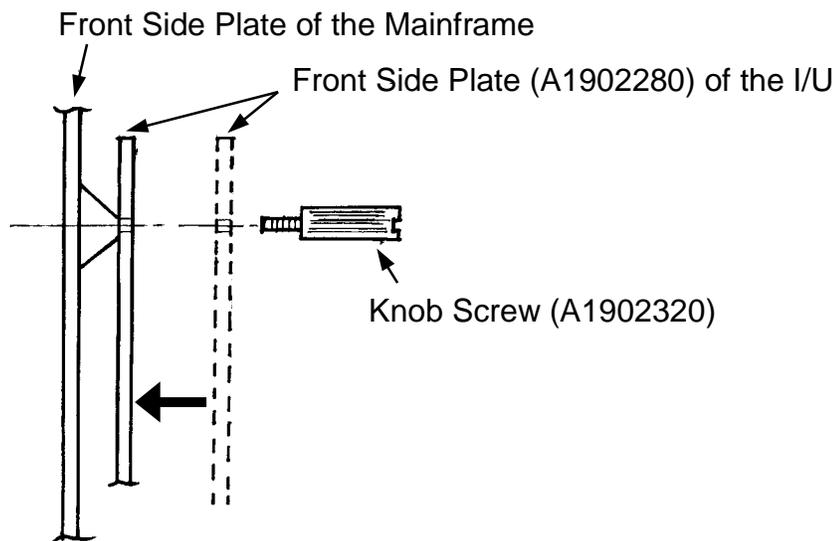
- 1) At machine installation or after the developer is replaced, SP66 (TD sensor Initial Setting) that would usually take about 60 seconds stops after only a few seconds.
- 2) After a new machine is installed, copies have high ID and/or toner drops onto copies. This occurs until about 100 copies are made.

The TD sensor connector (A1905346: Development Unit Harness) which is mounted on the I/U (Imaging Unit) is not properly connected to the connector of the Development Relay Board (A1905145). The board is mounted on the rear side plate of the mainframe.

If the service technician does not tighten the knob screw *while* pushing the I/U against the raised portion of the mainframe front side plate, the TD sensor connector will not be fully inserted into the receiving connector on the board.

- 1) Insert the I/U into the mainframe.
- 2) Push the I/U toward the back so that the I/U front side plate(A1902280) remains flush against the raised portion of the front side plate of the mainframe (see the illustration below). While holding the unit in this position (pushing on the handle), tighten the knob screw (A1902320) by hand until the I/U is secure.

- 3) Use a slotted screwdriver or coin for the final tightening.

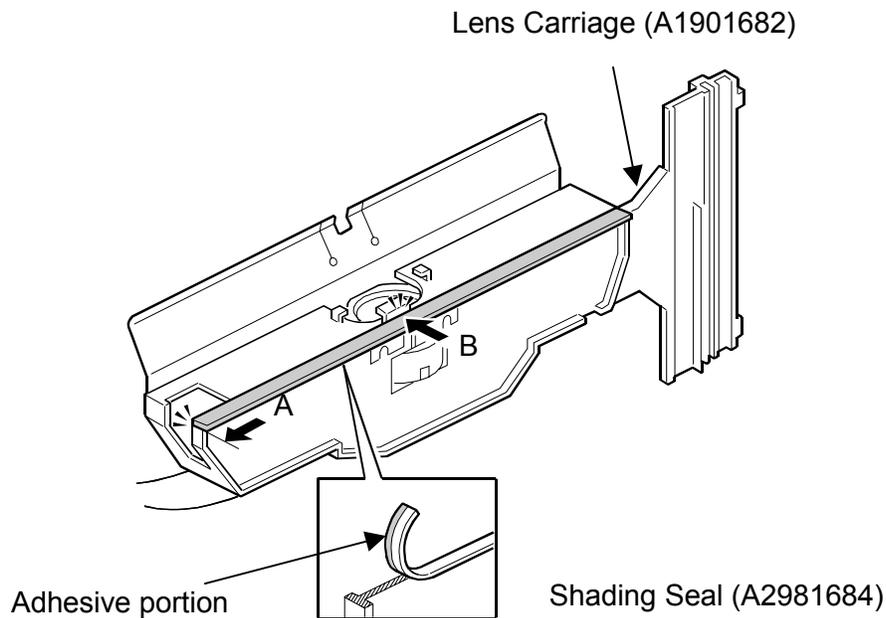
The image density of the leading (top) half of the copy becomes lighter when specific light or halftone originals are copied.

When the 1st and 2nd scanners start to move, part of the light from the 1st scanner is directly sent to the mirror of the 2nd scanner, as the two scanners are relatively close. This "extra light" received by the mirror will cause the image to appear lighter. As scanning continues, the 1st scanner increases to twice the speed of the 2nd scanner, causing the two scanners to get farther and farther apart. Therefore, less and less light "extra light" reaches the 2nd scanner mirror. This is why the image is lighter near the leading edge.

A: 0-1mm from the edge, B: 0-0.5mm from the surface

A shading seal (A2981684) should be attached to ensure proper image density at the leading edge (when making copies with very light/halftone originals). Because the extra light passes from the 2nd scanner mirror to the photoconductor via the base plate of the optics unit and lens carriage (A1901682), the seal should be attached to the lower portion of the lens carriage. This will prevent the extra light from passing between the optic base plate and lens carriage. This modification will be applied from August 2000 production. Please see the procedure as shown below.

3. Attach the shading seal to the lens carriage as shown in the illustration.

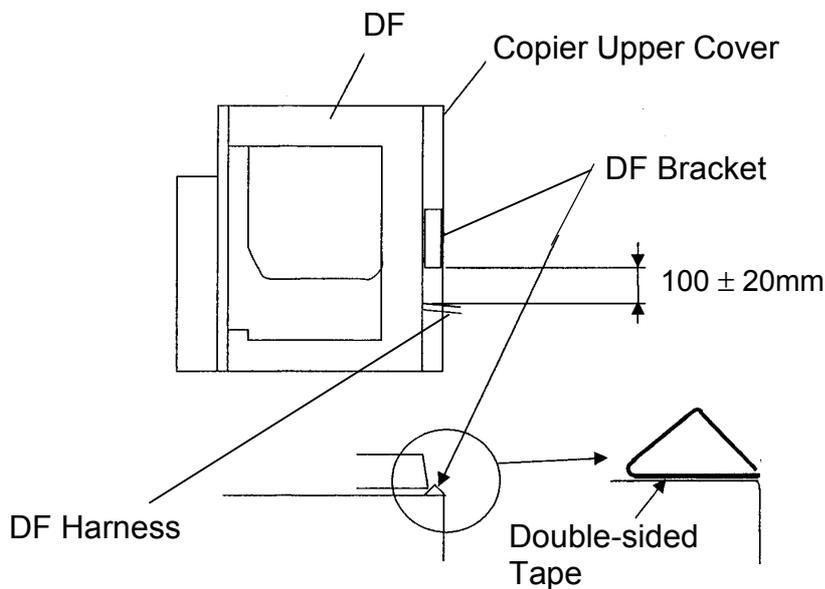
Damage to the harness connecting the DF44 and the copier.

Sometimes, the DF is forced past its normal stop position when it is opened. If this happens many times, the harness may be damaged.

A DF bracket (PN A2989500) has been registered as a service part. Place it on the copier upper cover as shown below to prevent the DF unit from being forced too far back.
