TECHNICAL SERVICE BULLETIN

Bulletin Number: ATV-07-01A
ATV-07-01B
Model Years: 2006

SUBJECT: **** REVISED** 2006 HAWKEYE 2x4 / 4x4 / Intl - Front Bearing Carrier Replacement and Steering Post Support Bracket Installation**

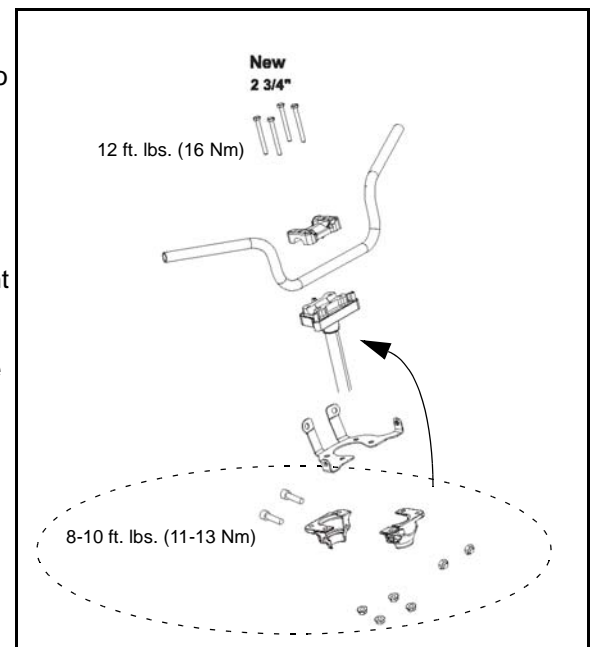
ATVs affected by this Safety Bulletin also have steering posts which may fatigue and break in the area where the handlebar attaches to the steering post. Failure of this component may lead to loss of steering control resulting in an accident and serious personal injury to the operator. A Support Bracket Kit has been developed to address this issue.

4. Assemble the steering support bracket and components according to the instructions in **Kit PN 2203644**. Torque all fasteners to specification.
5. Install the two screws that attach the pod support mounts to the pod mounting bracket.
6. Install the two plastic push rivets into the rear portion of the instrument pod.

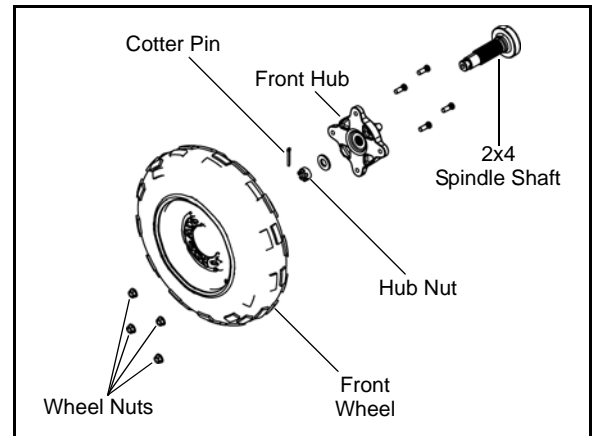
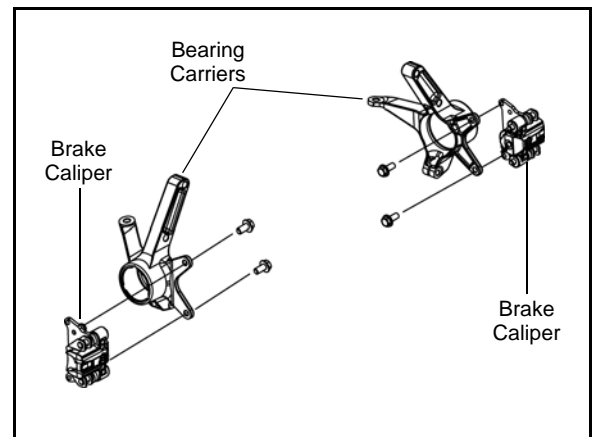
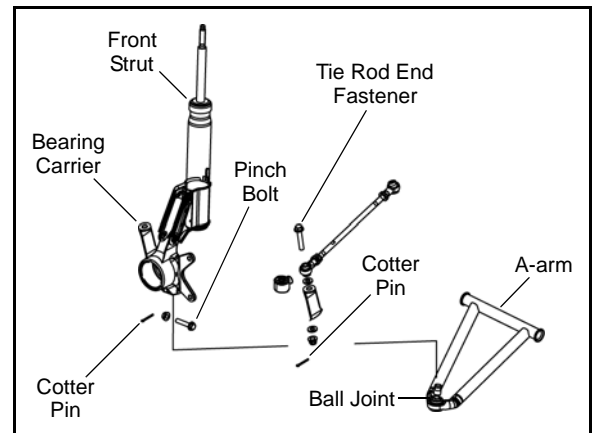
ATVs affected by this Safety Bulletin have front bearing carrier castings which may have been produced with an insufficient amount of material thickness in the area where the lower a-arm and ball joint attach. Failure of this component may lead to loss of steering control resulting in an accident and serious personal injury to the operator. Updated bearing carrier assemblies have been developed to address this issue.

1. Loosen front wheel nuts on both sides.
2. Remove cotter pins and loosen front hub nuts on both sides.
3. Elevate and support the front end of the ATV securely with both front tires off the ground. Remove both front wheels.
4. Remove both front calipers from the bearing carrier housing.
5. Remove both front hubs (2x4 ONLY - Remove the splined shafts from the bearing carrier assembly at this time).
6. Remove both tie-rod ends from the bearing carrier assembly.
7. Completely remove the cotter pins, pinch bolts and nuts that hold each A-arm ball joint to the bearing carrier assembly.
8. Remove the A-arm ball joint from each bearing carrier assembly (4x4 ONLY - Remove the CV splined shafts from the bearing carrier during A-arm removal at this time).
9. Remove the fasteners that attach the bearing carriers to the strut housings and remove the bearing carrier assemblies from the vehicle.
