97-1, *Publication Date: JANUARY 2, 1997*

97-1, Publication Date: JANUARY 2, 1997

Article No.  
97-1-17

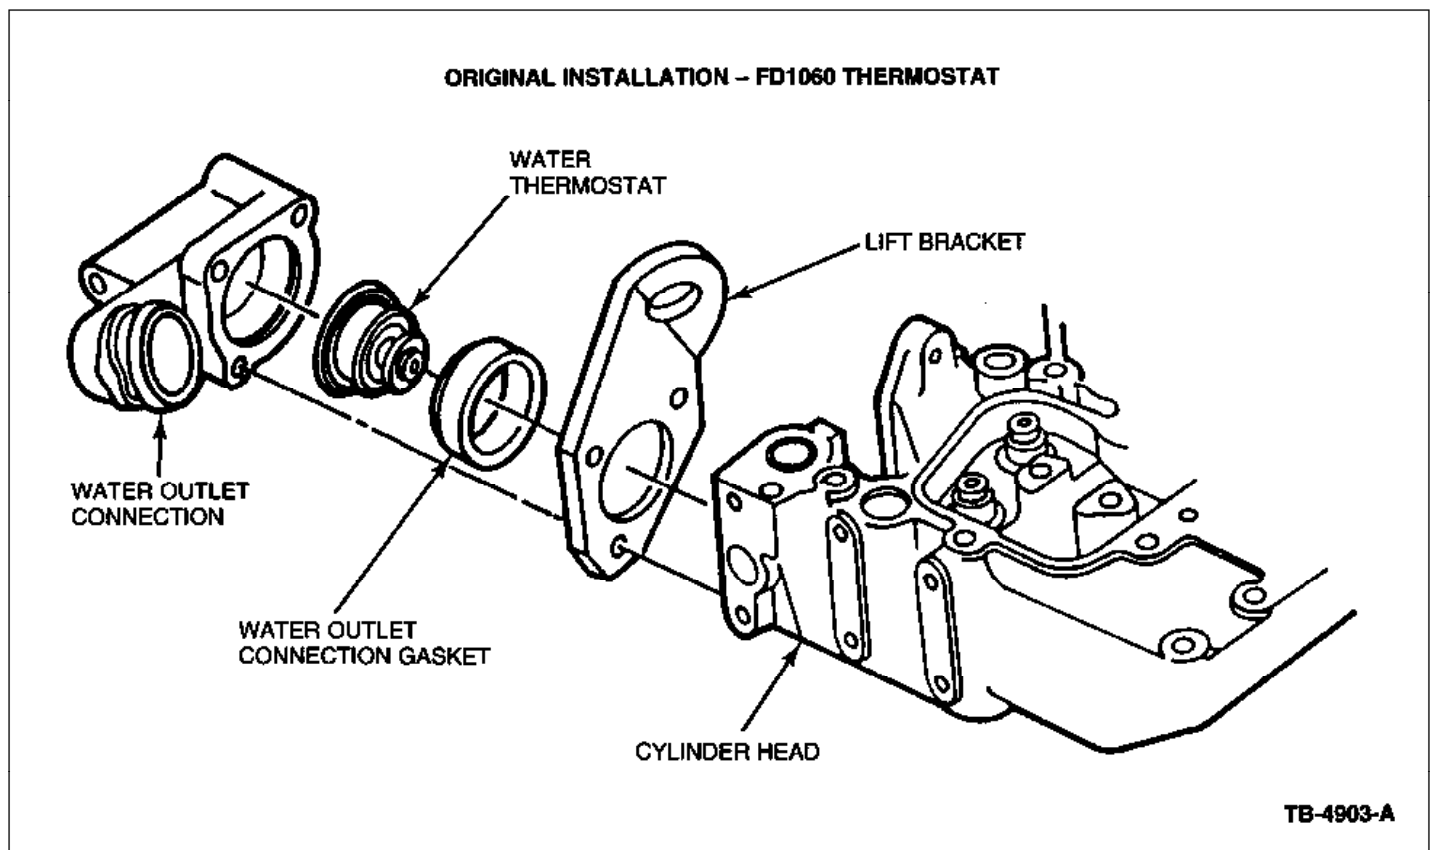
Figure 1 - Article 97-1-17

There may be a lack of interior cab heat and/or the engine may not reach normal operating temperatures. This may be caused by the thermostat and deaeration system currently used in FD1060 engines allowing coolant to bypass the thermostat and not reach normal operating temperatures.

Replace the thermostat and deaeration system. The new thermostat will allow for zero bypass of the coolant which should allow the engine to warm up to operating temperature quicker. Refer to the following Service Procedure for details.

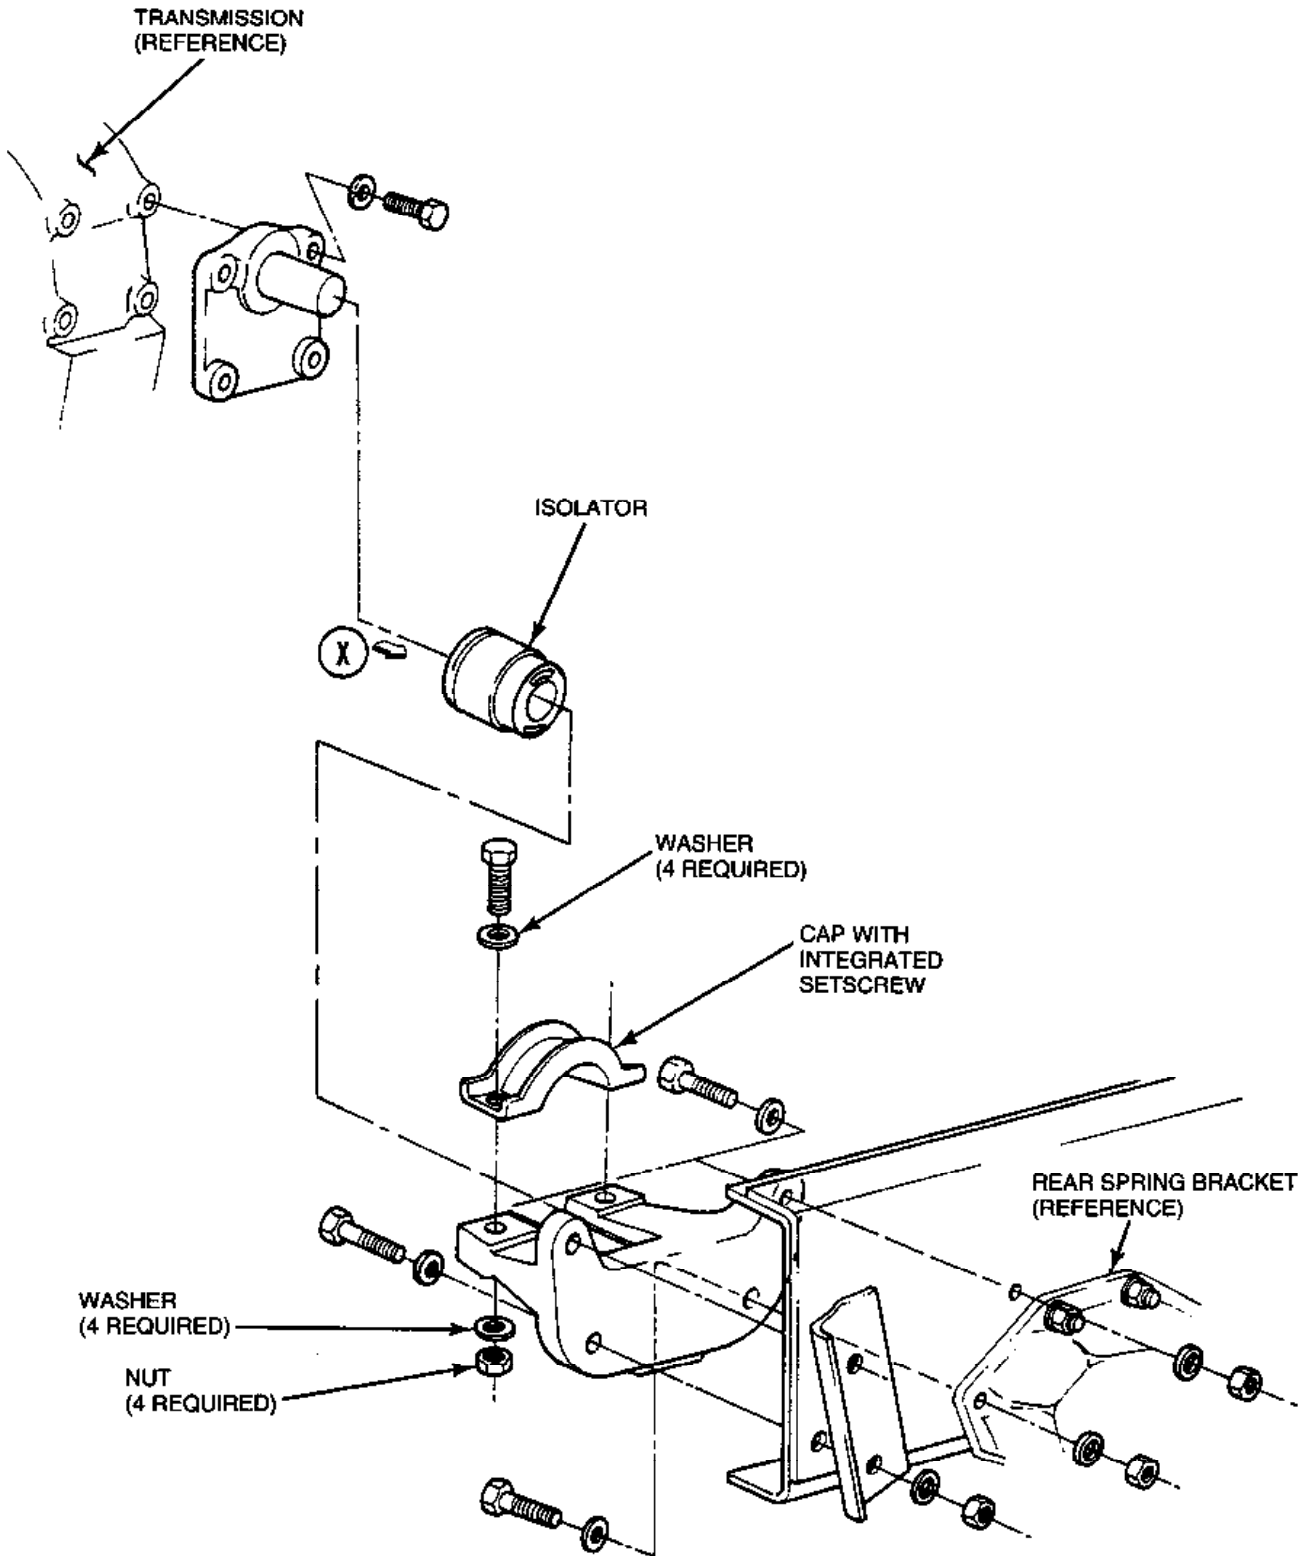
Figure 1 - Article 97-1-18

High engine noise/vibration/harshness (NVH) at low engine rpm may occur on some vehicles. This may be caused by a reduction in cushioning of the rear engine mounts.

Replace the rear engine mount with a revised rear engine mount. Refer to the following Service Procedure for details.

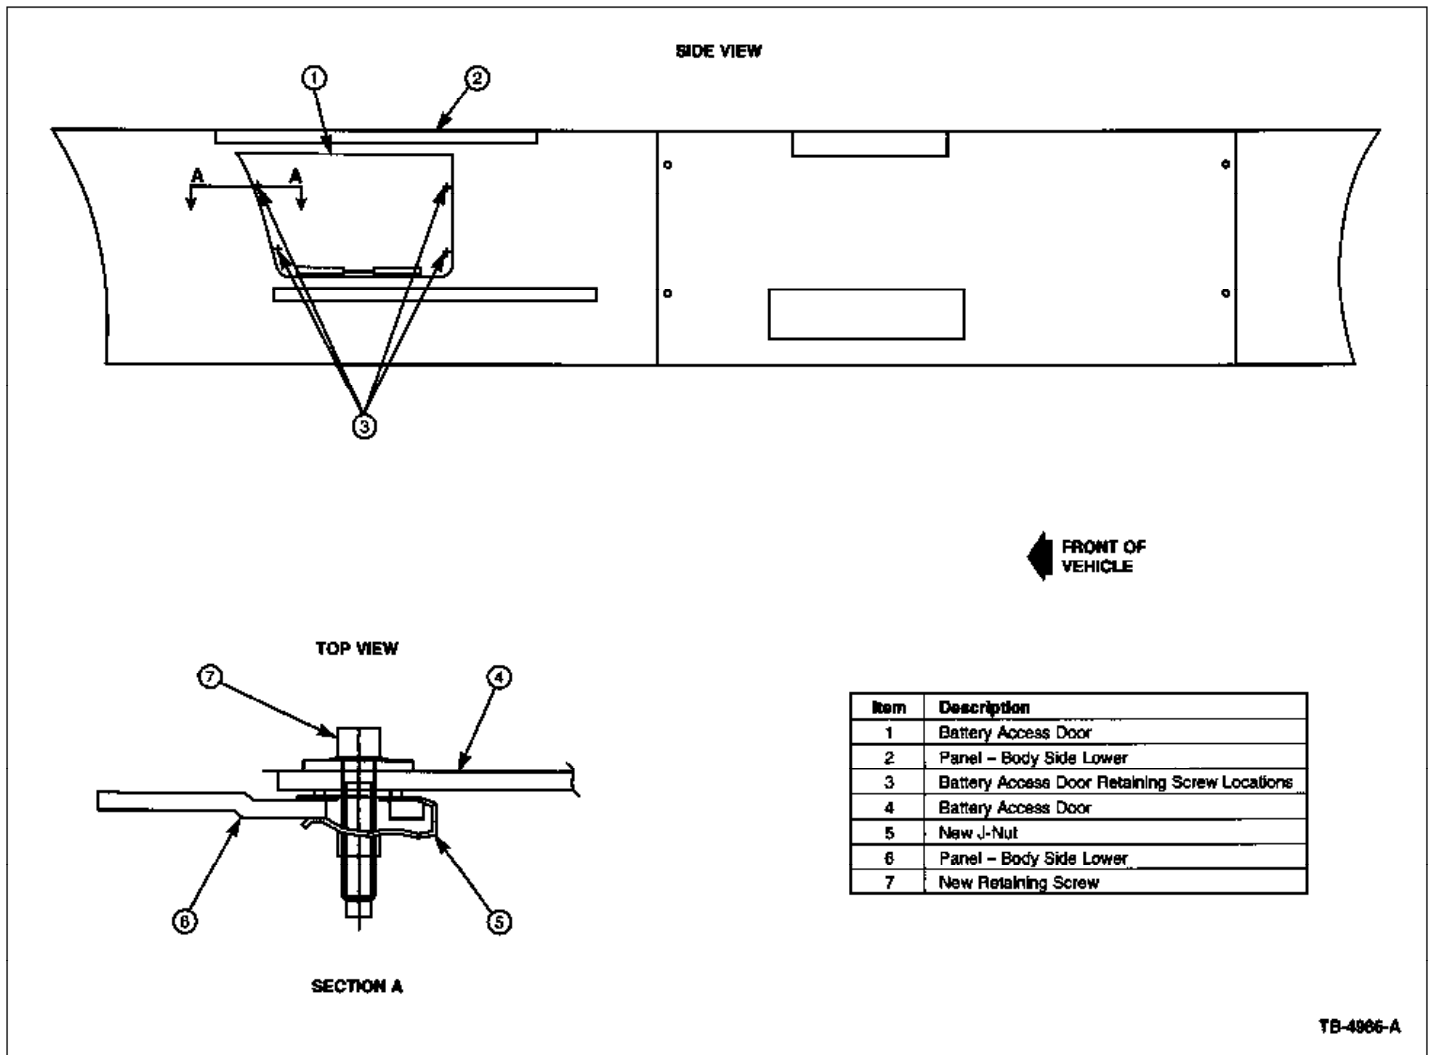
Figure 1 - Article 97-2-17

The fasteners for the battery access doors on vehicles equipped with lower body side panels may become loose. This may be caused by the current fasteners not retaining torque. Also, the battery access doors were not serviced/available individually and parts are now available.

Replace the existing door fasteners with new fasteners. The new fasteners should retain their torque and reduce the possibility of the door coming loose. Refer to the following Service Procedure for details.

1. Loosen the four (4) existing battery access door screws and remove the door from the body panel.
2. Remove the existing screws from the door and discard.
3. Remove the four (4) corresponding J-nuts from the lower body panel and discard.
4. Install four (4) new J-nuts (N623332-S100) onto the lower body panel at the location of the holes.
5. Place the battery access door into position on the lower body panel and secure it with four (4) new Screws (W701810-S300) and torque the screws to 10-13 N-m (85-115 lb-in).
6. Repeat this procedure for the opposite battery access door.

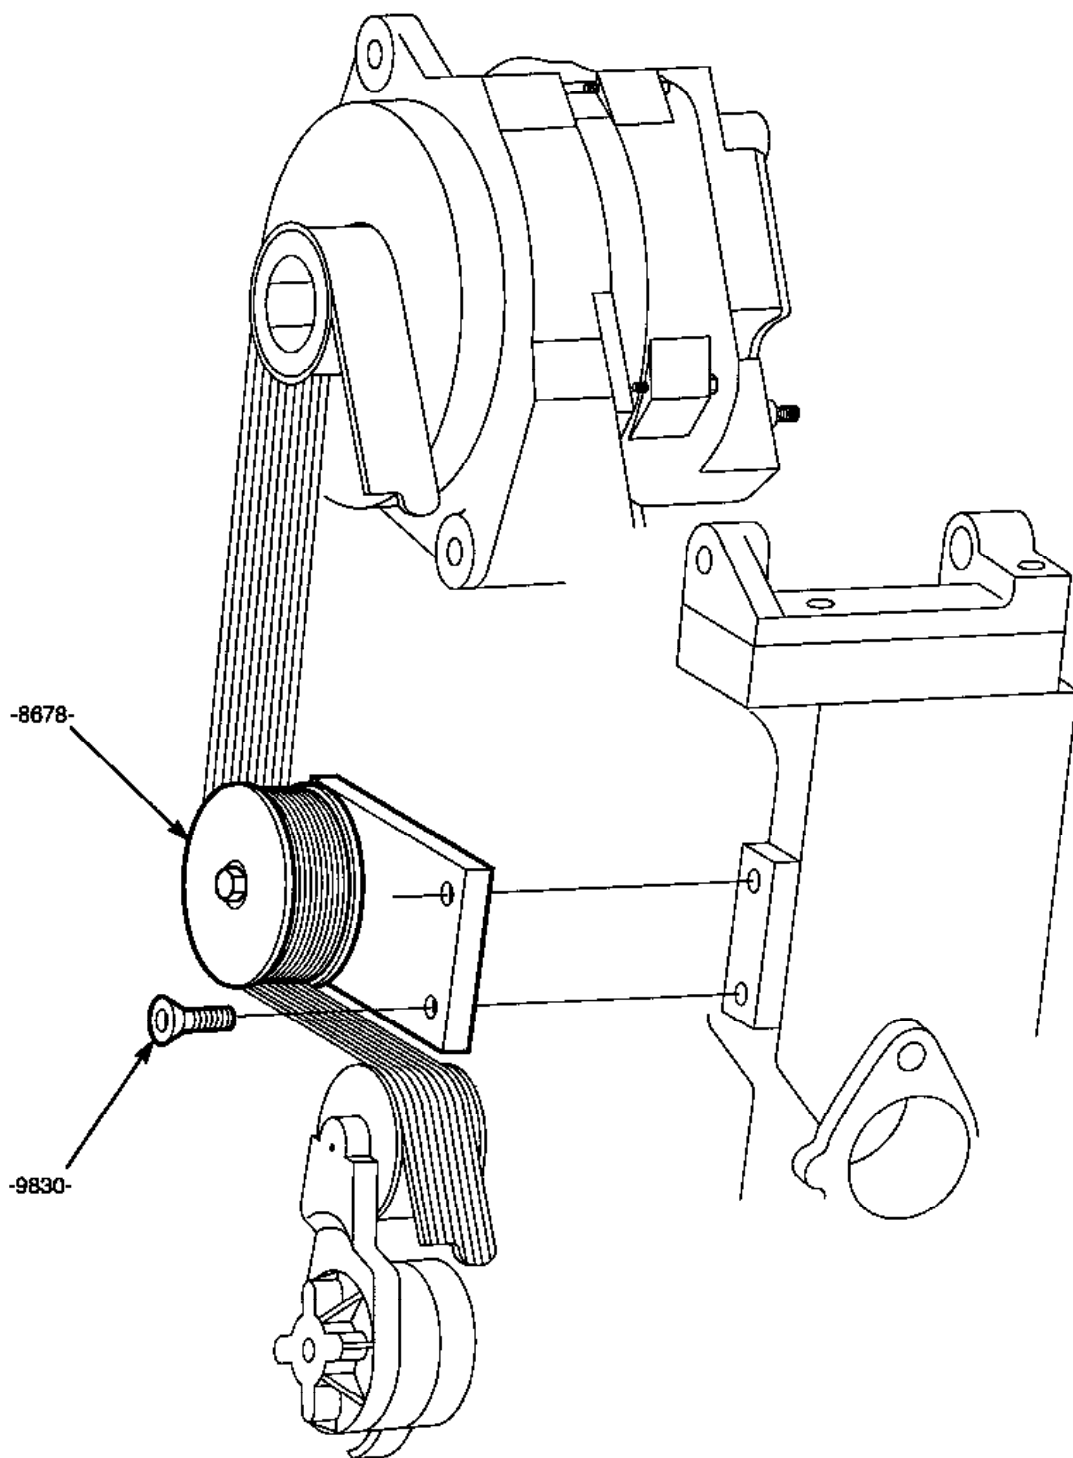
**Figure 2 - Article 97-4-11**

ON EARLY BUILT FD1060 ENGINES, THE TENSIONER AND IDLER SUPPORT PLATES WERE ATTACHED TO THE ENGINE WITH COUNTERSUNK BOLTS (REFER TO FIGURE 2). THE NEW IDLER AND SUPPORT PLATE ASSEMBLY NOW USES HEX HEAD FLANGE BOLTS. THEREFORE, IF AN ENGINE IS EQUIPPED WITH THE COUNTERSUNK BOLTS, THEN THOSE BOLTS MUST BE REPLACED WITH NEW HEX HEAD FLANGE BOLTS (3900631-CF).

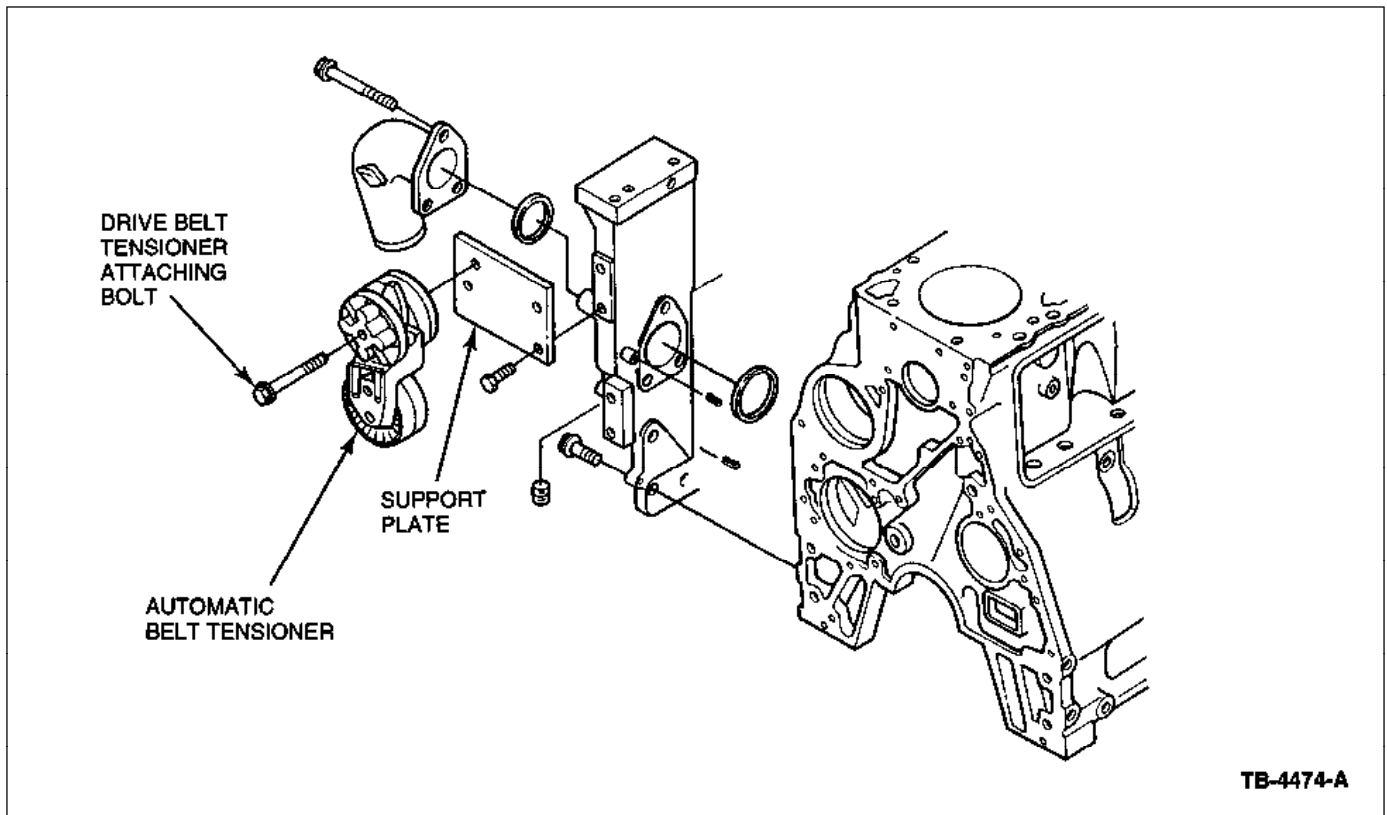
**Figure 1 - Article 97-4-11**

The Front End Accessory Drive (FEAD) belt may have high wear and/or may come off of the drive pulleys on some vehicles. This may be caused by the belt tensioner support plate and/or the idler pulley support plate not being flat. This can cause the tensioner and idler pulleys to be out of alignment which results in accelerated FEAD belt wear and/or belt roll off.

4. Remove the automatic belt tensioner from the support plate and then remove the support plate from the engine. Discard the support plate. Refer to Figure 1.

5. Install the new automatic Belt Tensioner Support Plate (F3HZ-6B209-AAA) onto the engine with the two (2) attaching bolts. Torque the bolts to 20-32 N-m (15-24 lb-ft).
6. Install the automatic belt tensioner onto the support plate with one (1) bolt and torque to 41-52 N-m (30-38 lb-ft).
7. If the vehicle is equipped with air conditioning, proceed to Step 9. If the vehicle is not equipped with air conditioning, proceed to Step 8.
8. Remove the idler pulley and support plate assembly from the engine and discard. Install the new Idler Pulley Support Plate (F3HZ-8678-AAA) onto the engine with two (2) bolts and torque to 24 N-m (18 lb-ft). Refer to Figure 2.

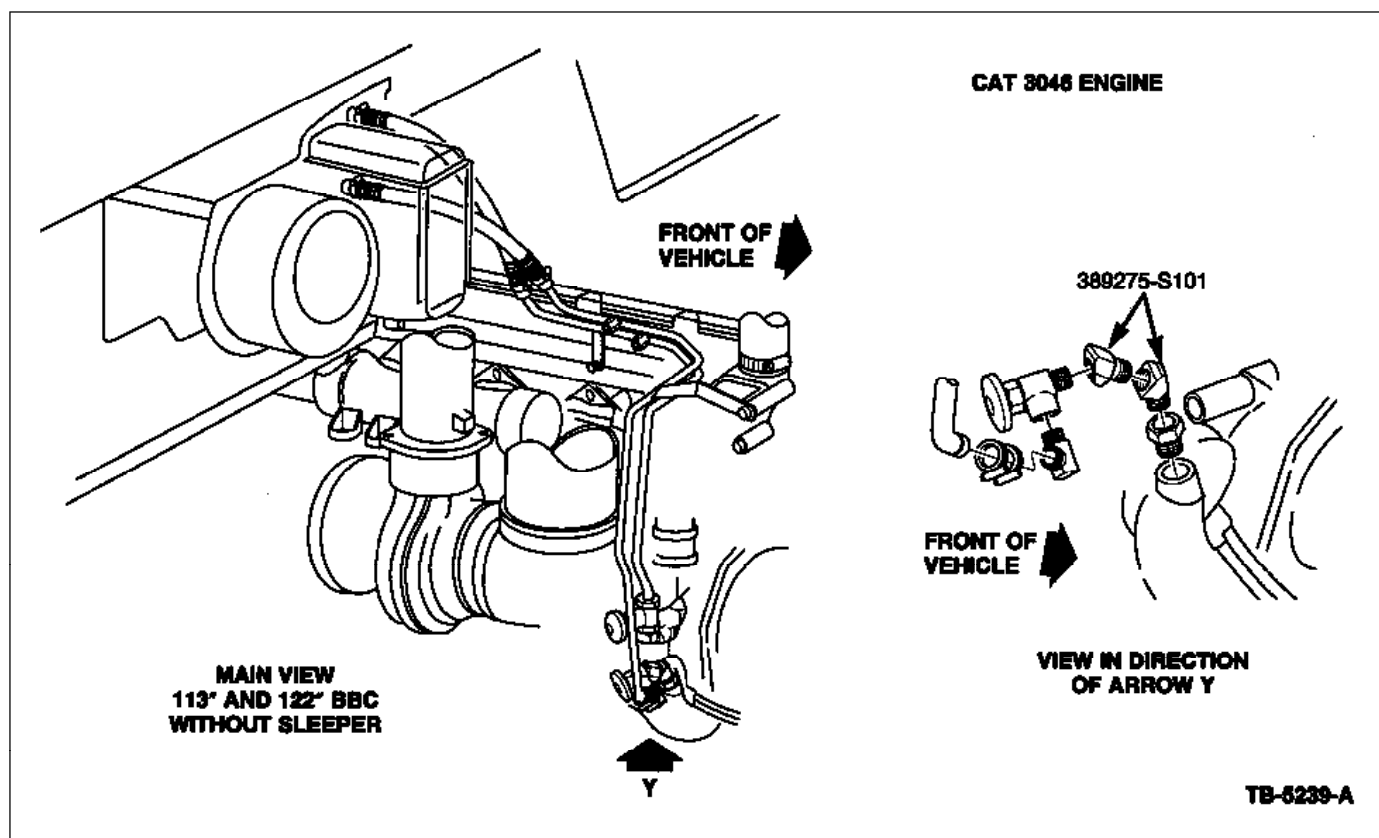
Figure 1 - Article 97-20-21

1. Verify the concern.
2. Drain coolant following the procedure outlined in the appropriate Service Manual.
3. Remove the 45 degree elbow fitting from location shown in Figures 1 through 4 and inspect for thread shortage.

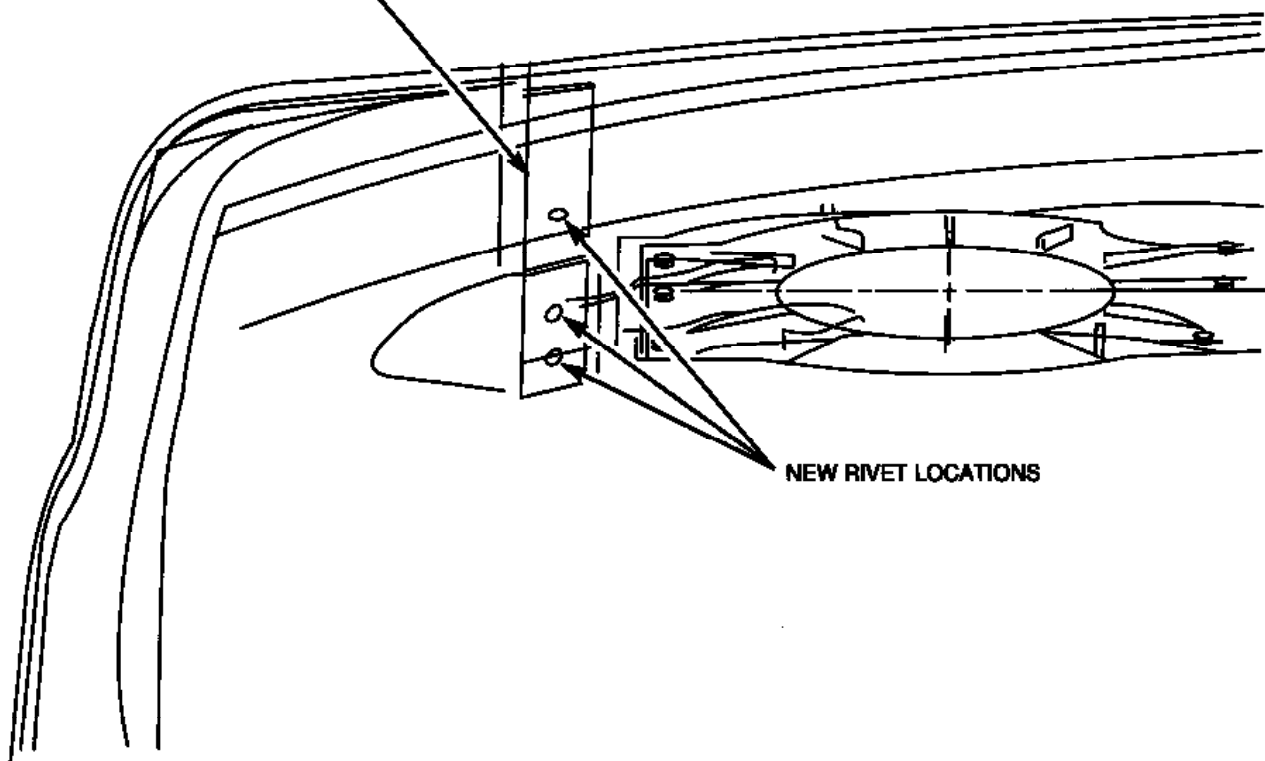
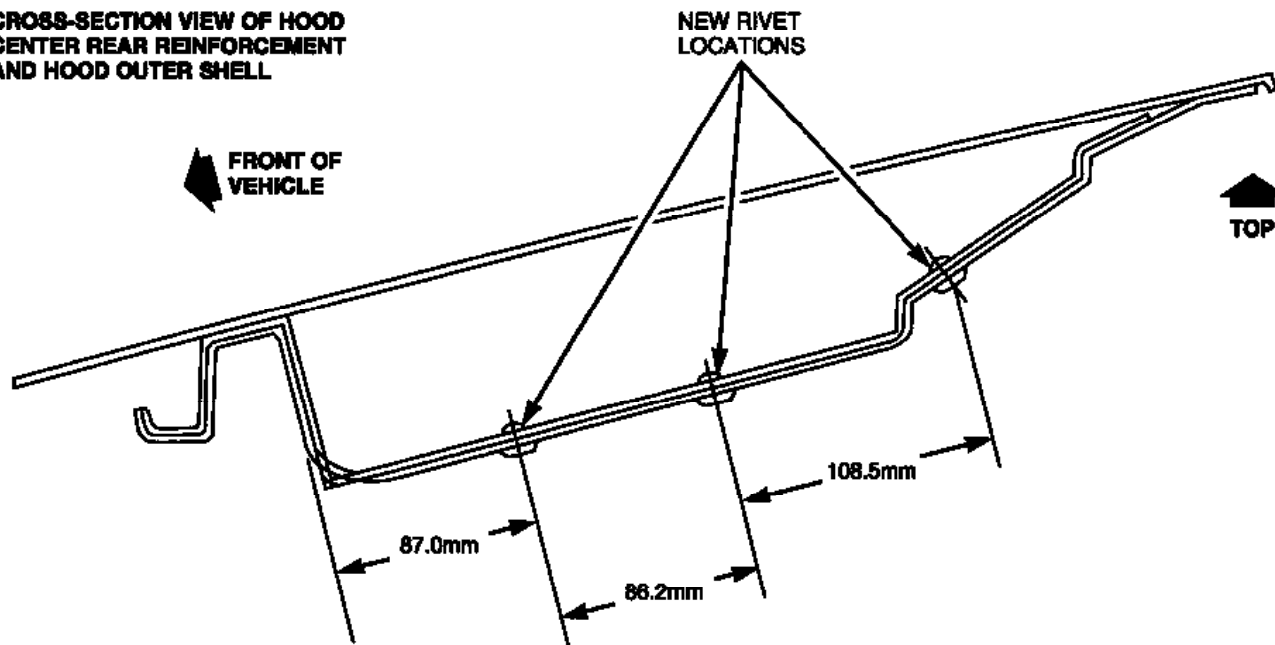
**Figure 2 - Article 97-23-16**

SEAM (LOCATION OF POSSIBLE HOOD REINFORCEMENT SEPARATION)
