September 15, 1982

S83-008

The affected model, indicated below, may have three possible defects involving the outer steering arms, the sheet metal plate which positions the lower portion of the main steering shaft, and the forward edge of the track slider frame.

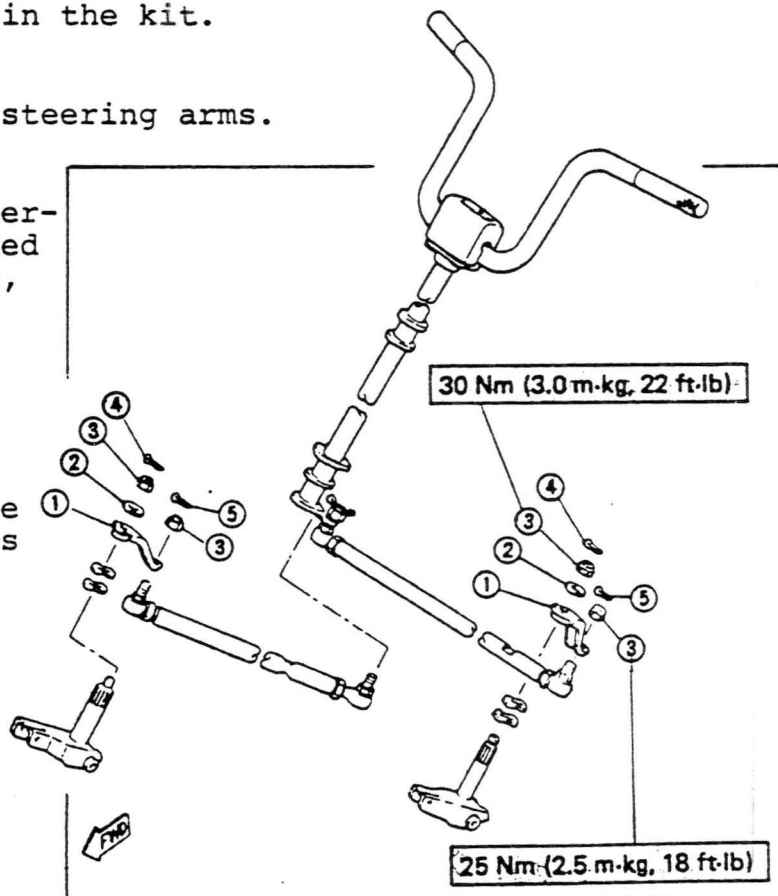
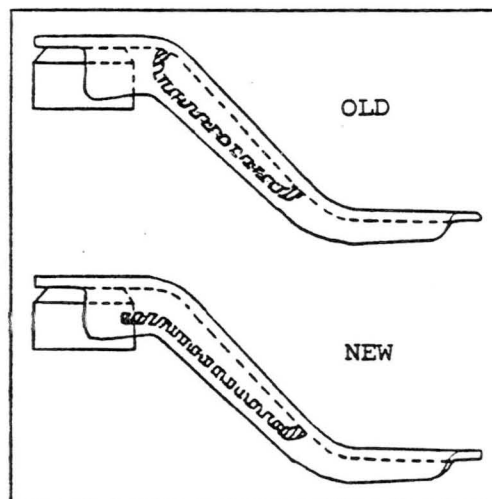
- 1) One defect involves insufficient reinforcement of the outer steering arms which control the movement of the skis. Under severe riding conditions, these arms may crack or break, resulting in partial loss of steering control.
- 2) Another possible defect involves inadequate penetration of the welds securing a sheet metal plate to the body of the snowmobile. This plate, which positions the lower portion of the main steering shaft, may separate from the body under extreme conditions, resulting in partial loss of steering control.
- 3) Another defect involves the possibility of the forward edge of the track slider frame entering the openings of the track. This may occur in instances of severe frontal impact on a track if the adjustment is too loose (i.e., which is not adjusted to Yamaha's specifications), resulting in rapid deceleration of the snowmobile.

6. Install new outer steering arms as illustrated using the new washers, nuts and cotter pins contained in the kit.

iii) The new and old outer steering arms can be distinguished from one another by comparing them with the illustrations shown opposite.

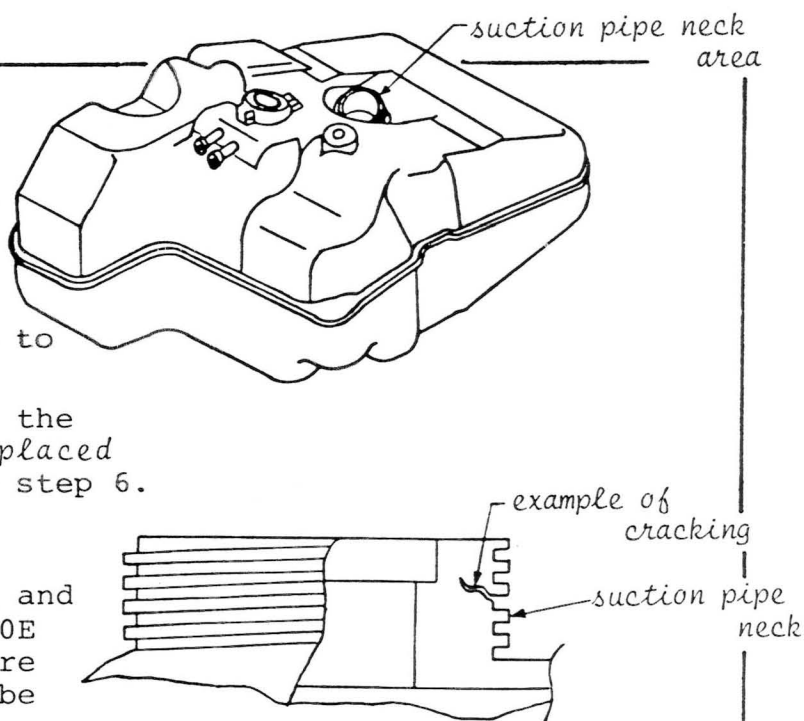
The affected models listed below are equipped with a suction pipe cap on the top of the fuel tank. This cap may have been overtightened at the factory, causing possible cracking of the suction pipe neck on the fuel tank to occur. Some fuel leakage may thus result when the tank is filled to capacity or the machine is tilted on its side.

5. Inspect the neck (threaded area) of the suction pipe cap for cracks.

If no cracks are found, the fuel tank does not need replacing -- proceed to step 6.

If cracks are found, the fuel tank must be replaced before proceeding to step 6.

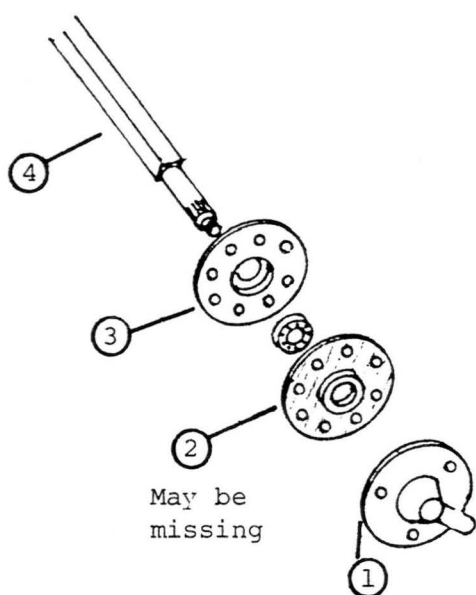
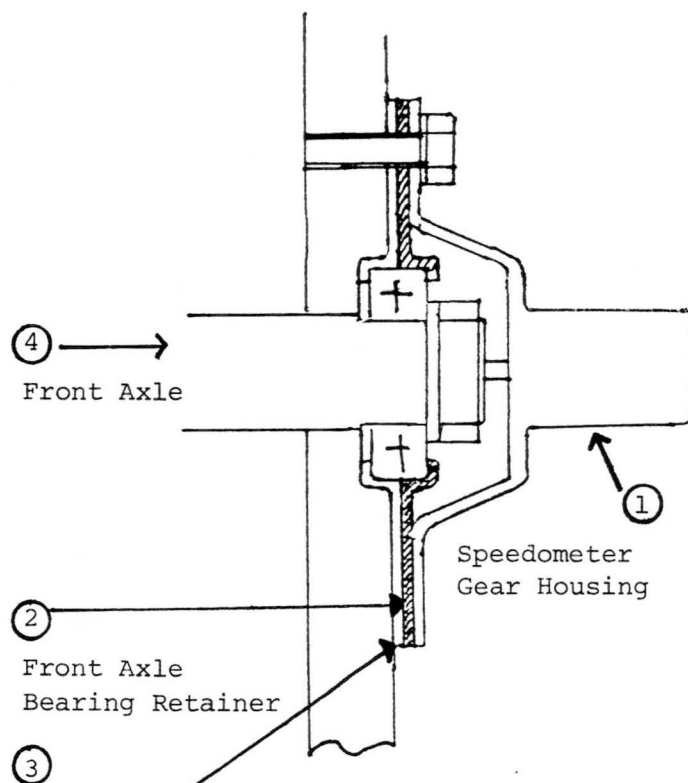
It has been determined that the front axle bearing retainer has not been installed on affected models. This may cause damage to the bearing, the speedometer gear or the front axle when the snowmobile is driven.

- a) If three plates are located in this area, there is no need to proceed.
- b) If one plate ② is missing from the right-hand front axle, proceed as follows.

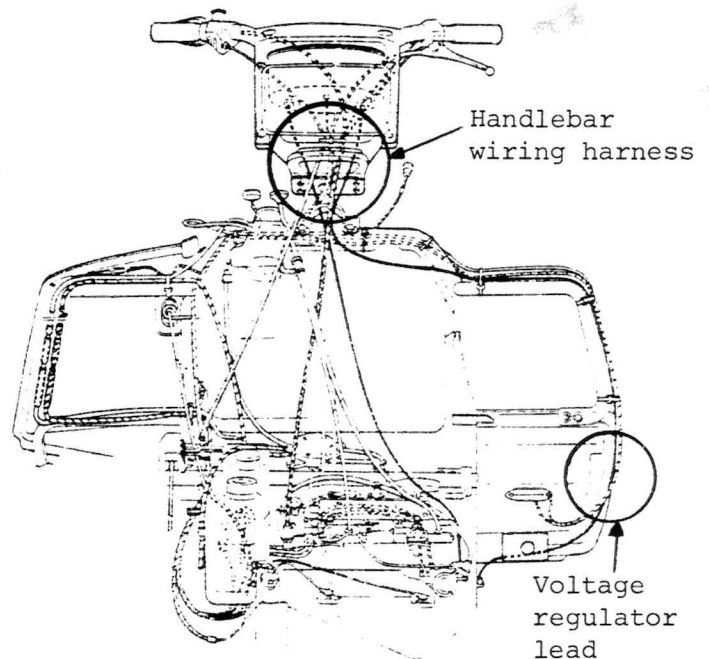
Engine misfiring and erratic headlight operation of the affected units may be caused by a shorting out of the handlebar wiring harness.

- 1) Remove the handlebar pads and the fairing.
- 2) Remove the strap holding the handlebar wiring harness to the handlebar and discard the strap.
- 3) Pull the harness away from the handlebar and inspect the wiring. Repair any damage as required.
- 4) Secure the wiring harness to the speedometer cable using electrical tape. Check to ensure that the harness is no longer touching any sharp edges; if necessary, use some emery paper to take off the sharp edges.
- 5) Reinstall the fairing and handlebar pads.

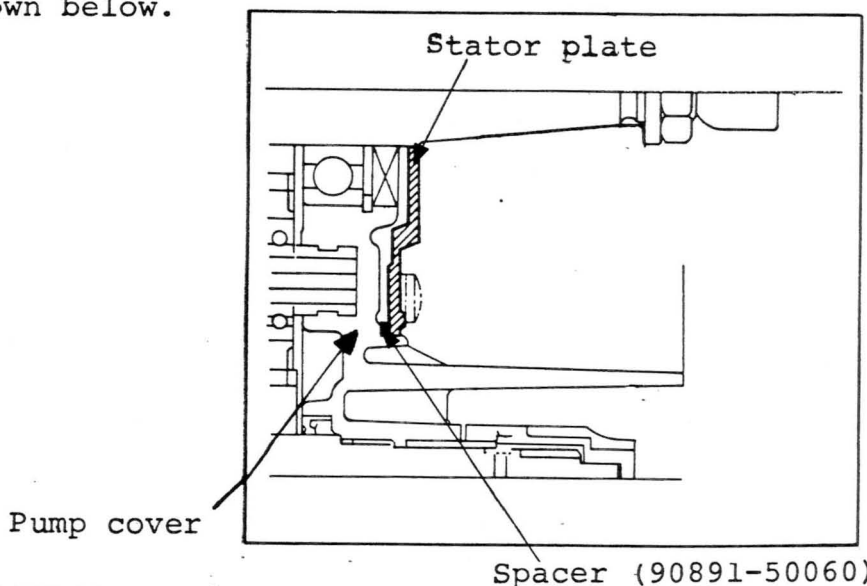
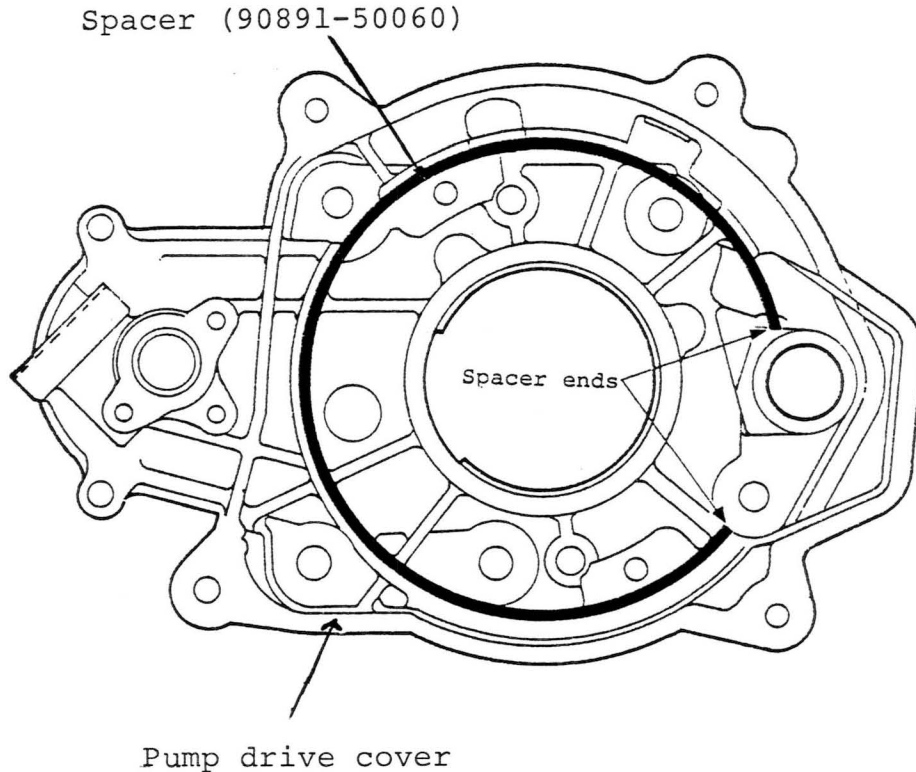
It has been determined that the water pump case cover has not been machined properly. This results in uneven seating of the C.D.I. magneto stator plate and may cause the plate to become cracked or damaged through engine vibration.

1. First, remove the engine from the chassis. To save time, you may choose to remove only those components which allow the right-hand end of the motor to be tilted for access to the recoil starter and magneto.
2. Remove the four bolts holding the recoil starter.
3. Remove the three bolts holding the starter pulley.
4. Using the flywheel puller, remove the flywheel magneto rotor and key.
5. Using a hand impact tool, remove the magneto stator plate bolts and check the stator for any cracks or damage.
6. Install the spacer between the stator plate and the pump cover as shown below.

NOTE: The spacer must be installed with the open ends positioned as shown below.

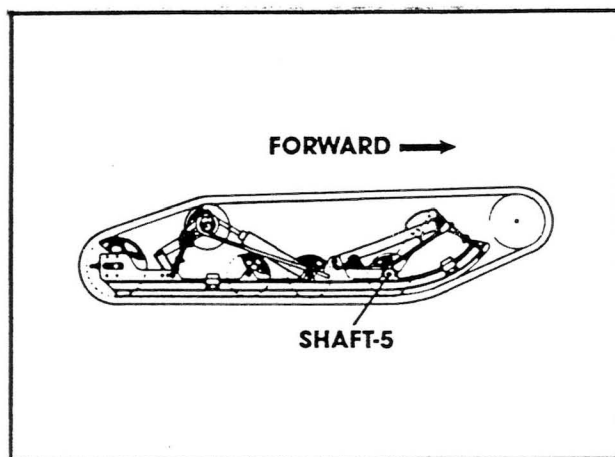
Shaft-5 is located near the front of the rear suspension system. If you have a broken or damaged Shaft-5, replace it with the replacement kit discussed in this bulletin.

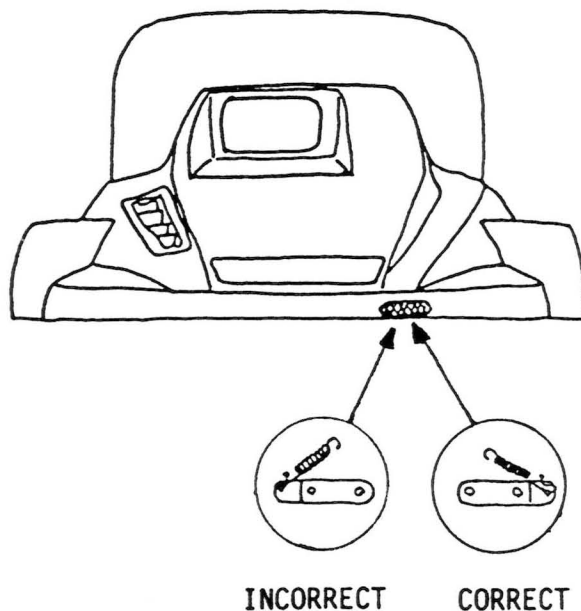
It has been determined that the hood stopper washer has been installed incorrectly on some units. This may cause the washer to catch in the front baffle plate when the hood is opened and closed.

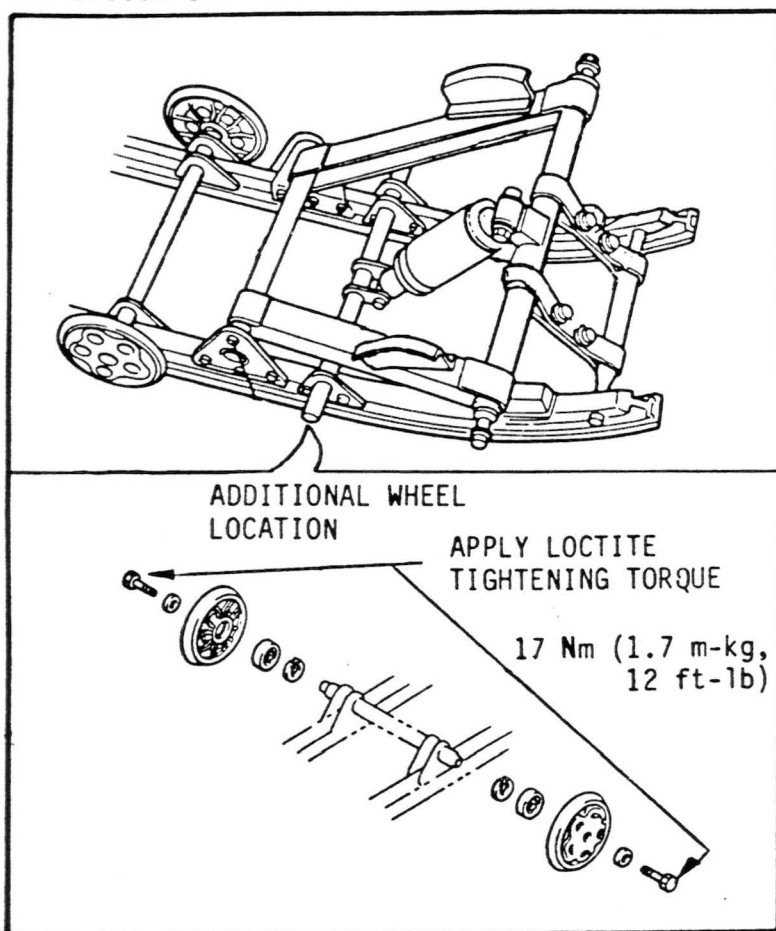
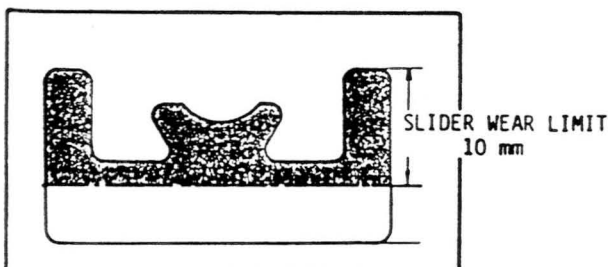
It has been determined during our early product testing that, under certain conditions, slider wear on the CF300K may be excessive. To eliminate this possibility, YOU MUST install the additional idler wheels on this model at P.D.I.

If the unit has been retailed and is in use, please contact your customer and arrange to have the unit brought in for this modification. If the unit has been used, check the sliders for wear and if the wear is beyond the limit, also replace the sliders.
