**SB-GA8-2012-85**

# Service Bulletin

Modifications required for aircraft to be registered in Malaysia

This Service Bulletin applies only to aircraft intended for registration in Malaysia

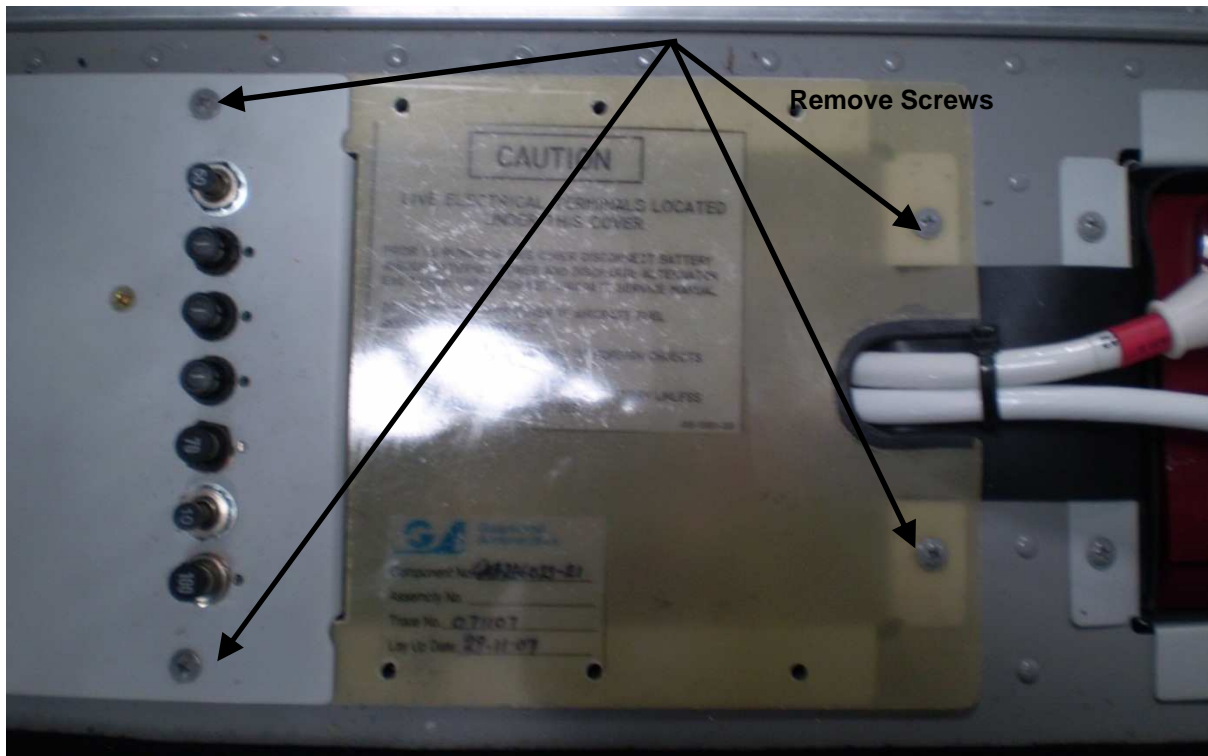
**Figure 1 :** Screws to be removed to gain access to internal assembly of the solenoid box

3. Gain access to the internal components of solenoid box by removal of screws as noted in Figure 1. Take care not to damage the heads of the screws when undoing them. Remove the fibre glass sheet. Refer to the GA8 Service Manual Section Chapter 24 taking specific note of the warning in Section 24-00-00.

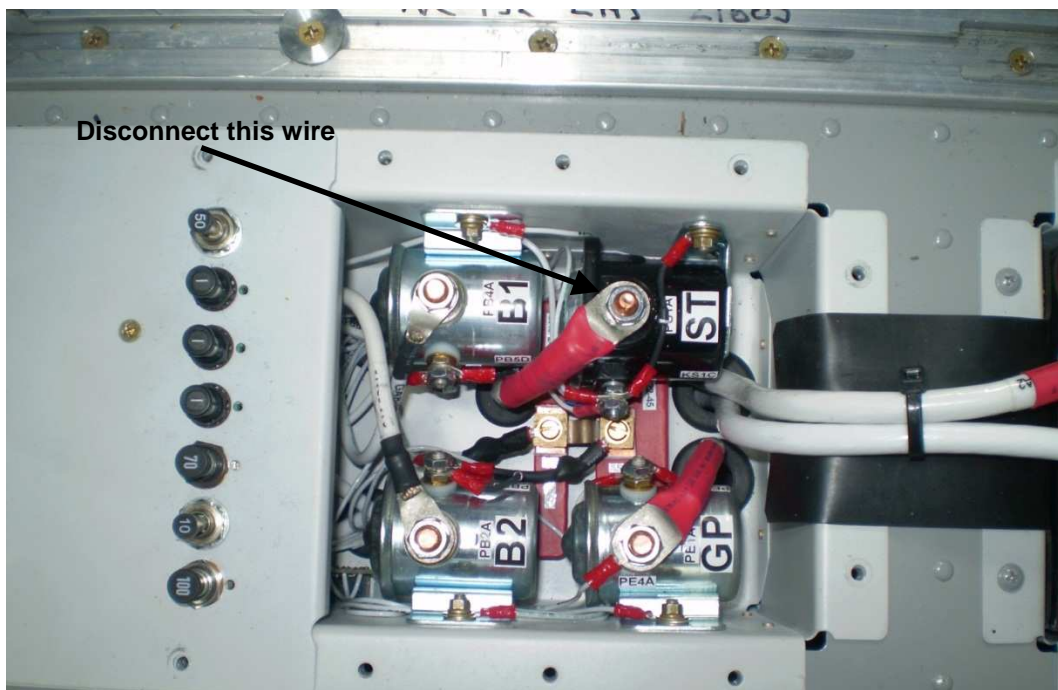
**Figure 2 :** Location of circuit PS1A2

4. Disconnect circuit PS1A2 from the Starter Solenoid. Refer to Figure 2.
5. Fabricate a single wire assembly, circuit WM1A22 as shown in Figure 3.
6. Combine the ring terminals associated with circuits PS1A2 and WM1A22 back onto the solenoid electrical terminal.

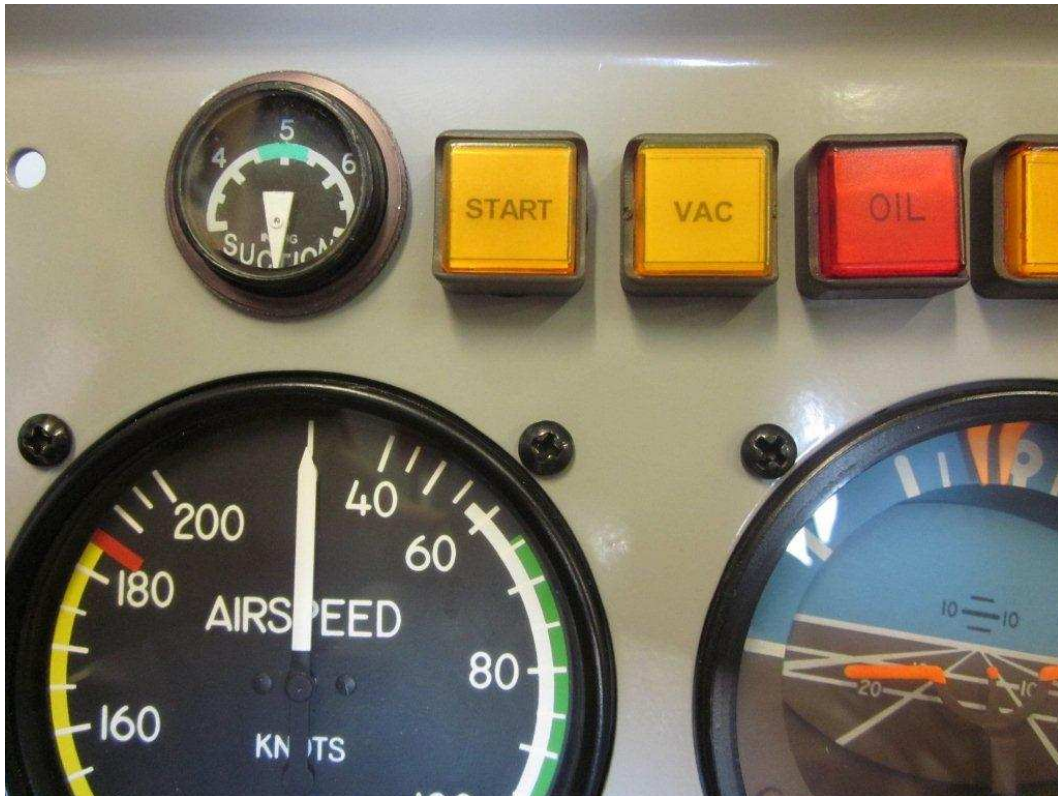
**Figure 4 : Completed Flight Instrument Panel**

12. Modify the "warning light" loom by inserting circuits WM1B22 and WM1C22 as shown in Figure 3.
13. Re-install the instruments (i.e. ASI, altimeter), loom, and annunciator into the new instrument panel. Figure 4 shows the flight instrument panel fitted with the START annunciator.
