99-2, *Publication Date: JANUARY 26, 1999*

Tire - Excessive Wear On One Front Tire - Vehicles Built Through 12/1997 Equipped With 14600, 16000, 18000 Or 20000 lb Front Axle	Article No. 99-2-7
--	-------------------------------

MEDIUM/HEAVY TRUCK:

1996-98 LOUISVILLE

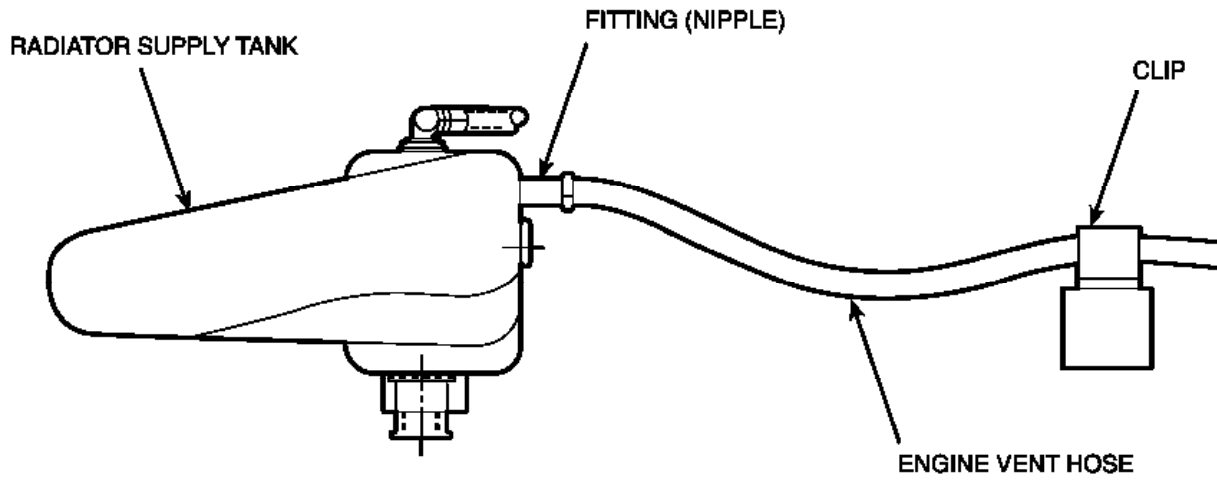
Figure 1 - Article 99-4-4

The radiator coolant supply tank vent hose nipple may break off at the tank connection. Engine vent hose routing may allow the engine to pull on the tank nipple during engine articulation.

1. Replace the coolant supply tank and associated hardware. Refer to the appropriate Louisville/AeroMax Workshop Manual, Section 303-03, or Service Manual, Section 03C-03.
2. Loosen the engine clip as necessary where the engine vent hose line is routed through and add 25.4mm (1") slack between the hose clip and the coolant tank nipple. The vent hose is sufficiently long to allow the 25.4mm (1") slack. Refer to «[Figure 1](#)».
3. Retighten engine clip to retain the vent hose.

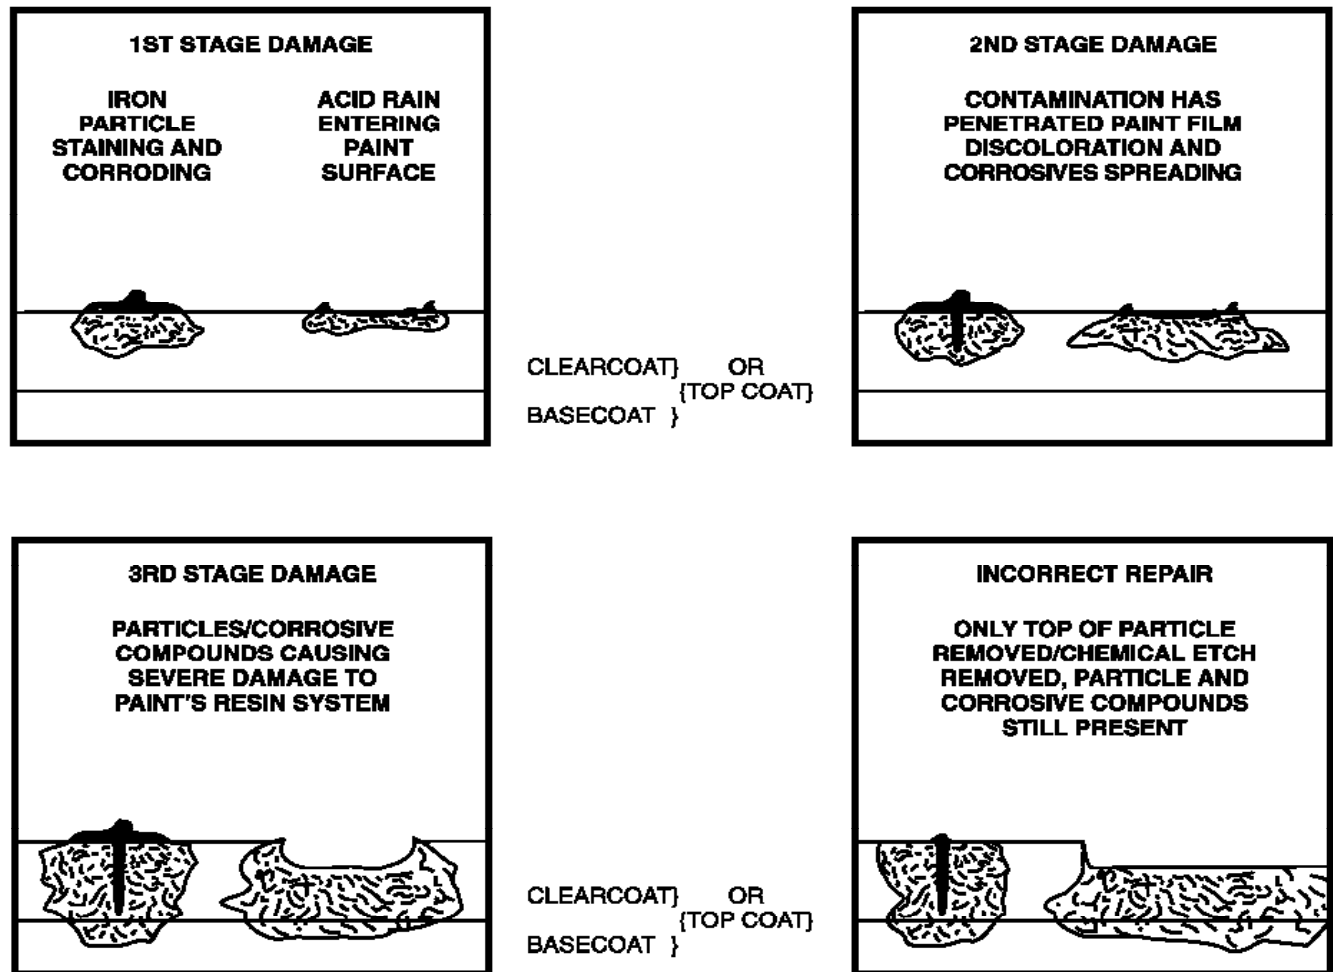
Figure 1 - Article 99-12-10

INDUSTRIAL FALLOUT (IFO) is a general term used to identify Rail Dust, Brake Dust, Ferrous Metal, Alkaline/Crystalline Deposits, Water Spots, Acid Rain, and other types of Environmental Contamination.

Studies conducted have shown the use of Oxalic Acid ferrous metal removers actually contribute to further damage of the paint's resin system, creating long term damage, which may not be evident for months. Additionally, Oxalic Acid products may damage soft exterior trim, aluminum trim and soften the paint.

The use of "clay" type products does not remove the entire ferrous particle or environmental contamination. Clay removes only the top of the particle and stain generated by the contamination, leaving the particle imbedded and the corrosive chemical compounds generated by the contamination in the paint system.

The particles and/or chemical compounds are still present and they continue to generate damage. Color sanding, buffing, or compounding the paint film to remove ferrous metal, industrial fallout, or acid rain damage may not remove the entire cause of the damage (they treat only the symptom and not the cause). The chemical compounds are still in the paint system and will continue to damage the paint. Color sanding and buffing may result in excessive removal of clearcoat film. Removal of OEM clearcoat in excess of 0.3 mil may contribute to premature clearcoat failure and is not recommended.

THE DECONTAMINATION PROCEDURE DIRECTED IN THIS BULLETIN MUST BE PERFORMED BEFORE ANY BUFFING, POLISHING, COLOR SANDING, OR REFINISHING IS ATTEMPTED.
