# Service Bulletin

NUMBER 2939 40002

MODIFICATION OF  
DOMESTIC BATTERY  
CHARGING AND  
GROUND CIRCUITRY

00001 to 00645  
2900R  
MOTOR HOME  
AND  
2900C  
CLUB COACHES

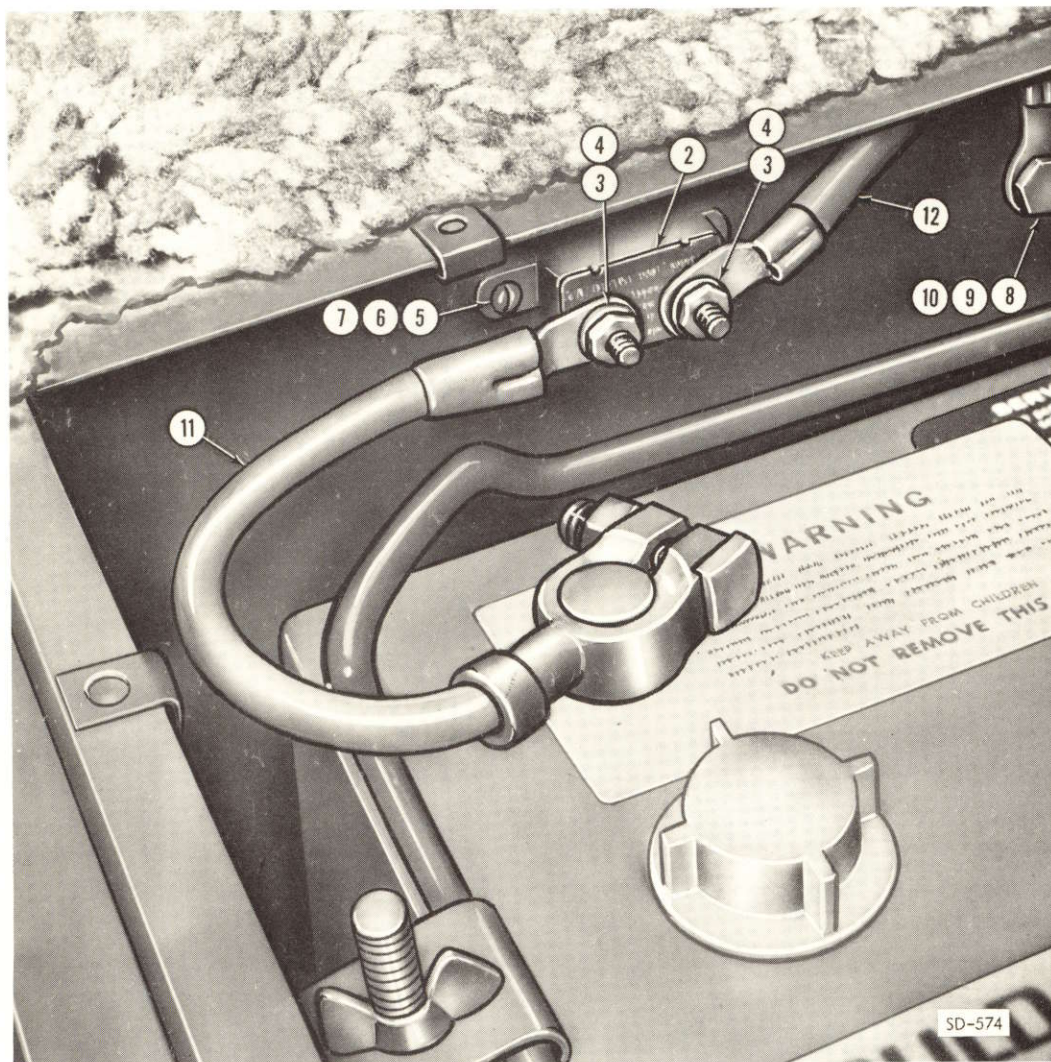
FIGURE 1. MODIFICATION OF DOMESTIC BATTERY GROUND LEAD

**DESCRIPTION** This Service Bulletin modifies the domestic battery charging input and ground circuitry by replacement of the converter fuse with a brass conducting link (slug) and installation of a 40 ampere circuit breaker (thermal-reset type) in the battery ground line. This modification minimizes the affects of high current spikes emmiting from the converter during APU starting or stopping.

ATTENTION: SERVICE MANAGER AND OWNERS		GROUP 39
<u>ACCOMPLISHMENT INSTRUCTIONS</u>  1. Remove AC power from coach (APU inoperative and service line disconnected). Turn off all DC operated domestic components and position the refrigerator thermostat knob to the "OFF" position.  2. Replace converter 50 ampere fuse with conducting link (item 1) as follows:  <u>a.</u> Gain access to converter bus fuse clips by opening the hinged access door on the front of the converter.  <u>b.</u> Locate and remove 50 amp fuse (largest fuse in converter).  <u>c.</u> Insert conducting link (Item 1) in fuse-holder clips then solder in place at both upper and lower clip.  <u>d.</u> Close converter access door.  3. Modify the forward domestic battery ground lead as follows:  <u>a.</u> Remove access cover from domestic battery compartment.  <u>b.</u> Loosen cable clamp nut and using a screw type cable puller, disconnect existing ground lead from forward battery negative terminal and cut off at opposite end at the ground screw on the inboard wall of the battery compartment; discard lead.  NOTE Do not remove the smaller white lead (refrigator ground) from the ground screw; retighten ground screw/nut with white lead remaining connected.  <u>c.</u> See Figure 1. Install circuit breaker as shown with the copper terminal stud out-board, on forward wall of compartment by attaching through existing vent slot with two screws (item 5), two lockwashers (item 7) and two nuts (item 6).		SUBJECT

ATTENTION: SERVICE MANAGER AND OWNERS	GROUP
<p><u>d.</u> Drill 1/4 inch diameter hole in forward wall of battery compartment about 4 inches to the inboard and slightly lower than circuit breaker. Grind or sand off area around hole to insure good ground connection for next step.</p> <p><u>e.</u> Attach the 1/4 inch ID ring end of cable assembly (item 12) to mount hole drilled in previous step, with screw (item 8), lockwasher (item 10) and nut (item 9).</p>	SUBJECT
<p><u>f.</u> Attach opposite end of cable (item 12) to inboard terminal stud of circuit breaker with lockwasher (item 4) and nut (item 3).</p> <p><u>g.</u> Attach the ring end of cable assembly (item 11) to the outboard (copper) terminal stud of the circuit breaker with lockwasher (item 4) and nut (item 3).</p>	MODEL (S) AFFECTED
<p><u>h.</u> Install cable (item 11) terminal clamp on negative post of the forward battery and tighten clamp nut.</p>	(Factory Use Only) Information added to:
