# SELECTED SERVICE DIFFICULTY REPORTS

1 April 2008 – 31 May 2008

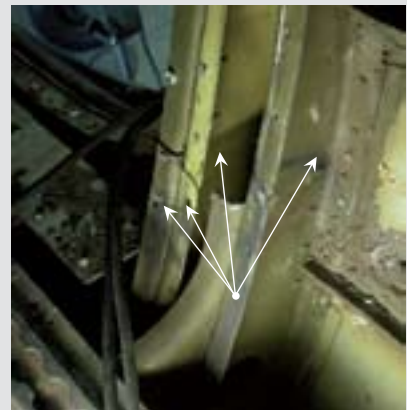
**Cessna 441 Fuselage frame cracked. Ref 510006365 (photo below)**

Fuselage frames cracked. Frames located LH corner of forward door pillar and at Stn 155.76, Stn 235.75, Stn 246.00 and Stn 247.87. TSN: 21,875 hours.

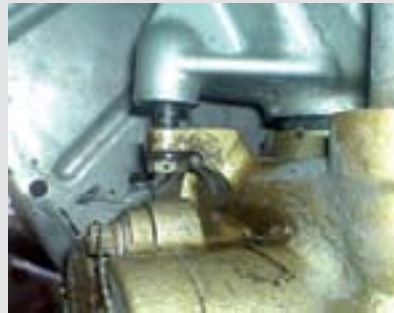
**PWA PT6T3B Engine accessory drive housing cracked. Ref 510006413 (photo below)**

No 1 engine leaking from oil transfer tube between accessory gearbox and combining gearbox. The O-rings were replaced but the leak persisted. Further investigation found the regulating valve attachment bolt helicoil had pulled out of the accessory gearbox and the mounting lugs on the opposite side had broken. Misalignment of the oil transfer tube caused wear in the housing bore allowing oil to bypass the O-rings.  
P/No: 3026669. TSN: 17,359 hours. TSO: 3,648 hours.
