TS 940 Mods

Expanded xmit for Kenwood TS-940S

TS-940S AGC circuit improvements

TS-940S Factory Assembly Mistakes

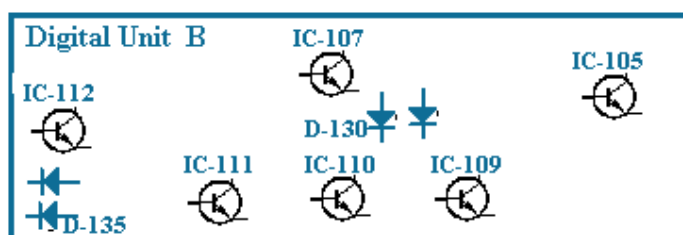
Locate IC number 109.

Now find diode 130 and cut it for all-band transmit.

If you want just MARS coverage, locate IC 111 and 112, and snip diode 135 beside it.

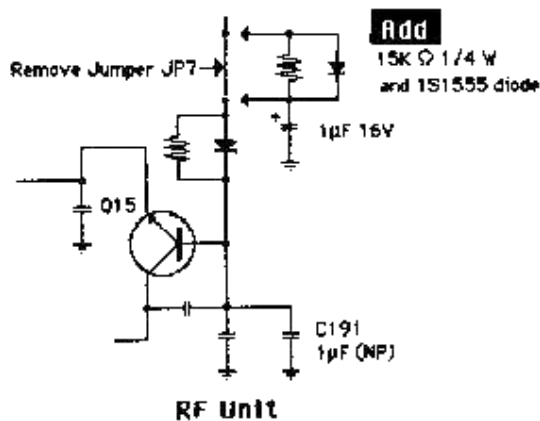
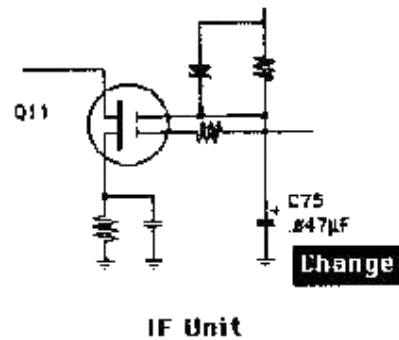
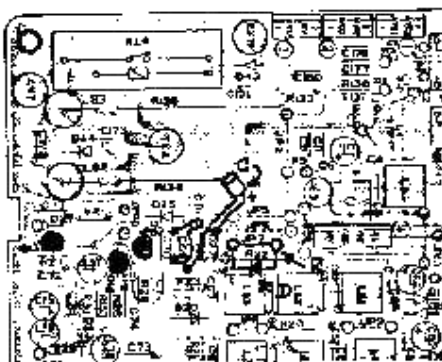
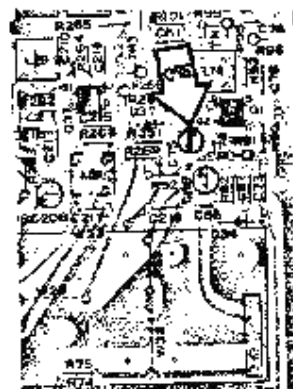
The following changes will improve the adjacent rejection of the TS-940S when a relatively strong nearby signal is present (s-4 or above).

Remove jumper wire JP7 and replace it with the parallel combination of the 15 Kohm resistor and the 1S1555 diode. Pay close attention to polarity.
 Add the 1 µF capacitor as shown in the diagram.

Change capacitor C75 from a 1 µF 50V capacitor to a .047 µF 50V capacitor.

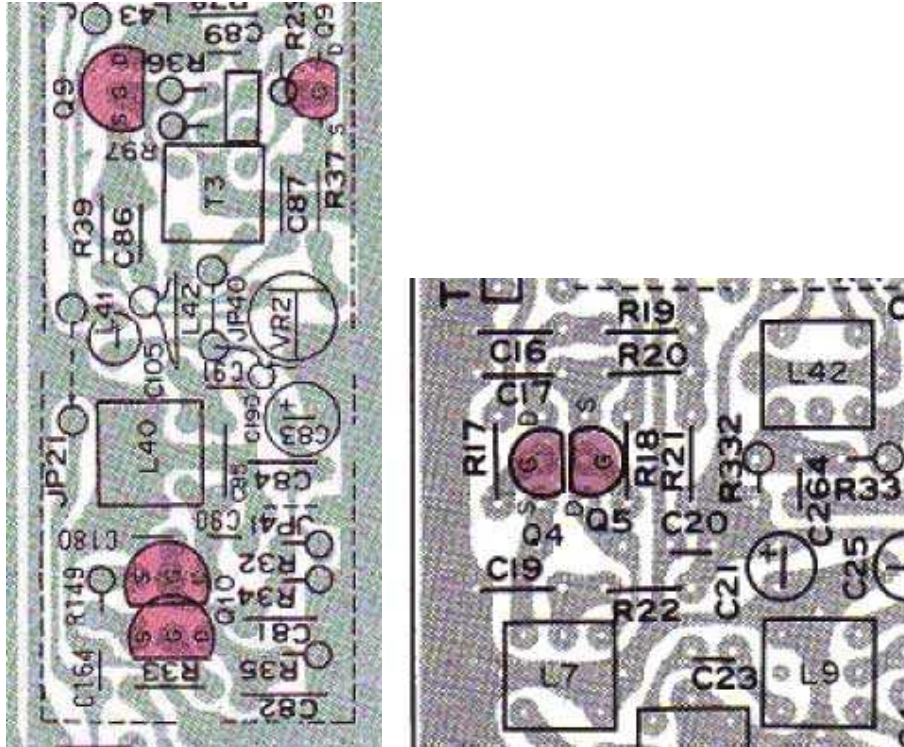
See the FETs Q10 (RF Preamp Preamp 2SK125, N-FET, 25V, 0.1A, 0.3W) and Q4 Q5 (2nd balanced mixer, also 2SK125).

The picture above was scanned from the TS-940S Service Manual, Revised Edition. In these pictures the FETs are in the wrong position.

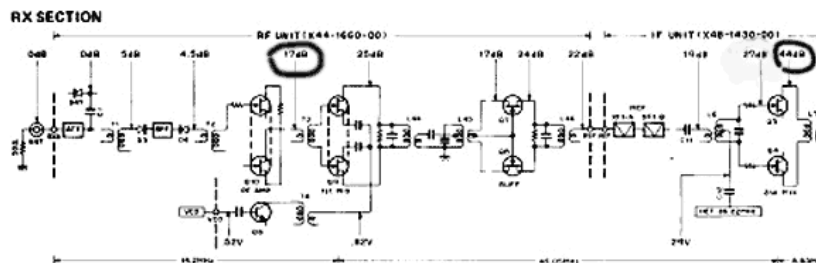
See the Level Diagram in the Service Manual. With the FETs on the right position, we would have 12.5 dB (17 - 4.5) gain in the RF Preamp, and 17 dB (44 - 27) in the 2nd balanced mixer at the indicated points in the picture above.

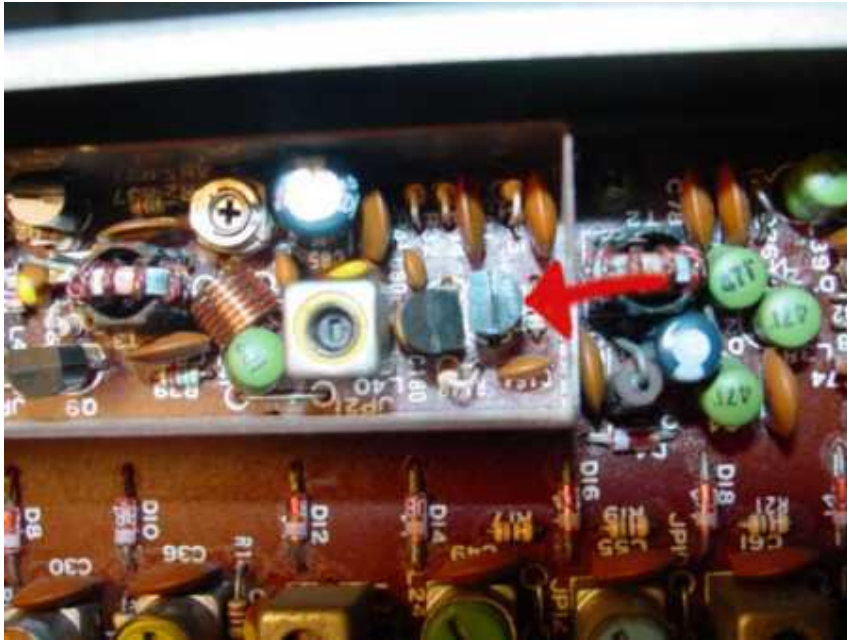
Preamp FET in a odd position, but only few days after I could focus and see that the cascode circuit was correct in the schematic diagram and wrong in the PC board. It was also wrong in the PC board view pictures in the Service Manual.

I also noticed that a FET was hotter than the other. It was as simple as disordered and turn the FET 180° and resolder it all over again.

This picture shows the FET in the correct position.

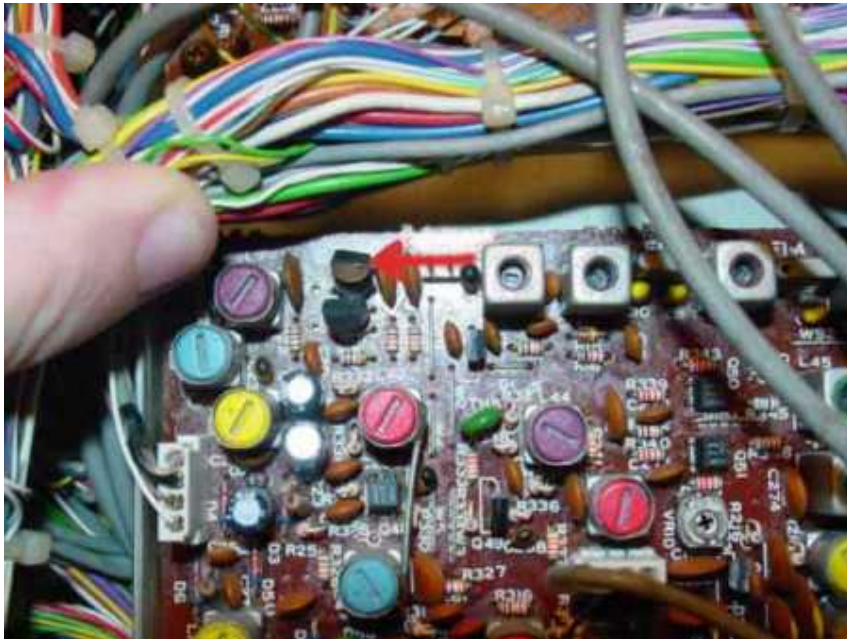
I got back to the Service Manual, and following the circuit diagram, checking the PC boards, I found a second mistake: in the 2nd balanced mixer, in the IF unit, another inverted FET (Q4), harming the mixing/conversion, the gain, and the AGC performance.

This picture shows the FET in the correct position.

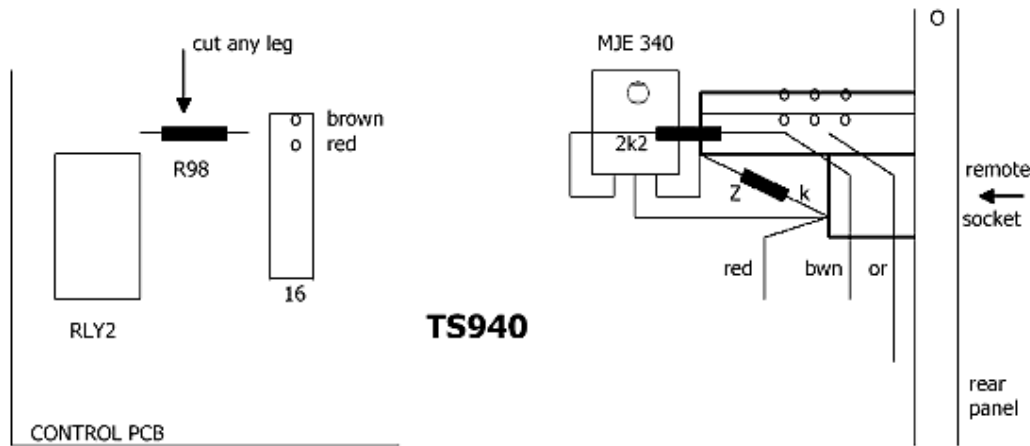
After many years of service the relay RL2 that activates the PTT to a linear amplifier can become unserviceable and its replacement is an elaborate process involving the complete removal of the Control PCB.

All this can be avoided by substituting the relay with a transistor that can be mounted physically on the Remote Socket and only one resistor leg needs to be cut on the Control PCB:

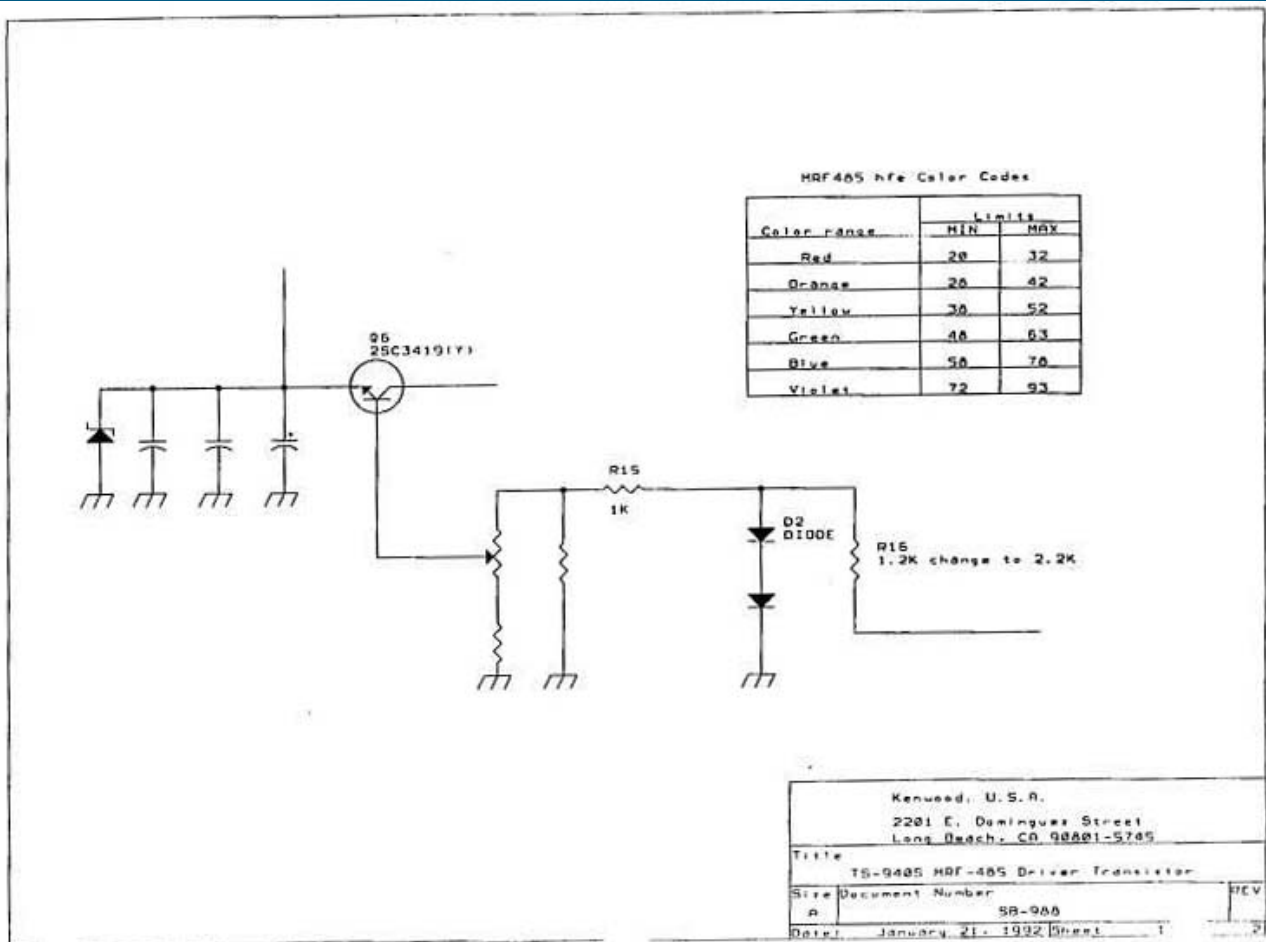
Some MRF-485 transistors are being supplied by Motorola with a Green or Blue color ranking. If these transistors are installed without modifying the driver bias circuit there is a strong possibility that they will fail within a very short time frame.

These high gain transistors cause the circuit to become unstable which can cause the circuit to break into self oscillation, and therefore self-destruct.

Use of Red, Orange, or Yellow hfe color rankings is recommended. These lower gain transistors work just fine and do not suffer from the circuit instability problem. If you are only able to obtain the high gain transistors you will need to modify the varistor/temperature compensation circuit on the final unit (X45-1400-00) by changing R16 from 1.2 Kohm to 2.2 Kohm.

Caution: If using a Green or higher hfe rank one of the above countermeasures must be taken depending upon the serial number of the set. After replacing the drivers check the bias current. We recommend transmitting for 1 hour in SBB mode with no modulation into a dummy load. After this time frame check the bias current. It must not exceed 300 mA on the original radio. If the current changes you must change R16 from 1.2 Kohm to 2.2 Kohm.

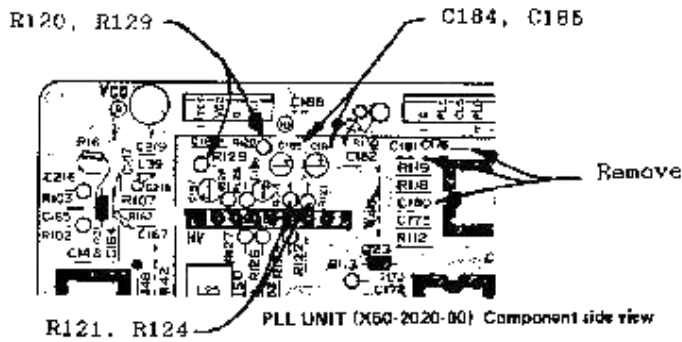
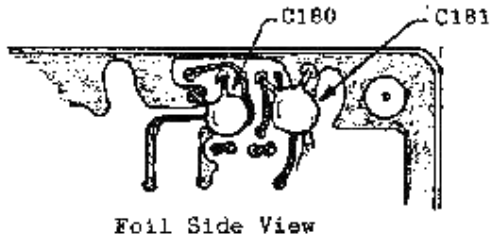
PLL UNIT

The Carrier to Noise ratio of the TS-940S may be improved by the following changes. This bulletin supersedes bulletin number 911 dated September 15, 1986.

On the PLL unit (X50-2020-00) remove capacitor C176, C180, and C181. Change resistor R120 and R129 from 470 ohms to 3.3 Kohm. Change resistor R121 and R124 from 1 Kohm to 680 ohms. Change capacitors C184 and C185 from .22 μ F to .33 μ F 35V tantalum capacitors. Install C180 and C181 in the positions shown in the accompanying diagrams. The use of new capacitors is recommended to improve reliability, don't try to reuse the old capacitors! Capacitors C181 and C180 should be attached to the foil side of the PLL unit.

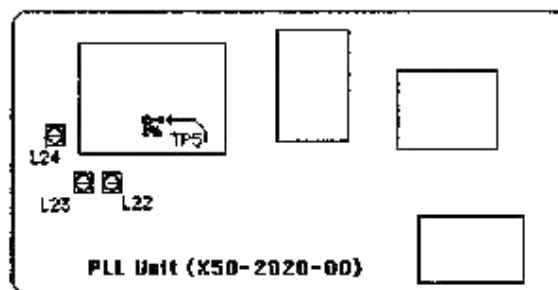
Some users of the TS-940S have reported a blanking of the display accompanied by a loss of transmit and receive. Readjustment of the PLL unit will correct this tendency.

Using an RF probe at TP5 adjust L22, L23, and L24 for a maximum reading on the meter. You should see approximately 250 mV.

Adjustment of L24 will produce the greatest change, which may be up to a 90° adjustment from its present position.

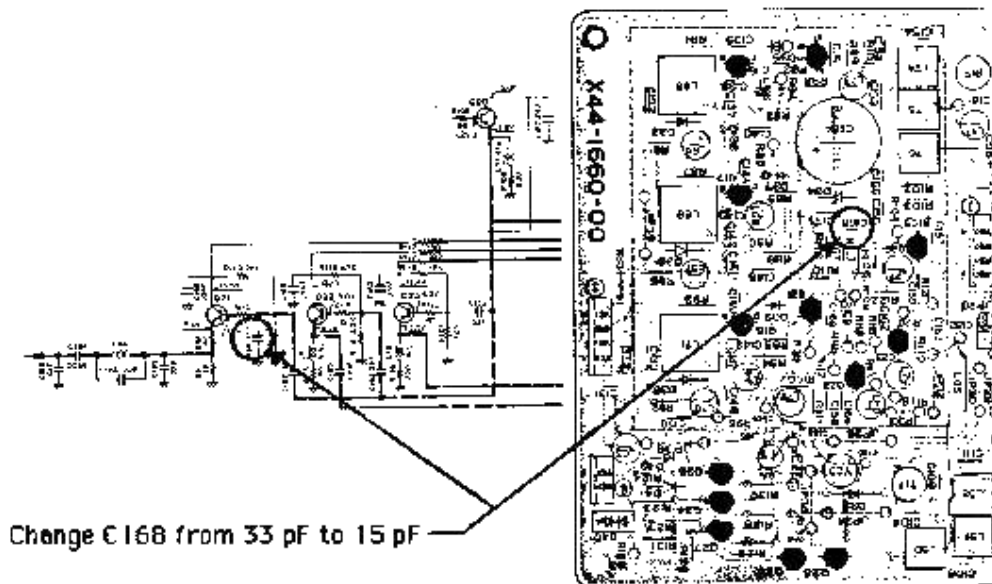
Reports of a PLL unlock on the lower frequencies may be due to low VCO levels. The following change will increase the VCO level and should prevent recurrence of this symptom.

Change C168 from 33 pF to 15 pF

On the RF unit (X44-1660-00) change C168 from a 33 pF capacitor to a 15 pF 50V capacitor.

Readjust the VCO BPF (RF unit L74-76) according to the instructions contained in the TS-940 Service manual.

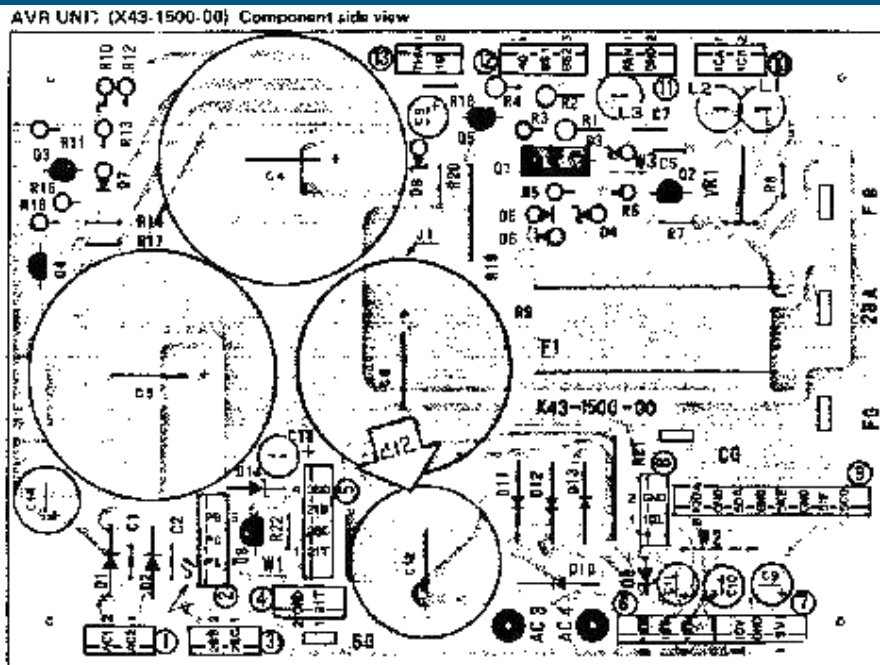
In those areas of the country that are subject to large power line voltage fluctuations, excessive voltage may be applied to capacitor C12 on the AVR unit (X43-1500-00). These voltage fluctuations might exceed the capacitor breakdown voltage. Replacing capacitor C12 with a capacitor having a higher breakdown voltage will help prevent this potential problem.

On the AVR unit (X43-1500-00) change C12 from a 6800 μ F capacitor to a 5600 μ F 25 V capacitor (C90-2037-05)
