HONDA Service Bulletin

08-045

February 17, 2011

Chirp From the Timing Belt Area

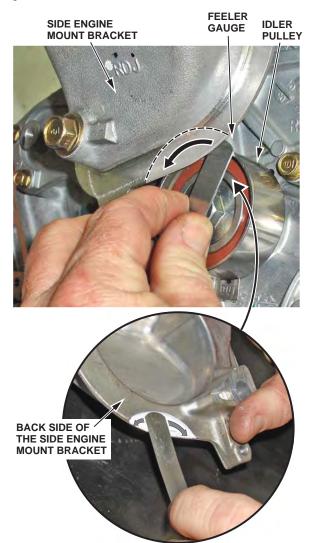
- 4. Remove the timing belt covers:
 - Refer to Section 6 of the appropriate service manual, or,
 - Online, enter keywords TIMING BELT, and select Timing Belt Removal fron the list.
- Try to insert a 0.95 mm feeler gauge between the top edge of the timing belt idler pulley and the back of the side engine mount bracket overhanging the pulley. This measurement is used to determine if step 12 is required.

NOTE: Remove the feeler gauge from its holder to get a more accurate measurement.

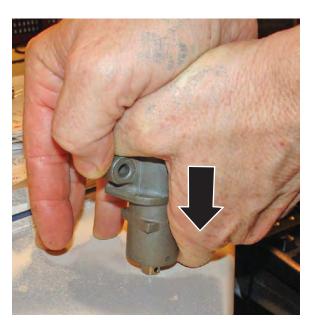
GOOD TENSIONER

NOTE: Remove the timing belt auto-tensioner, and inspect the tip of the piston for signs of damage. Test the tensioner by pushing it down against a flat surface. The tensioner should not compress. Replace it if it is damaged or if it compresses.

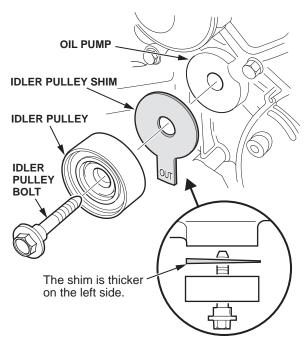
NOTE: The shim tapers from left to right. The word "OUT" is painted in white and stamped into the tang of the shim, and should be readable when the shim is installed.

08-045 3 of 5 15. Place the idler pulley shim between the idler pulley and the oil pump housing, and loosely install the idler pulley bolt with Hondalock 1 applied to its threads. Make sure to follow the assembly instructions on the Hondalock 1 container.
