01621 Version 1

AcuraLink[®] System Status Indicator Is Red and DTC B1403 Will Not Clear

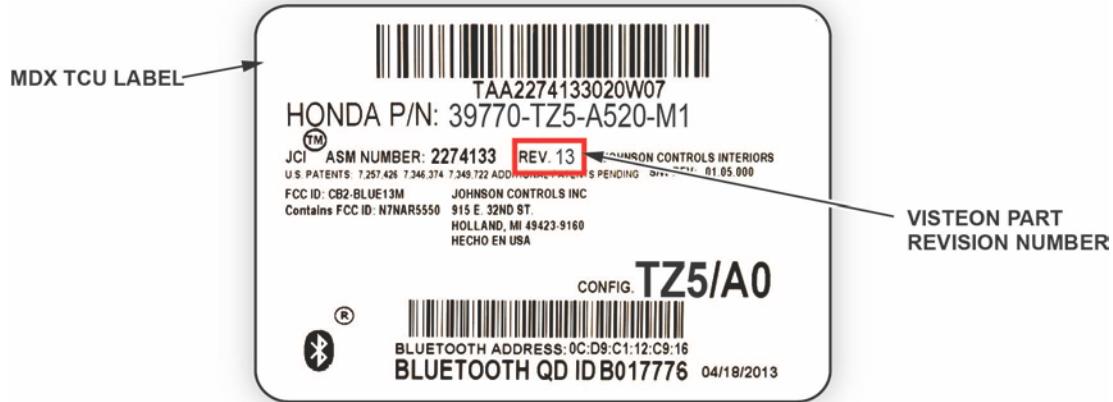
3. Check the label for the latest Visteon part revision number.
 - If the Visteon part revision number is 13 or above and the software revision number is 02.07.000 or above, the TCU is okay and this bulletin does not apply. Continue with normal troubleshooting.
 - If the Visteon part revision number is 12 or less and/or the software revision number is 02.06.000 or less, replace the TCU and go to step 4.

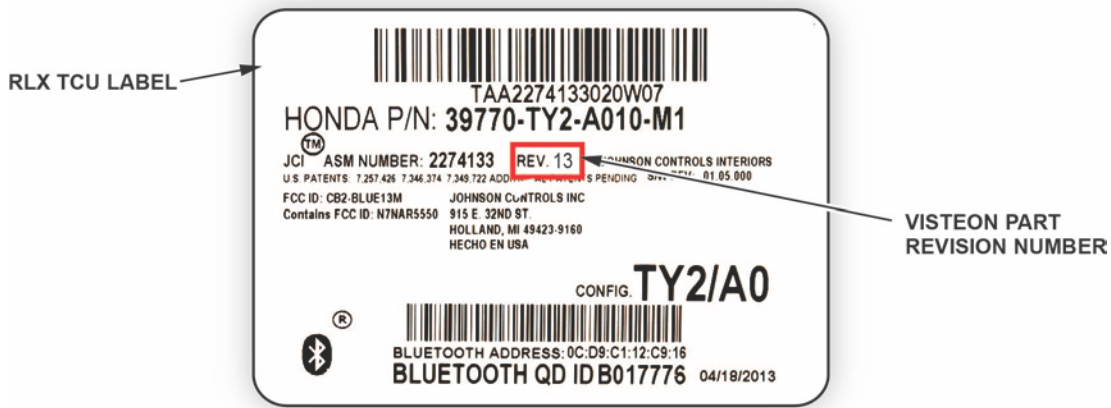
3. Check the label for the latest Visteon part revision number.
 - If the Visteon part revision number is 13 or above and the software revision number is 02.07.000 or above, the TCU is okay and this bulletin does not apply. Continue with normal troubleshooting.
 - If the Visteon part revision number is 12 or less and/or the software revision number is 02.06.000 or less, replace the TCU and go to step 4.

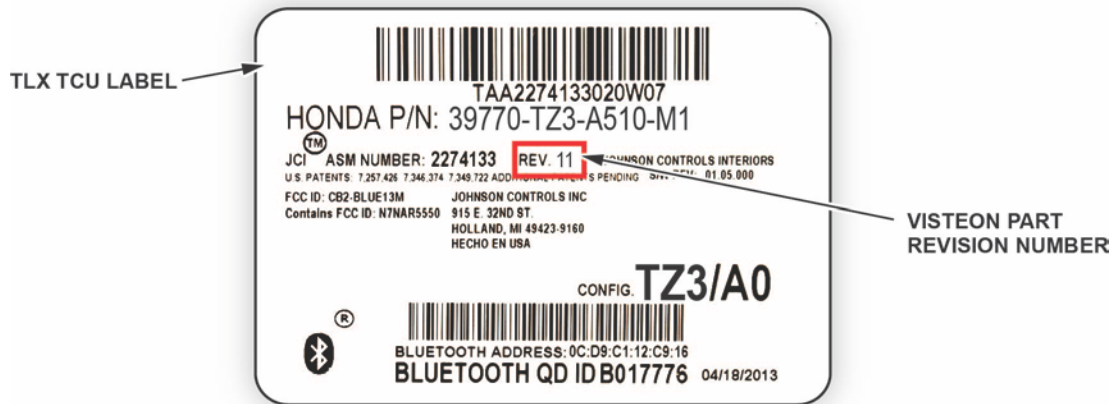
4. Check the label for the latest Visteon part revision number.
 - If the Visteon part revision number is 11 or above and the software revision level is 01.05.000 or above, the TCU is okay and this bulletin does not apply. Continue with normal troubleshooting.
 - If the Visteon part revision number is 10 or less and/or the software revision number is 01.04.000 or less, replace the TCU and go to step 5.
