RA07-004b

January 13, 2009

CLICKING NOISE FROM REAR AXLES

APPLIED VEHICLES: 2008 - 2009 G37 Coupe (CV36)
2009 FX35/FX50 (S51)
2008 - 2009 EX35 (J50)
2007 - 2009 M35/M45 (Y50)
2007 - 2009 G35 Sedan (V36)

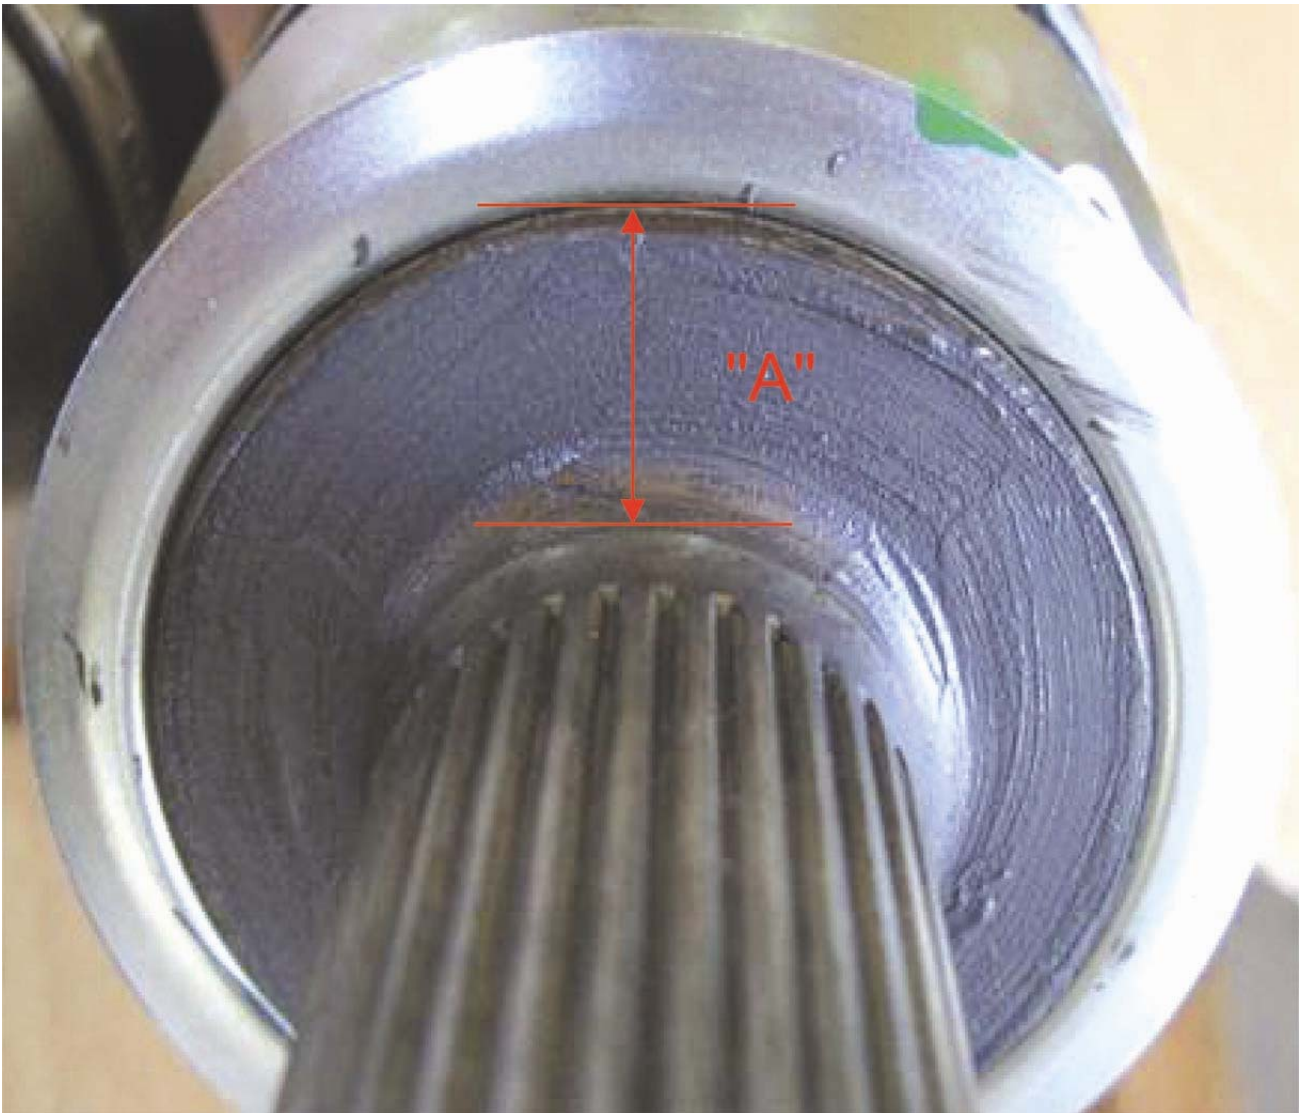
Figure 3

IMPORTANT: The amount of grease used is critical for success of the repair. **Do not** use too much or too little.

3. Clean the flange surface of the outer joint of the driveshaft.
4. Apply exactly 1.2-4.0g of Molykote M77 grease to the entire flat surface of the outer joint on the driveshaft.

- Cover the width shown in "A" below.
- Cover the entire circumference of that width.
- Cover it evenly.
